## D2.1 End User needs and practices report

Deliverable number	<b>D2.1</b>
Deliverable title	<b>End User needs and practices report</b>
Nature <sup>1</sup>	<b>R</b>
Dissemination Level <sup>2</sup>	<b>PU</b>
Author (email) Institution	<b>John Zeppos</b> <a href="mailto:John.zeppos@resiliencegard.ch">John.zeppos@resiliencegard.ch</a> (RG) <b>Maria Krommyda</b> <a href="mailto:maria.krommyda@iccs.gr">maria.krommyda@iccs.gr</a> (ICCS)
Editor (email) Institution	<b>Nikos Frangakis</b> <a href="mailto:nikos.frangakis@iccs.gr">nikos.frangakis@iccs.gr</a> (ICCS)
Leading partner	<b>RG</b>
Participating partners	<b>ALL</b>
Official submission date:	<b>01/10/2019</b>
Actual submission date:	<b>11/12/2019</b>

This work is a part of the HYPERION project. HYPERION has received funding from the European Union's Horizon 2020 research and innovation programme under grant agreement no 821054.

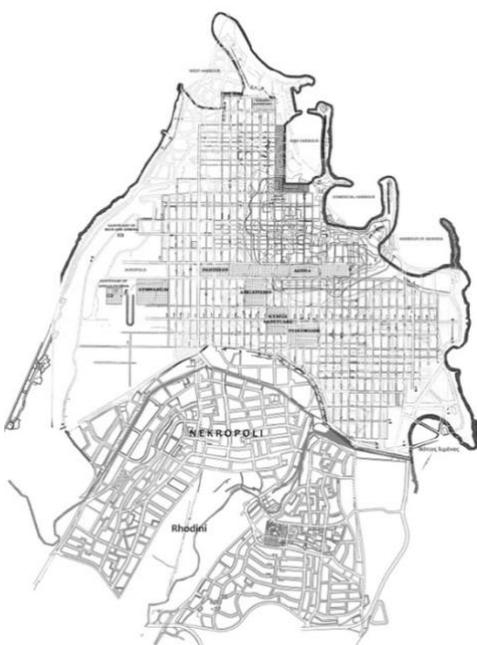
Figure 1 Urban Plan of the ancient city of Rhodes

The ancient city of Rhodes, as shown in Figure 1, was founded in 408 BC, in the place of the modern city of Rhodes. It was the capital of the federal Rhodian state, created after the unification of the three old city-states of the island, Ialysos, Lindos and Kamiros. The new capital was meant to become one of the most important metropolises of the Hellenistic World; it was planned according to the Hippodamian urban system, which provided straight continuous streets, oriented North to South and East to West, division of the city in zones of different functions and residential insulae of equal dimensions, arranged in successive terraces following the geological relief. The acropolis of the city, with the stadium, the gymnasium, temples and grotto sanctuaries, was lying on the hill to the west of the city. The agora was located to the east, close to the harbors, in the place of medieval town. South of the city, just outside the fortification walls, the necropolis was extending; it was one of the biggest necropolises of the ancient world. Two streams divided the necropolis in three sectors. The stream of Makri Steno to the west, preserved until the Second World War, is today transformed into a roadway and buildings are constructed inside its bed. The eastern stream, the Rhodini stream, is preserved in all its length; along its banks the monuments that are going to be monitored by the Hyperion project are located.

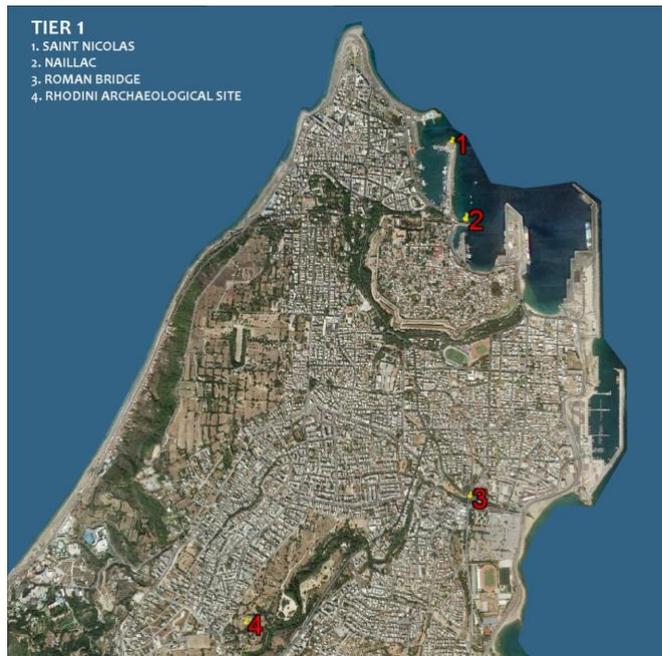
Figure 2 Tier 1 Buildings - Rhodes

**1. Saint Nikolas lighthouse and fort** at the entrance of the Mantraki port (part of the medieval fortifications with a waterfront location).

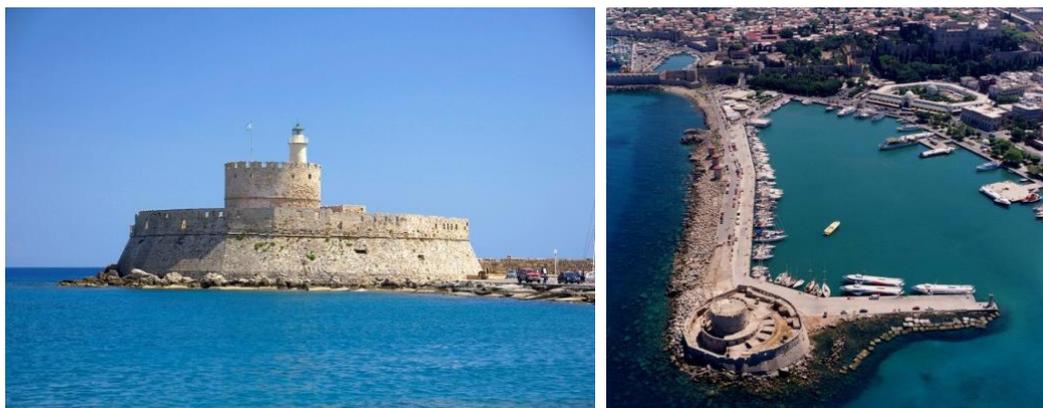
Figure 3 Saint Nikolas lighthouse and fort

The fortress of Saint Nikolas is a single stronghold that occupies the northern tip of the homonymous pier. It includes consecutive reinforcements and expansions after the destructions it suffered from sieges, during which it acted as “a key to the defense of the city”. It was built by the duke Philip of Burgundy in 1464-67. Previously, there was only a small chapel dedicated to Saint Nicolas at the same place, which was turned into a fort by the Egyptians when they invaded and was used to bomb the town. The walls around the fort of Saint Nicolas were built by Grand Master Pierre d’ Aubusson, who also restored the damage suffered by the fort during the Turkish siege in 1480. The fort was transformed into a lighthouse in 1863.

The island of Rhodes, is greatly affected by intense winds and the saline humidity coming from the sea. Especially the fortification walls and Saint Nikolas lighthouse, which is a Tier 1 building for this study.

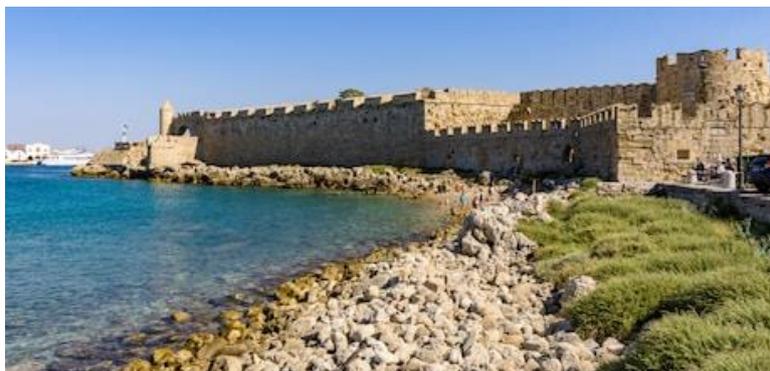
Figure 4 Nailac Pier

2. **Nailac Pier** at Saint Paul's rampart. (part of the medieval fortifications with a waterfront location). Nailac pier and rampart was constructed around 1400 on the Hellenistic pier and it was part of the fortification of the "Great Port", the Commercial Harbour of Rhodes.

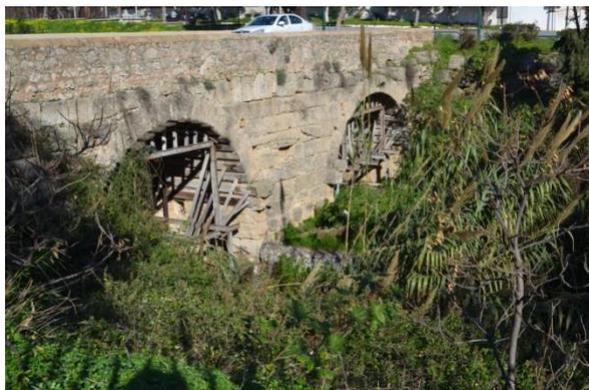
Figure 6 The Roman bridge east facade

3. **The Roman bridge.** The bridge was built across the stream of Rhodini, a few meters before its outfall to the sea. It is a monument of particular archaeological importance, since it is one of the few ancient bridges surviving in Greece, being furthermore in use until today. The bridge belongs to an enclosed archaeological site, where part of the Hellenistic fortification wall of the city is preserved. The stream of Rhodini that flows along the fortification, served here as a natural defense motte. The bridge is built in isodomic masonry, without employment of connecting mortar; it has two arched openings, 6.50 m. wide and 8.20 m. high. Previously it was dated in the Hellenistic Period, however in more recent studies, specialized in bridge construction, is dated in Roman period. Later repairs are noticed at the piers of the arches.

The Roman bridge is in continuous use from Antiquity until today, since it is located in the main exit of the city towards the east coast of the island. The traffic, in particular the crossing of heavy vehicles, has deteriorated the static competence (efficiency) of the bridge and caused fissures in its masonry, widening of the joints between the stones and falling of stones. The wooden scaffolds, that temporarily sustain the arches, are partially destroyed and at risk to collapse. Although consolidations work has been carried out a few years ago on the banks of the torrent, the flow of the water is blocked impeded by the dense vegetation and the elevation of the initial riverbed by the modern one, made of reinforced concrete. Furthermore, the water passes only through the southern opening, while the north one is filled with alluvial debris.

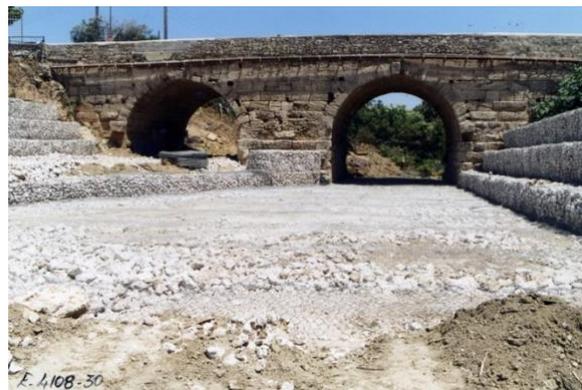
Figure 5 The Roman bridge west facade

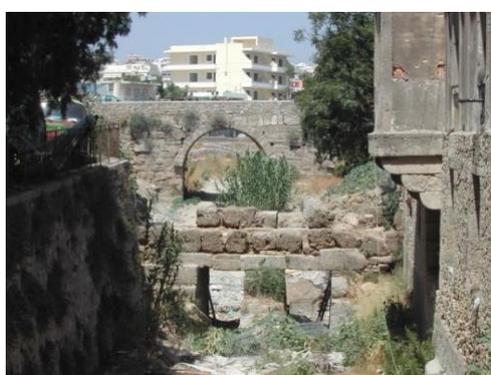
Figure 7 The dam east of the Roman bridge

A few meters east of the bridge there is a second bridge or dam of very different architectural form. It is built with rectangular sandstones and has three relatively narrow rectangular openings, which were closed and opened with movable slabs, regulating the flow of the water. The length of the structure is 10 m., the width of the passageway 2.50 m. The date of the monument is still under discussion; initially it was dated in classical or Hellenistic period, recently though it was discussed that it might be dated after the Roman times.

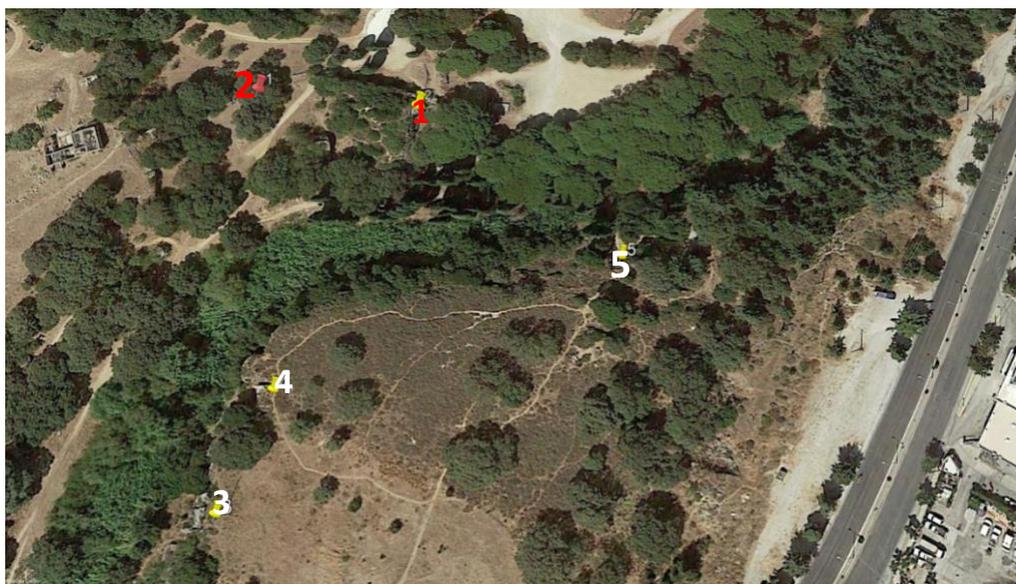
Figure 8 Rhodini. 1. “Tomb of the Ptolemies”. 2. Grave enclosure with shields (to be monitored by Hyperion project) and “Korinthian Tomb”. 3. Sanctuary with vaulted-roofed chambers. 4. Grave enclosure. 5. Grotto sanctuary.

The monumental graves preserved in Rhodini are dated in the Hellenistic period, in the 3<sup>rd</sup>- 2<sup>nd</sup> century BC. They are concentrated in the southern part of the Archaeological site, around the so called “Tomb of the Ptolemies”, a maussoleion type tomb of big dimensions, cut into a rocky hillock. The other tombs are hewn on the high rocks faces framing the stream-bed. They are formed as enclosures, open towards the stream and their main characteristic are false facades cut above the graves. The false façade of the so called “Korinthian tomb”, lying at a distance of few meters to the west of the “Tomb of the Ptolemies”, consists of semicolumns and false doors. Another grave enclosure adjacent to the “Korinthian tomb” has pedestals and arched niches for the placement of funerary altars as well as relief stele sculptures; on the pedestals and under the niches circular shields are barely visible due to the erosion of the rock. To the opposite bank of the stream a sanctuary with two vaulted-roofed chambers, and another grave enclosure with two staircases on its corners, leading from the upper terrace into the stream bed, are also preserved. Another grotto complex, created after quarrying of the rock, it was probably a sanctuary dedicated to chthonic deities. A roadway passing through the grottoes in an Italian intervention.

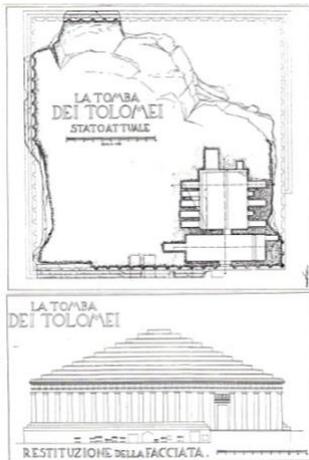
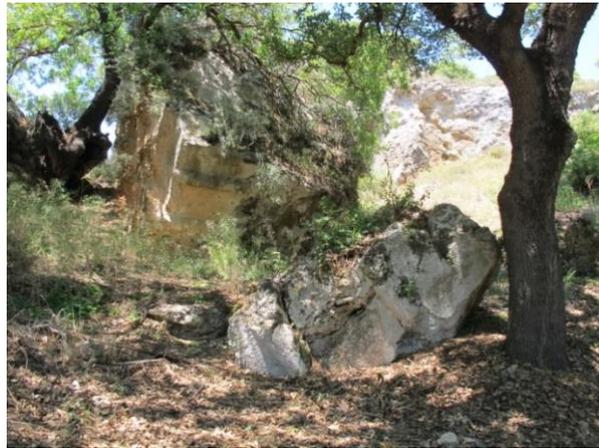
Figure 9 The tomb of the Ptolemies

The environmental conditions and the microclimate of the area, in which critical role plays the stream of Rhodini, in combination probably with extreme natural disastrous events, such as earthquakes, have caused severe damages to the tombs ranging from the erosion of their stucco-coated facades, as at the “Korinthian tomb”, to fissuring, detachment and collapse of the monuments. More severely affected are the **“Tomb**

of the Ptolemies”, great parts of which have been detached from its back side, and the grave enclosure with the shields, whose south wall is crossed by numerous fissures, inside which an oak tree is grown. The conservation status of the wall is constantly deteriorating, there is a rapidly aggravating inclination from the vertical and the monument is thus in imminent danger to collapse in pieces.

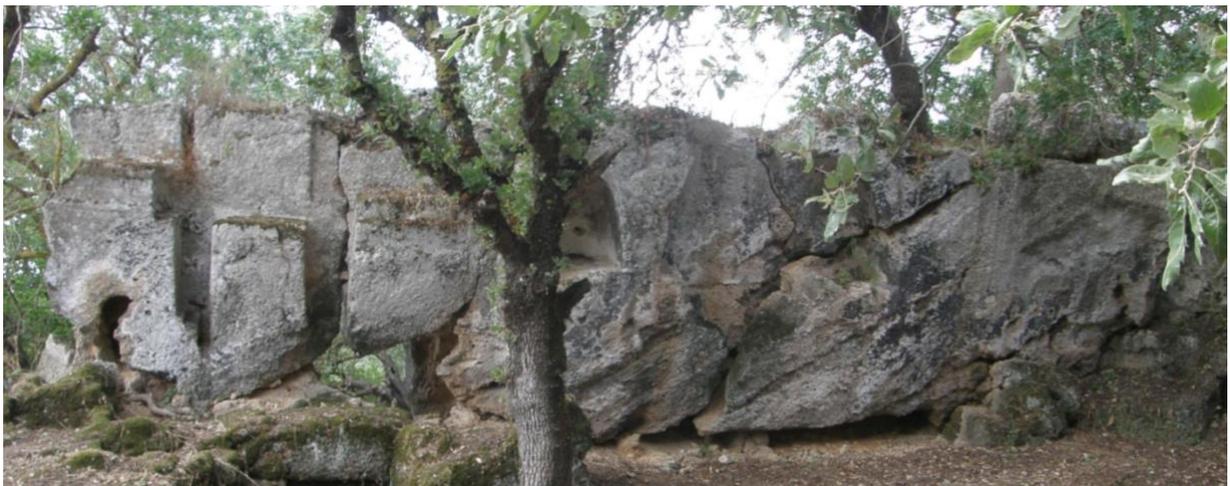
Figure 12 Rhodini. Grave enclosure with pedestals, niches and relief shields

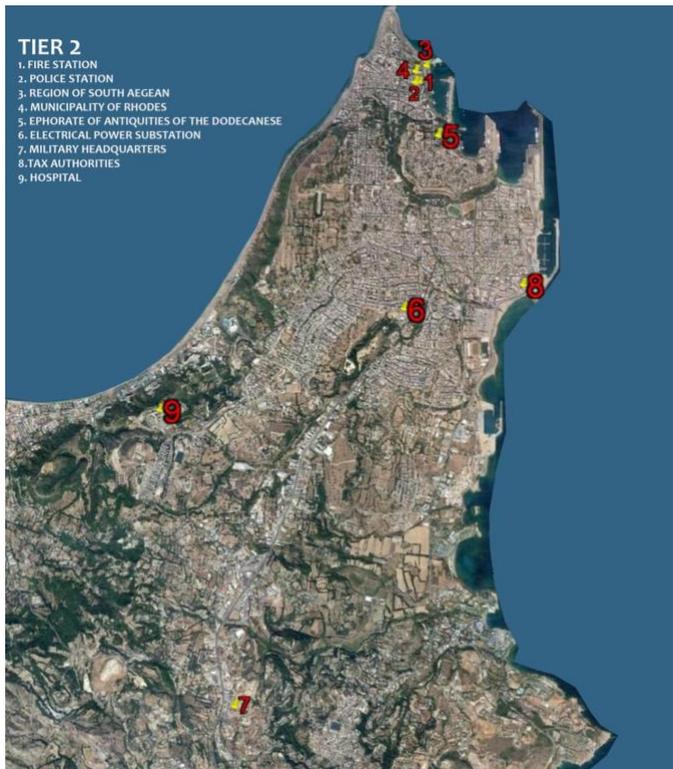
Figure 14 Tier 2 buildings - Rhodes

Buildings that are important for the Business Continuity and financial sustainability of the study area are included in the Tier 2. These building, presented in Figure 14, are:

1. Fire station. Operational as well as CH building
2. Police station. Operational as well as CH building
3. S. Aegean Regional building. Operational as well as CH building
4. Municipality of Rhodes (City Hall). Operational as well as CH building
5. Central offices of Ephorate of the Dodecanese islands. Operational as well as CH building
6. Electrical power substation. Operational building
7. Military Headquarters. Operational building
8. Public services building. Operational building
9. Regional Hospital. Operational building

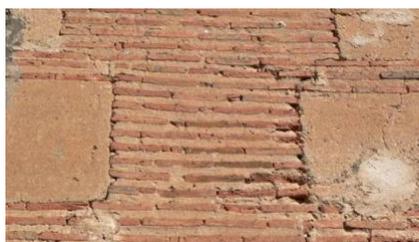
Figure 18 Rammed earth construction, locally named as "tapial".

Several types of structural elements are present in the CH of Granada city: rammed earth, bricks, stone (limestone), wood, bricks and mortar. Rammed earth construction (locally named as "tapial") was widely used during the Islamic period of Granada. It is often reinforced with bricks so the rammed earth is used as an in-fill.

In this case, the wall is built between brick masonry as wall reinforcing, and can also appear brick rows between successive walls. These reinforcements can remain outside or be hidden behind a scab that covers the entire wall. These brick reinforcements are arranged and displaced in each course, so that they constitute the lateral reinforcement of each rammed earth module and, in addition, each wall moves with respect to the lower one.

The main cause of deterioration of the rammed earth are water ingress, low dry capacity, salt transport, biological attack, and the different mechanical behavior among the different materials used. As possible hazards are identified the flooding, which will increase the presence of water in the rammed earth; the extreme heat, which may trigger the effect of expansion that produce the loss of cohesion in the material; and the long period of return earthquakes, which will increase the action over the structures that has to be considered, among others. In relation to the rehabilitation, the mechanical incompatibility has been by large the most relevant misused in restoration of rammed earth. Proper mortars, compatible with each type of rammed earth, is the main objective when restoring this type of materials.

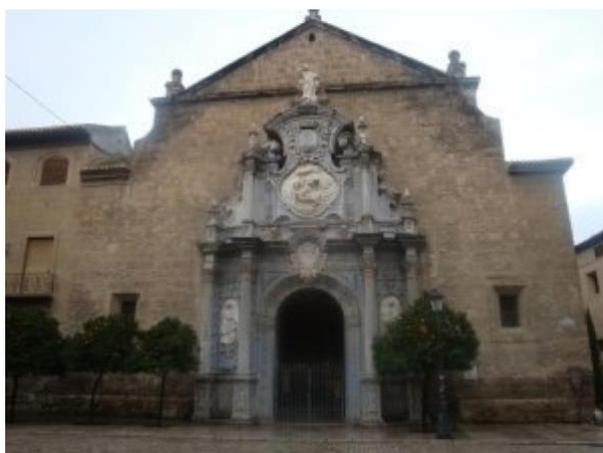
Figure 19 *Saint Justo and Pastor Temple*

Regarding to the porous lime stone, there are two main types of lime stones in Granada area used for construction material. One is the highly consolidated Elvira mountain range lime stone and the second is a characteristic porous lime stone used in walls in most of the main monuments built after the end of the muslim period (after XIV century). The *Saint Justo and Pastor Temple* is an example of both materials (**Error! Reference source not found.**). The main facade is the Elvira mountain range lime stone and the rest of the walls are the porous lime stone. This porous lime stone is very vulnerable to freeze thaw cycles as well as biological attack.

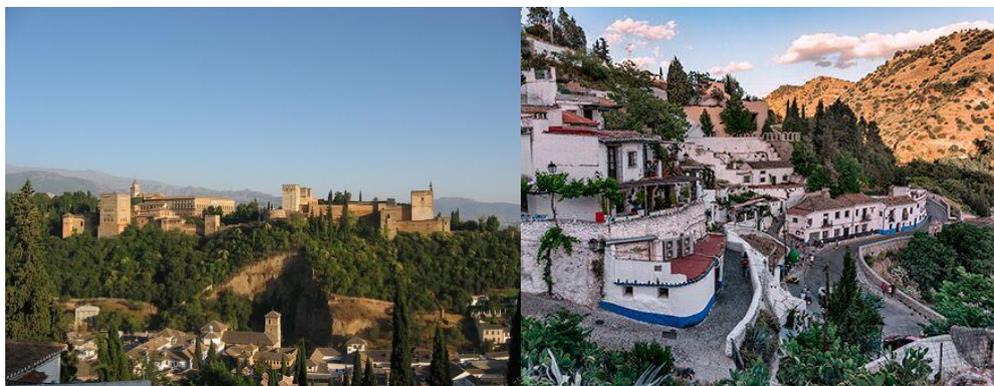
Figure 20 Sabika & Valparaiso hills

Another important material in Granada is the quaternary conglomerate, composed by a clay matrix with boulders. It is very common in the hills where several CH structures are located, such as some of the most important towers of the Alhambra Palace. For

example, *Sabika* is the hill of the Alhambra and *Valparaiso* is the hill of Sacromonte area. This quaternary agglomerate is very vulnerable to freeze-thaw cycles, where landslides are common, likely due to the climate change.

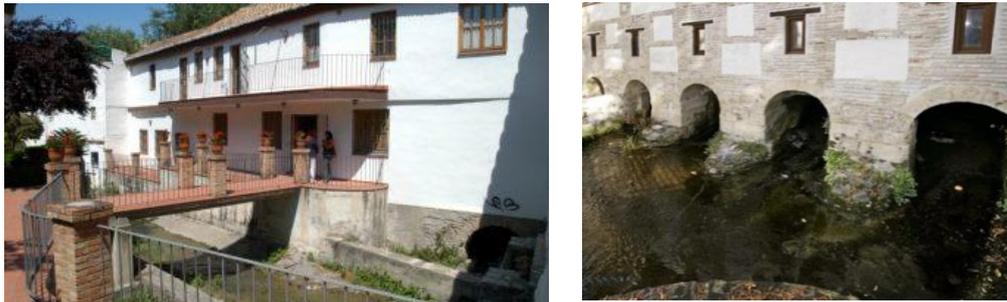
Figure 22 *The mill of the Marquis of Rivas* (Tier 1).

Inside Realejo area, the CH building named *The mill of the Marquis of Rivas* is selected to study it and classified as **Tier 1**. The main characteristic of this CH building is the rammed earth construction with bricks from XI century. This type of construction is highly vulnerable to the changes in the cycles of humidity. Consequently, it is more vulnerable than other constructions of the same period because it is a river mill. The most important variables, such as temperature and humidity, will be monitored by installing sensors around the building. For that, it is not necessary to get any special permissions since the CH building belongs to the Granada Council, who is a participant of Hyperion Project.

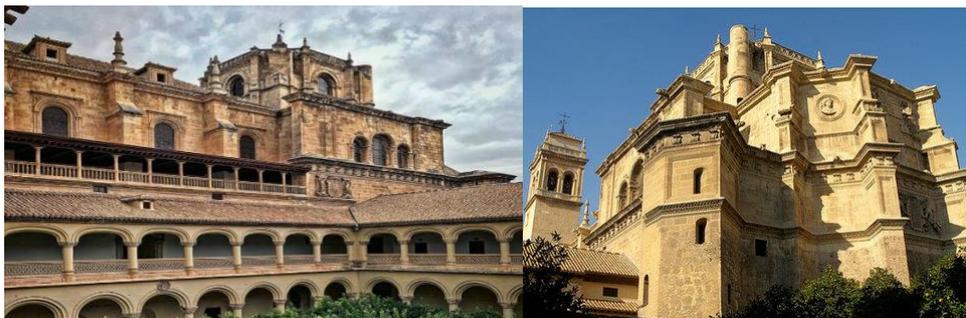
Figure 23 *Saint Jeronimo Monastery* (Tier 2).

The other selected CH building is *Saint Jeronimo Monastery*. It is classified as **Tier 2** since it is a very important building but it is not possible to get permission for sensor installations. Its main characteristic is the construction material, the porous lime stone. This type of construction is very vulnerable to freeze thaw cycles as well as biological attack. Satellite imagery and the accelerometer located at the School of Architecture will be used to inspection it.

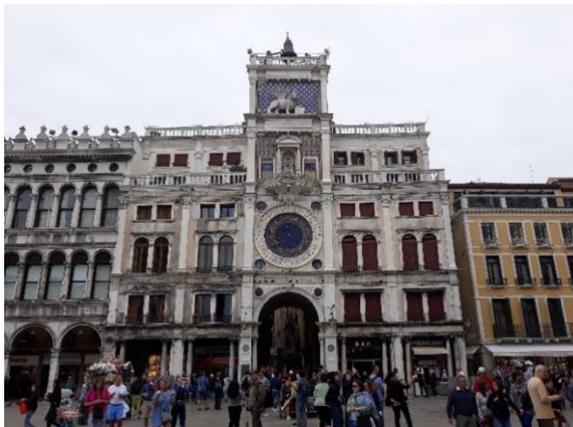
Figure 26 The clock tower

The Clock Tower, is one of the most famous architectural landmarks in Venice, standing over an arch that leads from St. Mark's square into what is the main shopping street of the city, the old Merceria. The tower with its large Astronomical Clock was designed by Mauro Codussi in the early 16<sup>th</sup> century, it was built with brick, stone and wood and covered with stone material. The monument that stands in the Marciana area, faces the city's waterfront and it

is therefore exposed to the sun, rain, high water, wind with all the saline humidity coming from the sea. In addition, the foundation of St. Mark square is lower than the rest of the city, and frequently subjected to the high water phenomenon, which comes directly from the large San Marco basin by wave motion. The presence of erosive salty water is massive, almost constant, and salt affects the buildings' masonry. Its position makes it a perfect place where to position specific devices to detect the polluting agents responsible for the deterioration of the building materials.

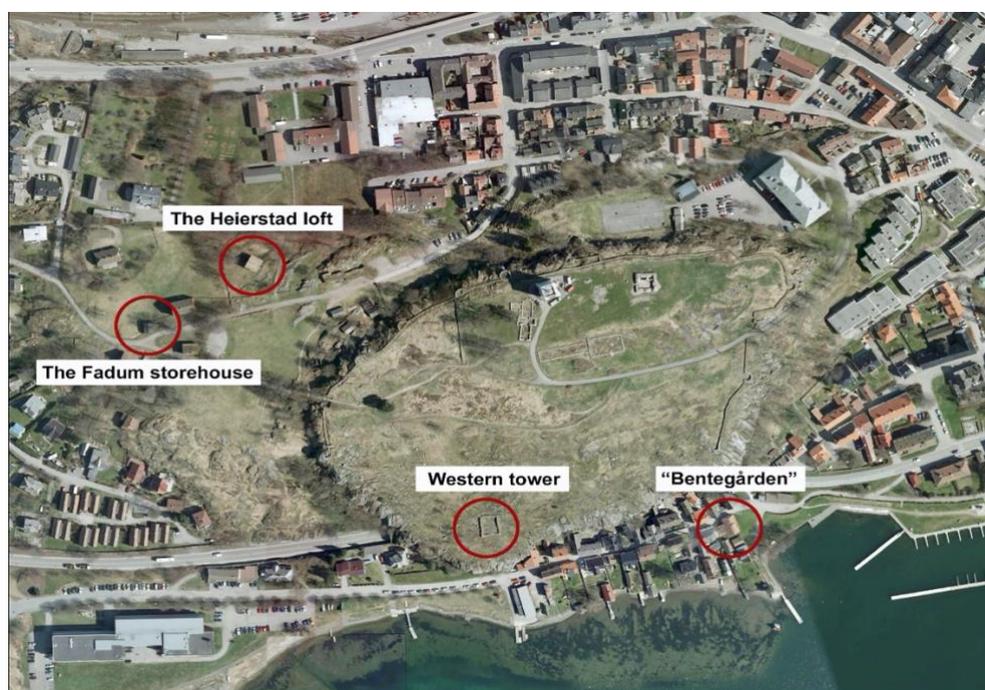
The proposed monuments and buildings selected for sensor installation and detailed modelling (Tier 1) include different types of objects in which both masonry and wood constitute the main material.

Figure 34 Part of the selected site with a stone building (ruin) and three wooden buildings indicated for sensor installation and detailed modelling (Tier 1 buildings)

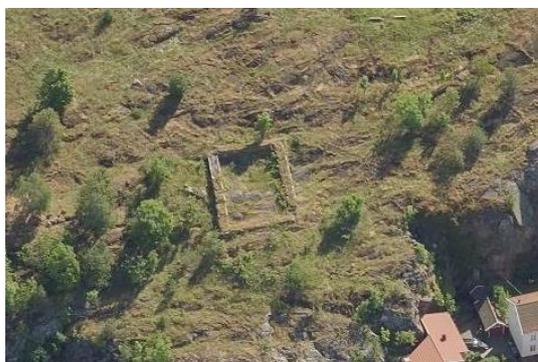
*Figure 35 Aerial view of the Western Tower ruin*

The ruin has a rectangular plan measuring ca. 16x13m. Masonry thickness varies between 1.2-1.7 m. The building material consists mainly of local stone (granite and porphyry), laid in shifts in varying sizes with traces of bricks. The ruin has starting to decay with loose stones as well as cracks in mortar joints and the protective, concrete top layer. The most relevant degradation factors are: general weathering, freeze/thaw cycles, biological growth and man-made hazards.

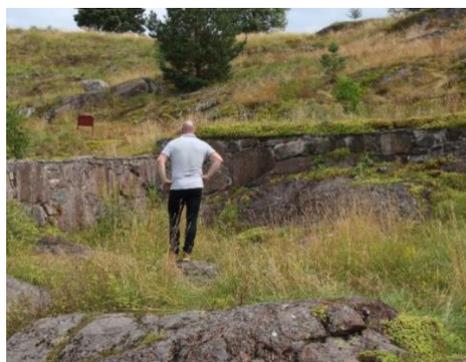
*Figure 36 Detail taken inside the ruin*

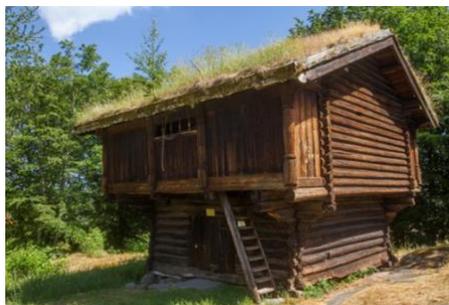
Figure 37 The Fadum Store House

The building has a rectangular plan measuring ca. 8x9m, and a height of ca. 9 meters. It is built (logged) of large pine or spruce logs, with a simple gable roof construction. The roofing material is traditional, consisting of coarse wooden boards, a layer of birch bark and turf. The exterior is surface treated with tar. The building is generally in good condition but requires continuous maintenance. The most relevant degradation

factors are: General weathering, high humidity levels, biological growth and destabilization caused by settings in the ground.

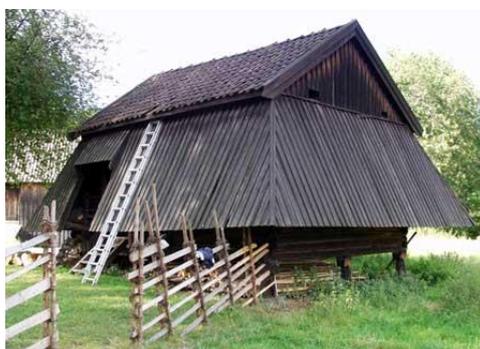
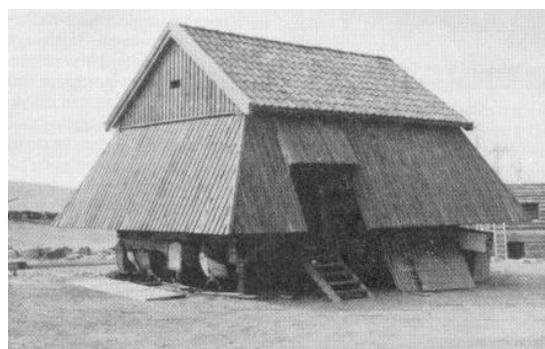
The *Fadum store house* is a building dating from ca. 1820, that was moved from its original location at *Sem*, 5 km north-west of Tønsberg to the Slottsfjell Museum, where it was re-erected in 1952. The building has a rectangular plan measuring ca. 7,5x9m, and a height of ca. 5 meters. It is built (logged) of pine or spruce logs, with a simple gable roof construction. The roofing material is brick tiles. The exterior is surface treated with tar. The building is generally in good condition but requires continuous maintenance. The most relevant degradation factors are: General weathering, high humidity levels, biological growth and destabilization caused by settings in the ground.

Figure 39 The Fadum Store House dated from 1820. To the right on its original location before its movement to the museum in 1952.

Figure 40 The Fadum Store House dated from 1820. To the right on its original location before its movement to the museum in 1952.

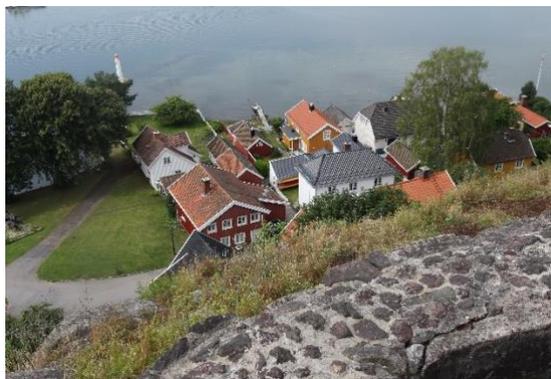
Figure 41 Bentegården is the red house to the left, here seen from Slottsfjellet surrounded by buildings from the same period.

Bentegården is located in the northern part of Tønsberg, at the western foot of Slottsfjellet, close to the sea. It is part of an old building environment consisting of densely built wooden houses with 1-2 floors, dated to the 18th and 19th centuries. Bentegården consists of a main building dated ca. 1700, which today is used as a private home. Its constructive parts consist of a logged timber core standing on a low foundation wall of local stone and mortar. The exterior is panelled with vertical coarse wooden boards painted with linseed oil paint. The roof is covered with brick tiles. The building is generally in good condition but needs continuous maintenance. The most relevant degradation factors are: General weathering, high humidity levels, biological

growth, destabilization caused by settings in the ground, flooding and storm surges, rock slide/landslide.

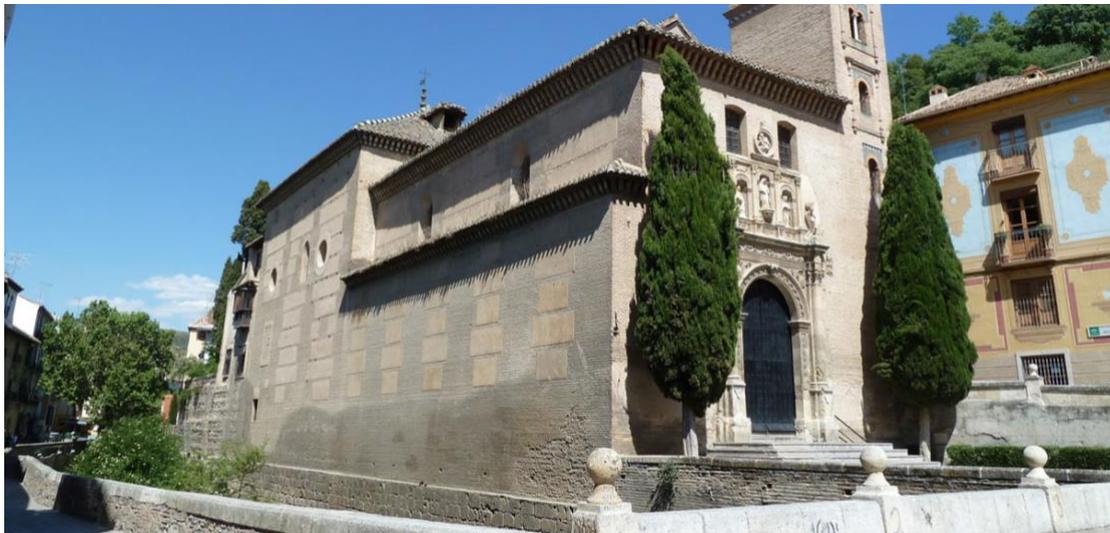
Figure 43 Saint Ana's Church

Focusing to the study area, the main hazards are related to the adaptation of the building materials to changes to the weather phenomena, intensified by the Climate Change. The three main materials at the Granada site, rammed earth, limestone and quaternary conglomerate, are highly vulnerable to the presence of water. As an example, see the lateral wall of *Saint Ana's Church* corresponds with a rammed construction. It can be observed the humidity reaches half of the height of the Church.

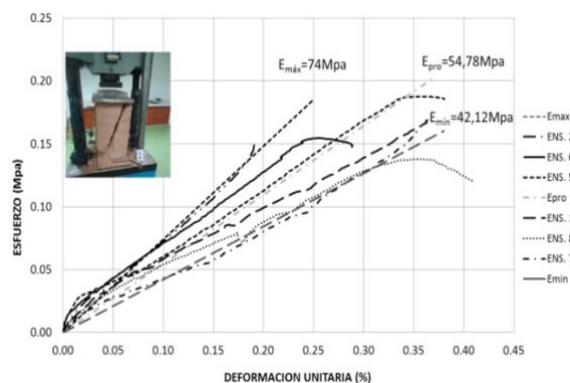
Figure 44 . Stress versus deformation. Afanador et al. (2013)

According to *Gonçalves et al. (2007)* cycles of drying/hydration of the salts of the rammed earth material produce tensions which induces loss of cohesion in the material. In addition, *Afanador et al. (2013)* analysed the behaviour of rammed earth in Colombia, having a linear behaviour with almost no incursion into the plastic range. The compression strength was 0.17 MPa, the Elastic modulus between 40 and 70 MPa and a Poisson modulus of 0.26.

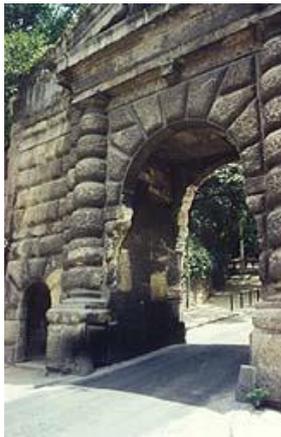
Figure 45 “Puertas de las Granadas” before the restoration.

Subsequently, “Puertas de las Granadas”, other CH monument, was restored and the transport was removed since its deterioration was generated by the pollution of the vehicles. Nowadays, touristic buses with hybrid-drive are the only vehicles that are passing through this monument.

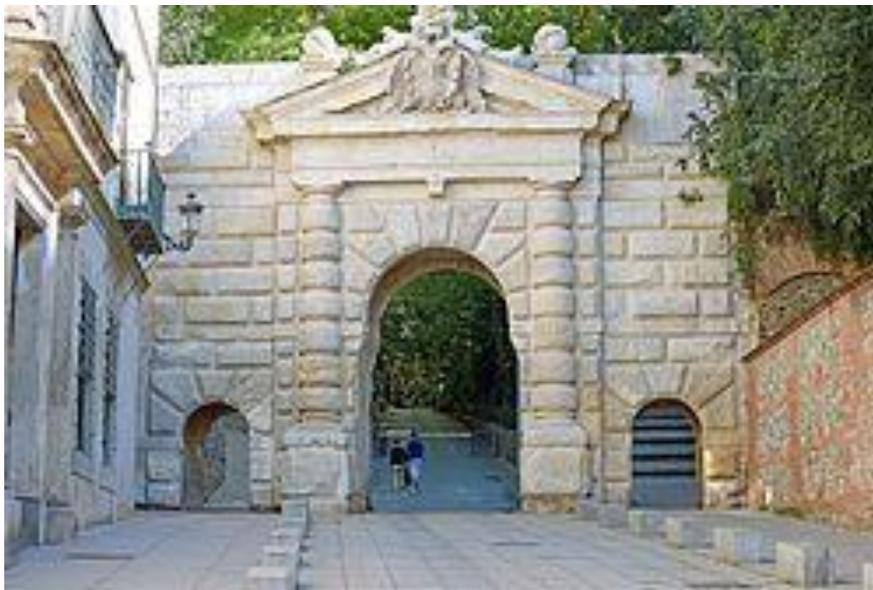
Figure 46 “Puertas de las Granadas” after the restoration.

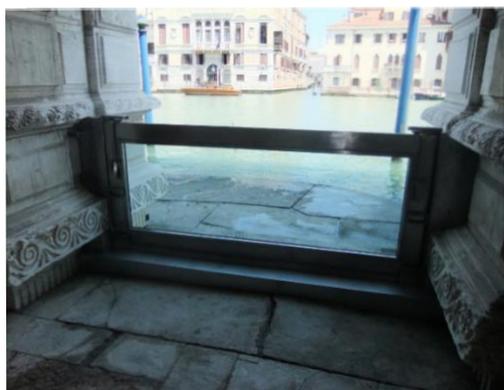
Figure 47 Removable Barriers

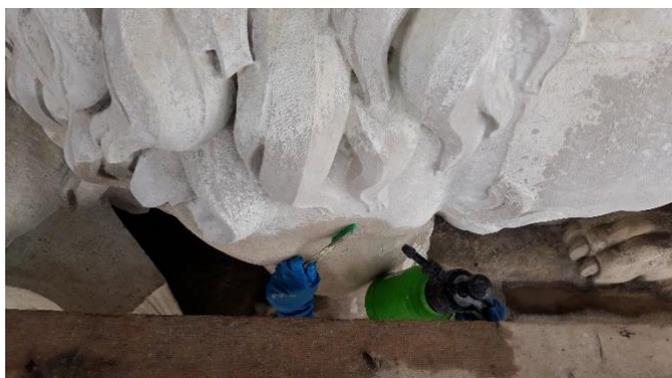
Figure 48 Absorbents and Protectors

Absorbents and protectors are periodically applied to the marble and brick surfaces to protect them from the erosion.
