# Hygrothermal performance of log walls in a building of 18<sup>th</sup> century and prediction of climate change impact on biological deterioration

Petros Choidis<sup>1,\*</sup>, Katerina Tsikaloudaki<sup>2</sup>, and Dimitrios Kraniotis<sup>1</sup>

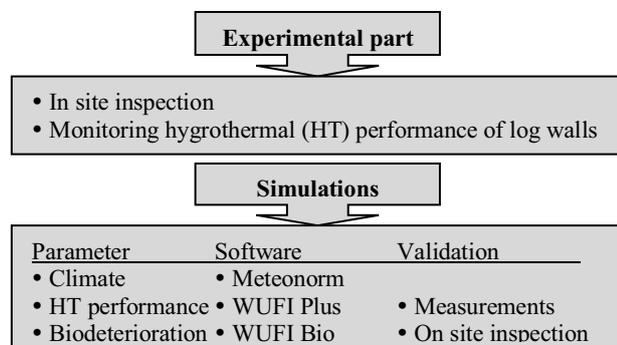
**Fig. 1.** Schematic representation of the methodology of the study.

The methodology followed in the current study is summarized in Fig. 1.

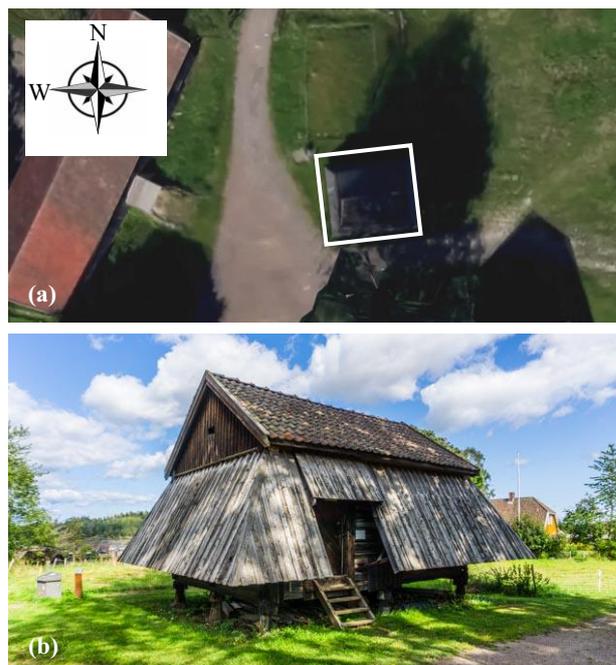
**Fig. 3.** The Fadum storehouse as observed (a) from a satellite view and (b) in situ picture from south-west.

The building has a rectangular plan with its major axis East-West oriented (Fig. 3a). Its entrance is in the southern façade (Fig. 3b). It is a two-storey building, with the ground floor used as a storehouse, where food was kept, while the upper floor may have served as a bedroom. The building’s unique design could ensure cool and dry conditions for the products stored in the ground floor, as well as protection from animals such as mice and insects.

The passive systems incorporated in the historic building’s design are the pillars or stumps upon which it stands, the shed or coating that surrounds its outer walls, as well as the openings in the eastern and western façade of both ground and upper floor (Fig. 3b). The stumps contribute to keep the lower part of the construction dry, since they protect it from the ground rising damp and also allow the wind to pass under the main body of the construction. The coating protects the outer walls from rain, wind and solar radiation. Finally, the openings in the smaller facades of the building ensure adequate natural ventilation to its interior.

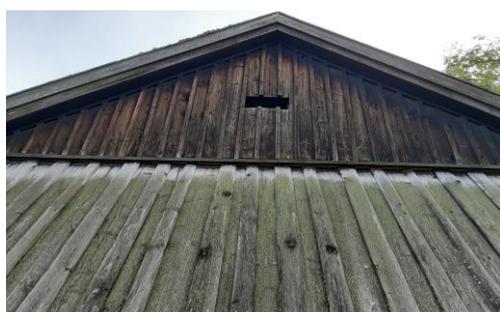
**Fig. 4.** Microclimatic conditions have a strong impact on the discolouring as well as the development of lichen on coating's surface.

The historic building's design has contributed significantly to its well-preserved condition. The in-situ inspection confirmed that the log walls have not experienced significant weathering. Their good maintenance is attributed to their protection from rain, wind and solar radiation. However, damages were observed on the coating and the roof of the building. More specifically, the outer surfaces of these two building elements were infested by lichen and green moss (Fig. 4). In addition, some timber boards of the inner side of the roof were attacked by fungi. The key climate parameter affecting these two types of deterioration is rain. On the outer surfaces, direct exposure to rain strengthens lichen and moss growth, while in the inner side of the roof mould grows in wet areas close to leakages. Restoration of the above-mentioned damages includes scraping of lichen and moss, as well as replacement of the timber boards colonized by mould fungi.

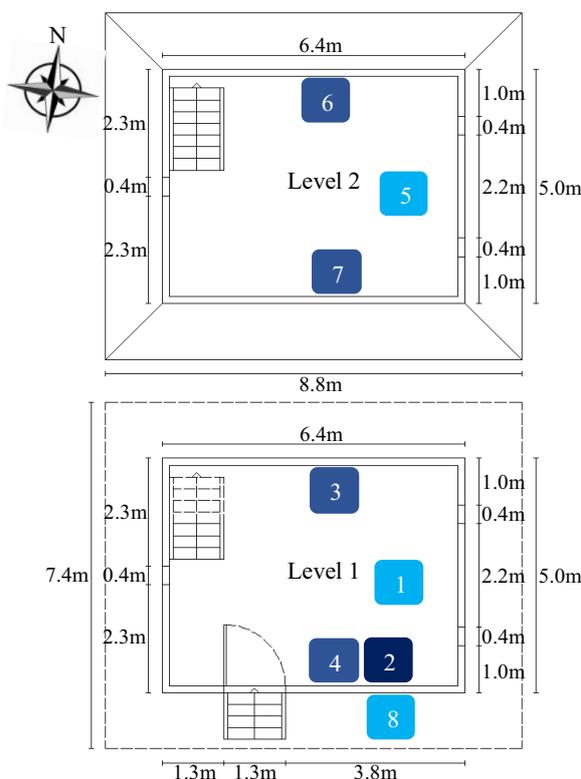
**Fig. 5.** Plan view presenting the sensors position.

The micro-climate conditions, as well as the temperature and moisture content in the log walls of the Fadum storehouse, are monitored by a set of sensors presented in Table 1 and Fig. 5. Air temperature and humidity sensors are installed on the first level (sensor 1), the second level (sensor 2) and outside the building in a position shielded by the coating (sensor 8). Furthermore, on the first level there is a sensor monitoring the temperature inside the south-oriented log wall (sensor 2). The installation depth of sensor 2 is 10mm and its measurements correspond to the average temperature along the installation depth. Finally, on both levels there are sensors monitoring the water content in the interior side of the south and north-oriented log walls (sensors 3, 4, 6, 7). These devices measure the electrical resistance between two electrodes and convert it to water content units based on a function that is presented later in this subsection. The electrodes are installed in depth of

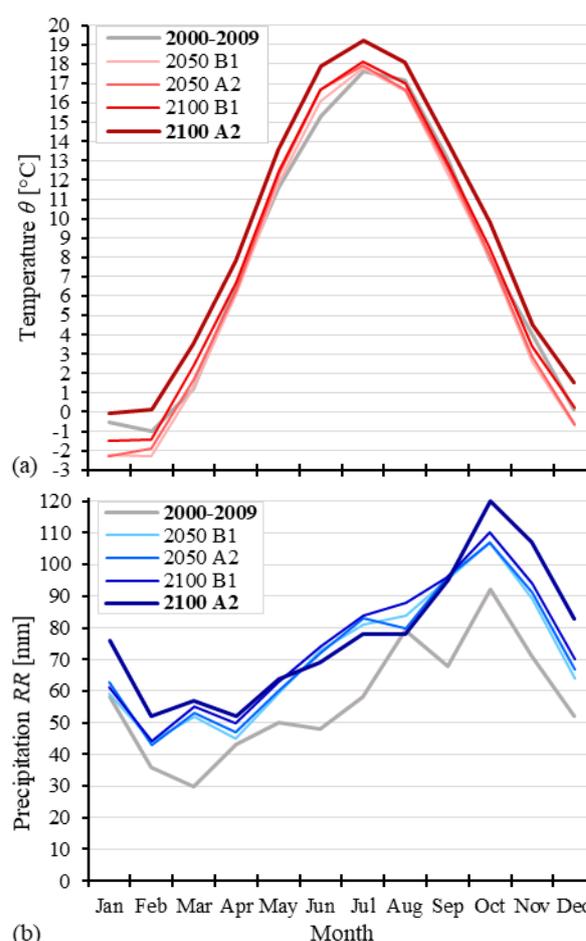
**Fig. 6.** Mean monthly (a) air temperature and (b) precipitation for past and future (under SRES B1 and A2) years for the project's site.

From the climate data referring to the past years, it is observed that the prevailing temperatures ( $\theta$ ) are low with an annual average of 7.8°C (Fig. 6a). Precipitation ( $RR$ ) is moderate and well distributed throughout the year, with a mean annual value of 685mm. Maximum rainfall takes place between summer and autumn and minimum in spring (Fig 6b). Relative humidity ( $\varphi$ ) remains in high levels during the whole year, having a mean annual value of 76%. Relative humidity fluctuates around 70% during spring and summer and around 80% during autumn and winter. In addition, mean monthly wind speed ( $FF$ ) fluctuates between 3.5m/s and 5m/s (gentle breeze, according to the Beaufort scale), while the predominant wind direction ( $DD$ ) is from South. The

According to the data referring to the future conditions, most of the climate parameters change slightly or does not change at all. The most significant changes are predicted for temperature and precipitation (Fig. 6a and b), the mean annual values of which are predicted to increase by 1.2°C and 36% respectively in 2100 under the SRES A2. Temperature predictions for the rest three examined cases (SRES B1 and A2 for 2050 and SRES B1 for 2100) indicate a decrease in air temperature during the coldest months of the year. The temperature decrease contradicts to other studies [3, 8, 9]

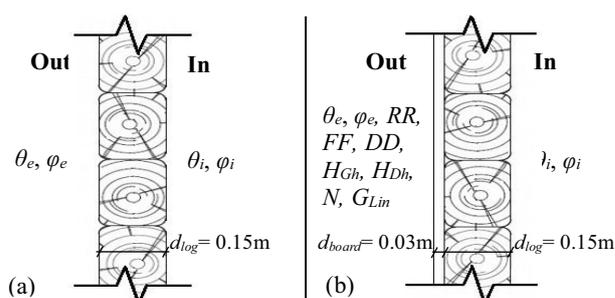
**Fig. 7.** Cross section and boundary conditions of (a) the log walls protected by the coating and (b) the upper gable walls.

The log walls of the Fadum storehouse are made either of pure logs treated with tar in their outer side (Fig. 7a) or logs with a layer of softwood boards in their outer side (Fig. 7b). The first type of cross section corresponds to the walls of the ground level as well as the north and south oriented walls of the upper level. These walls are protected by the coating. The second type of cross section corresponds to the east and west oriented upper gable walls. Moreover, in the framework of the simulations, it is assumed that the walls shielded by the coating are exposed only to the ambient temperature and relative humidity (Fig 7a). Both their inner and outer side are considered to be protected from rain, wind and radiation. On the other hand, the upper gable walls are exposed to rain, wind, short and long-wave radiation, ambient air temperature and relative humidity on their outer side, while on their inner side they are exposed to the indoor temperature and relative humidity (Fig. 7b).

In order to verify that the employed model represents adequately the physical problem, a comparison is made between the measured and the simulated temperature and water content in the logs. For that purpose, two different simulations are employed. The first one corresponds to the hygrothermal performance of the log walls of the ground level. In this case the simulated assembly is the one presented in Fig. 7a, while the outdoor and indoor

boundary conditions correspond to the air temperature and relative humidity monitored by sensors 8 and 1, respectively. The other simulation refers to the hygrothermal performance of the north and south oriented walls of the upper level. In that case the examined assembly is also the one presented in Fig. 7a, while the outdoor and indoor boundary conditions correspond to the air temperature and relative humidity measurements from sensors 8 and 5, respectively.

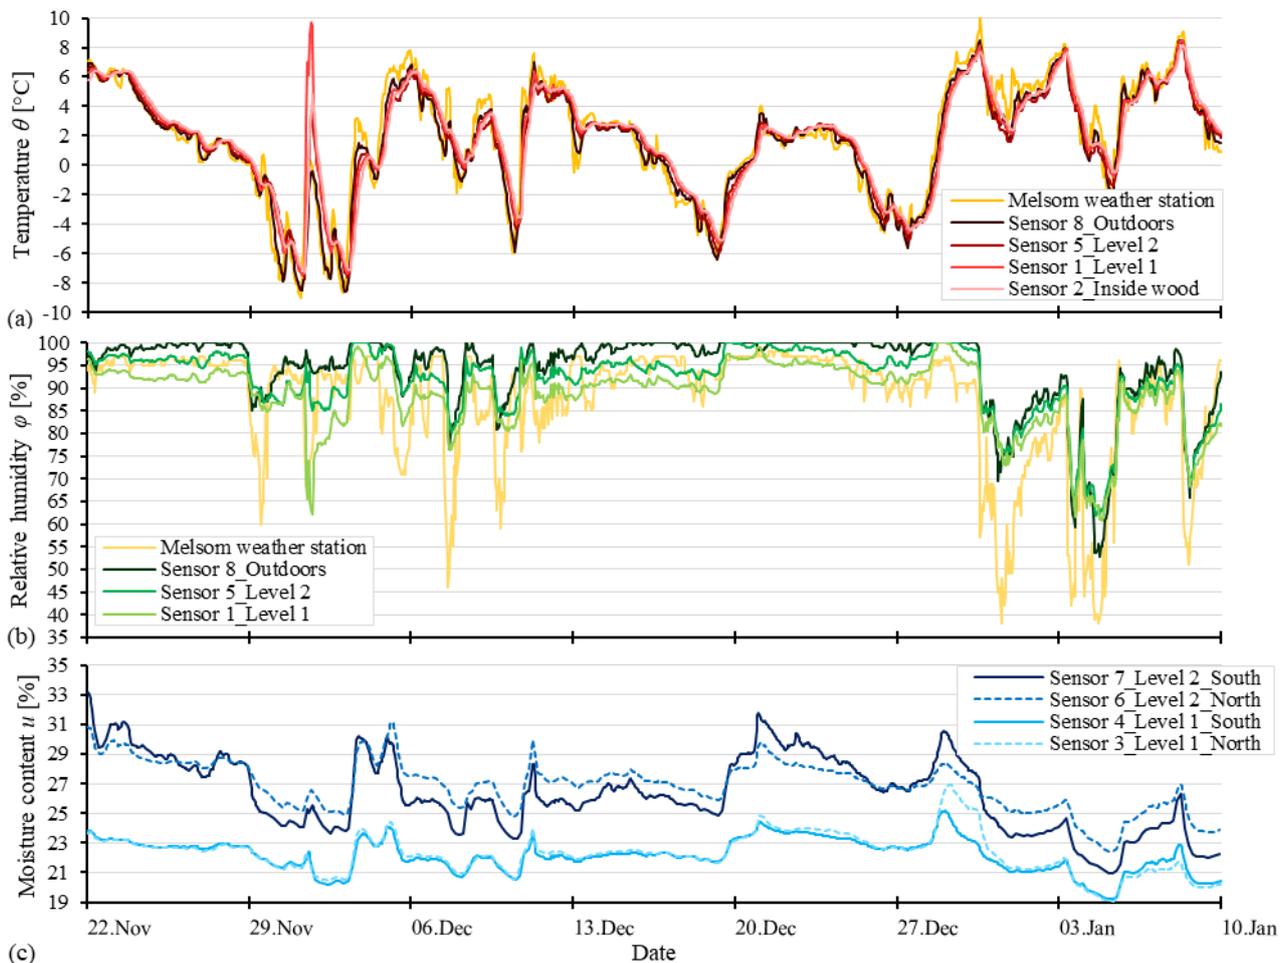
**Fig. 8.** Measurements of (a) air and wood temperature, (b) air relative humidity and (c) moisture content in wood.

From Fig. 8a and b it can be observed that the air temperature and relative humidity measurements derived from the sensors are in accordance with the respective measurements from Melsom weather station, 5.8km far from the project's site. Furthermore, it is seen that the lower mean air temperature and the higher mean relative humidity values occur outdoors, followed by the interior on the second level of the building and finally the first level. Furthermore, the highest range of these two parameters is monitored outdoors and the lowest one on the first floor. In the 1<sup>st</sup> of December, extreme high temperatures and extreme low relative humidity values were monitored by the sensors indoors. These measurements are linked to the function of a portable radiator inside the building, used by the workers conducting rehabilitation work. Due to these extreme values, measurements from that day are not considered in the description of results in this section. Moreover, in Fig. 8a, b and c it can be observed that within the fourth

In Fig. 8a, the difference between the outdoor air temperature and the air temperature on the second level is on average  $0.05^{\circ}\text{C}$ , while its maximum value is  $3^{\circ}\text{C}$ . The respective temperature differences for the first level are  $0.21^{\circ}\text{C}$  and  $3.10^{\circ}\text{C}$ , while inside the wood they are  $0.24^{\circ}\text{C}$  and  $4.82^{\circ}\text{C}$ . Moreover, the extreme minimum and maximum temperatures inside the wood occur later than the respective ones on the outdoor environment. This time lag is approximately 2 hours.

In Fig. 8b it is observed that more than 80% of the air relative humidity measurements derived from the sensors are higher than  $\varphi = 85\%$ . The respective measurements from Melsom weather station correspond to slightly lower values. However, taking into account that the project's site is closer to the sea and that  $\varphi$  is highly dependent on the local environmental conditions, measurements from sensors are considered to be credible. The difference on the relative humidity between the ambient environment and the second level of the building is on average 1.13% and at maximum 9.7%. The respective values for the first level are 3.71% and 16.4%.

In Fig. 8c it is observed that high moisture content values are monitored by all four sensors. However, the fact that the air temperature remains in low levels within the examined period is determinant to the insignificant mould risk of the logs. The highest mean values and range of the water content measurements in the log walls are observed on the second level. Within the second level, the respective values for the south oriented wall are higher and exceed the ones measured for the north oriented wall by 0.98% on average and 2.39% at maximum. Moisture content measurements on the first level appear to have smoother fluctuations.

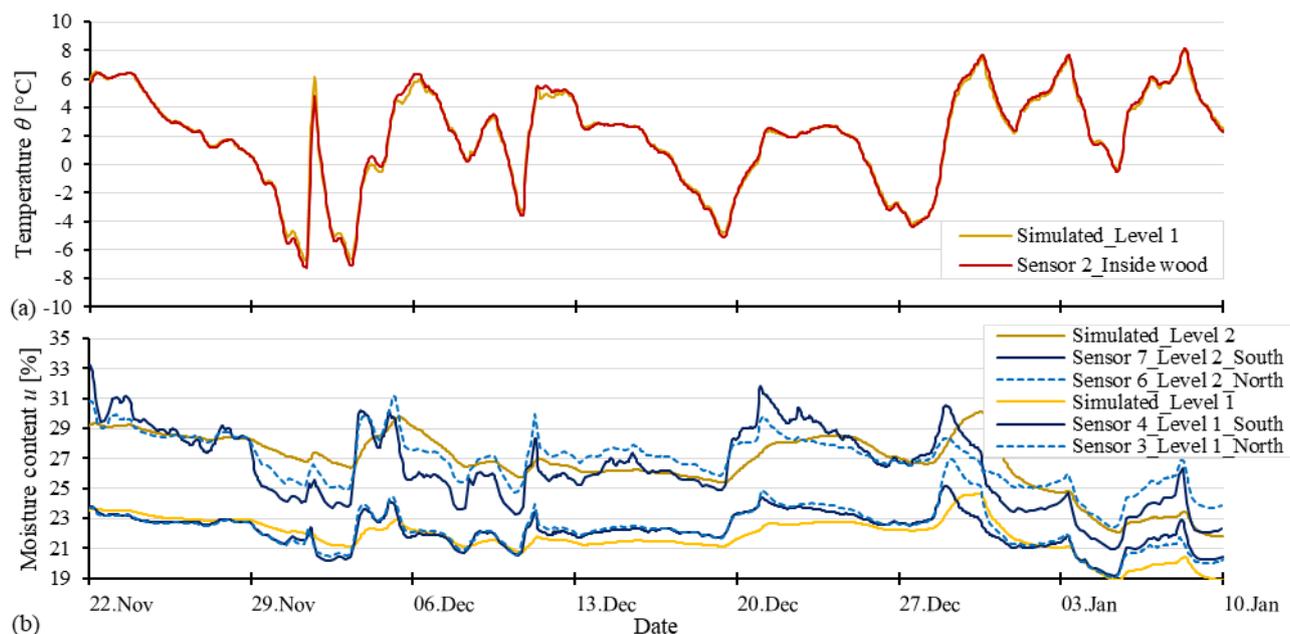
**Fig. 9.** Comparison between simulations and measurements of (a) wood temperature and (b, c) moisture content in wood.

In Fig. 9a and b simulated, and the respective measured temperature and moisture content values are presented. Simulation results correspond to the average values of the examined parameters along a depth of 10mm from the inner side of the wall. This approach makes simulation results consistent with the actual measurements that take place in the installation depth of 10mm. It is worth mentioning that the simulation results are independent of the orientation of the wall configurations, based on the assumed boundary conditions. Thus, simulated values vary only between the different levels of the building.

From Fig. 9a and b it is observed that simulations' results fluctuate in a similar way to the respective measurements. The mean difference between the simulated and the measured temperature values is 0.015 °C, while at maximum it reaches 0.72°C. The water content simulation results fit better with measurements in the case of the first floor. Within the first level, the difference between the simulated and the measured values is equal to 0.72% on average and 2.58% at maximum for the south oriented wall, while for the north oriented wall the respective differences are equal to 0.83% and 3.29% respectively. On the second level, the greatest difference between the simulated and the measured values is observed for the south-oriented wall and it is 1.24% on average and 4.45% at maximum. The respective values for the north oriented wall are 1.02% and 3.97%. The observed differences are acceptable in order to consider the model validated.
