A Preliminary Structural Survey of Heritage Timber Log Houses in Tonsberg, Norway

A. Shabani, H. Hosamo, V. Plevris, M. Kioumarsi

DOI: 10.23967/sahc.2021.012

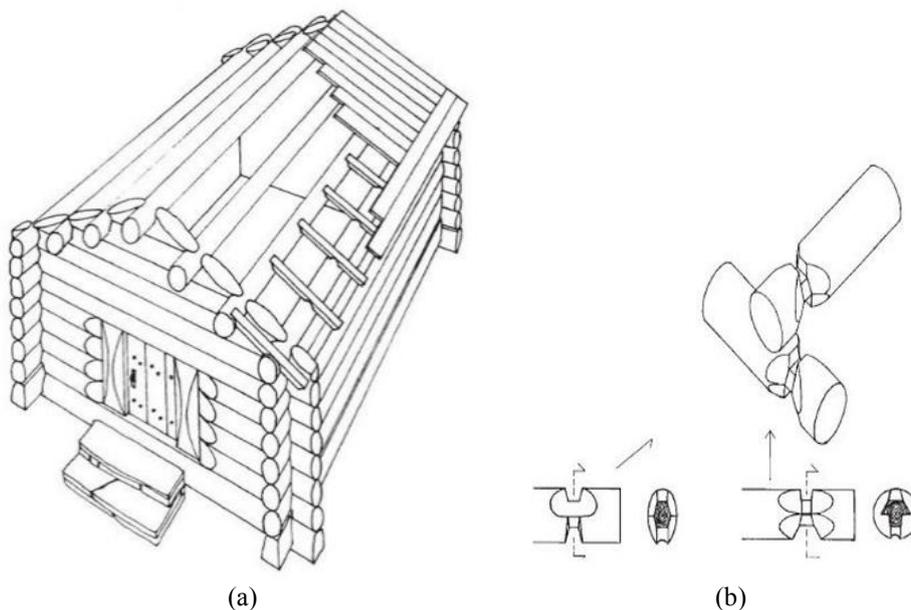
Log houses are one of the ancient timber structural systems. In a log house structural system, the horizontal timber logs are laid on top of each other and the stability of the structure is provided by the corner joints where the wall planes interlock, as illustrated in Figure 1. The log house system is used in northern European countries and in the central Alpine region, which also extends into several eastern European countries. The technique can also be seen in Japan, China and North America. The low heat conductivity of wood is taken advantage of in this structural technique for high insulation of the building, which is very important for countries with harsh winters [2].

Figure 1: (a) Typical Log house schematic view, (b) Typical log house corner connection detail [2]

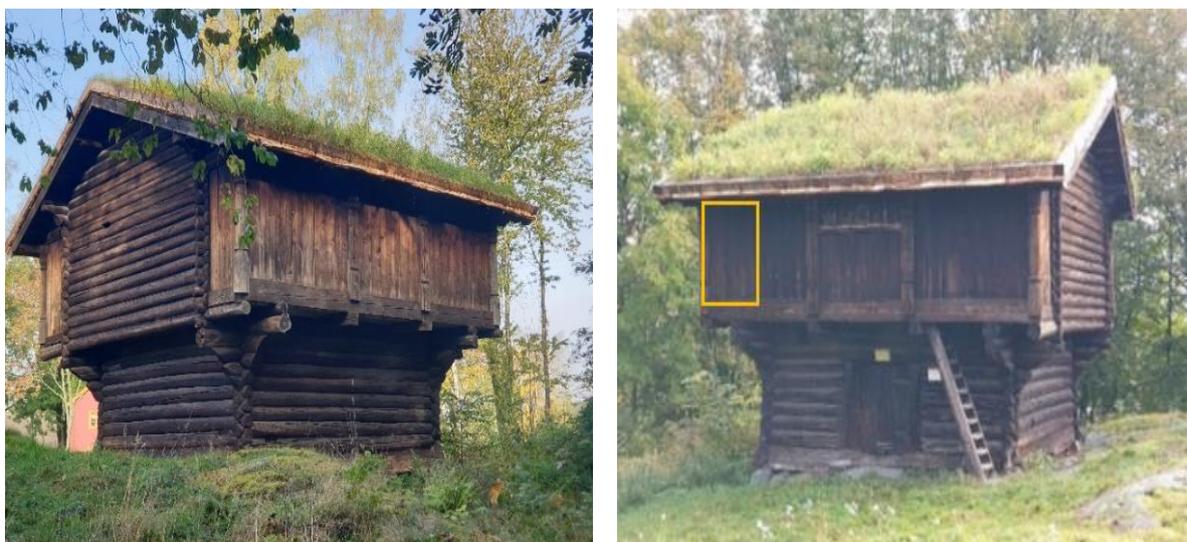
The building has a rectangular plan measuring about 8×9 metres, and a total height of about 9 metres. It is built (logged) of large softwood pine or spruce logs, with a simple gable roof construction. The roofing material is traditional, consisting of coarse wooden boards, a layer of birch bark and turf. The exterior surface has been treated with tar. Two views of the building and details of the roof and connections are shown in Figure 4.

Figure 3: Heierstad Loft case study from two different views

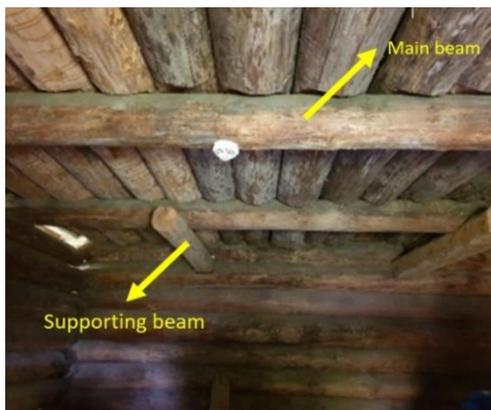
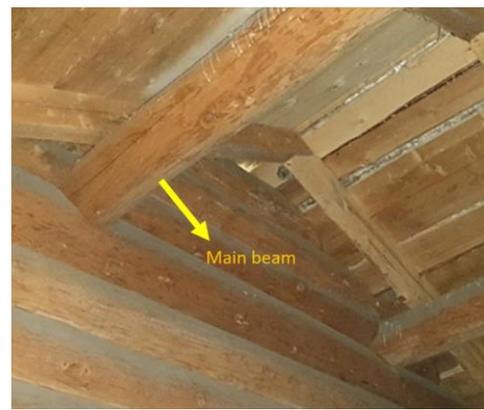
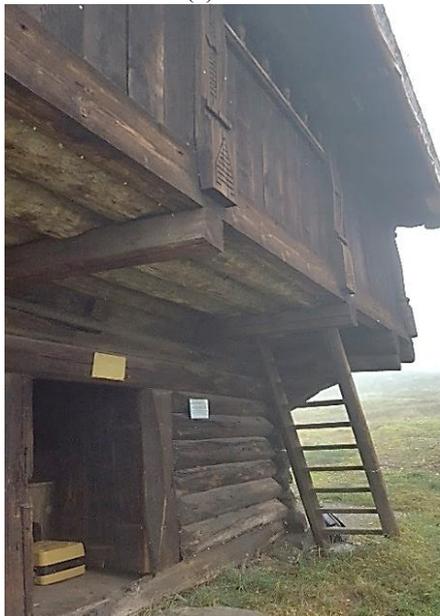
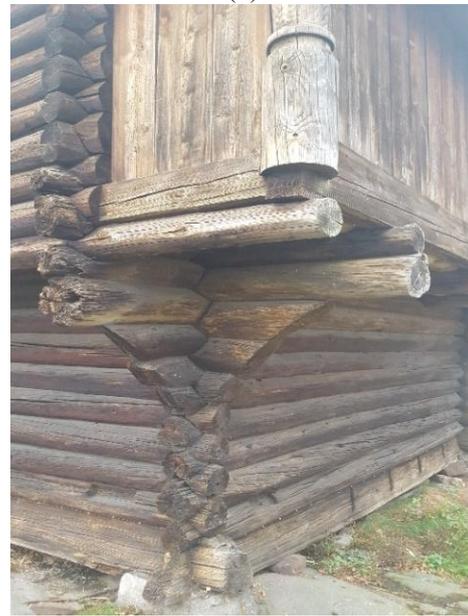
As it is illustrated in Figure 4(b), two supporting beams are employed, and the main beams are laid orthogonally on them. All the roof system's timber logs of the second floor are laid orthogonally on the main beams. However, due to the lower dead and live loads on the second roof compared to the first roof, the supporting beams have not been utilised and the roof system's logs are laid on the main beams as it is shown in Figure 4(c).

The area of the second floor is more than the first floor. As it is illustrated in Figure 4(d), this issue can lead to overturning of the building and in order to tackle with this risk, the main beams of the first floor are continued and as it is shown in Figure 4(e), upper logs are longer in the corner joints.

Figure 4: (a) Connection details inside the building for the 1st and (b) 2nd storey roof, (c) structural details of the 2nd floor system, (d) connection detail of the corner joint

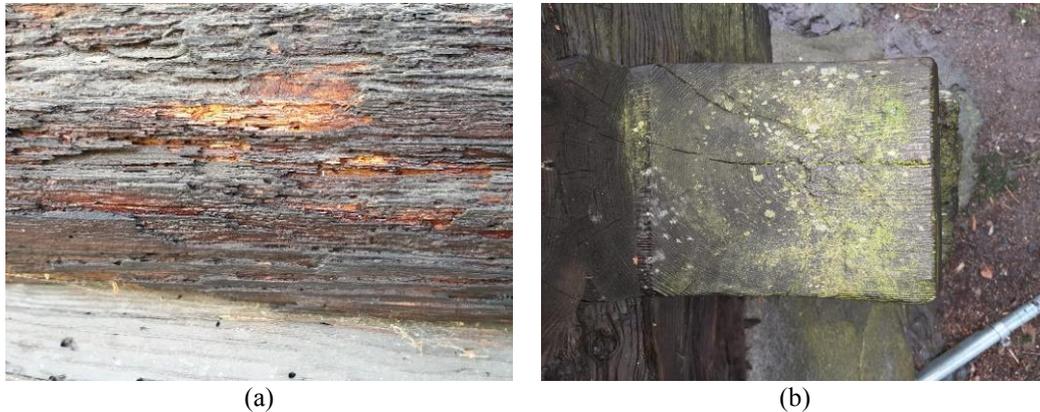
The building is in good condition in general, but it requires continuous maintenance. The most relevant degradation factors are general weathering, high humidity levels, biological decay (see Figure 5) and foundation settlement.

Figure 5: Biological defects in Heierstad Loft

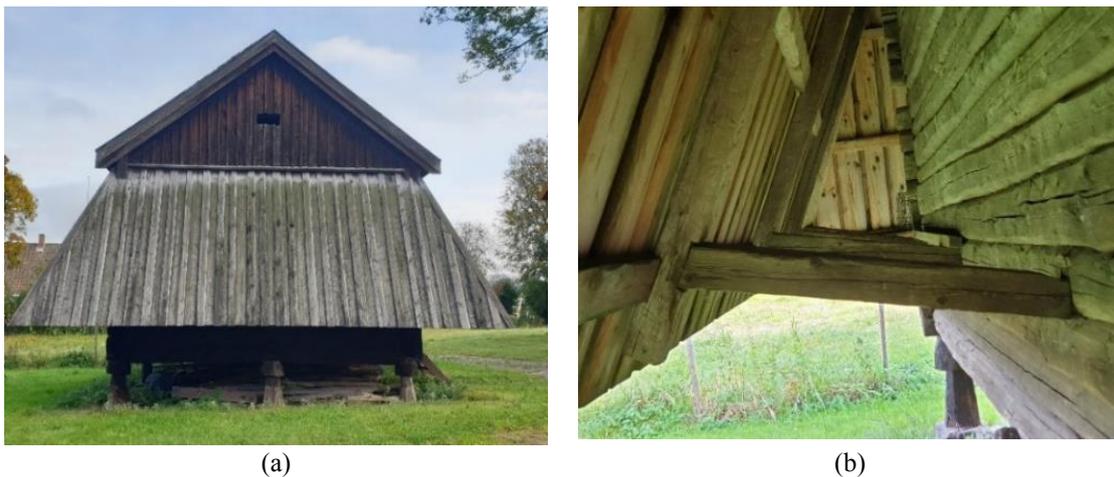
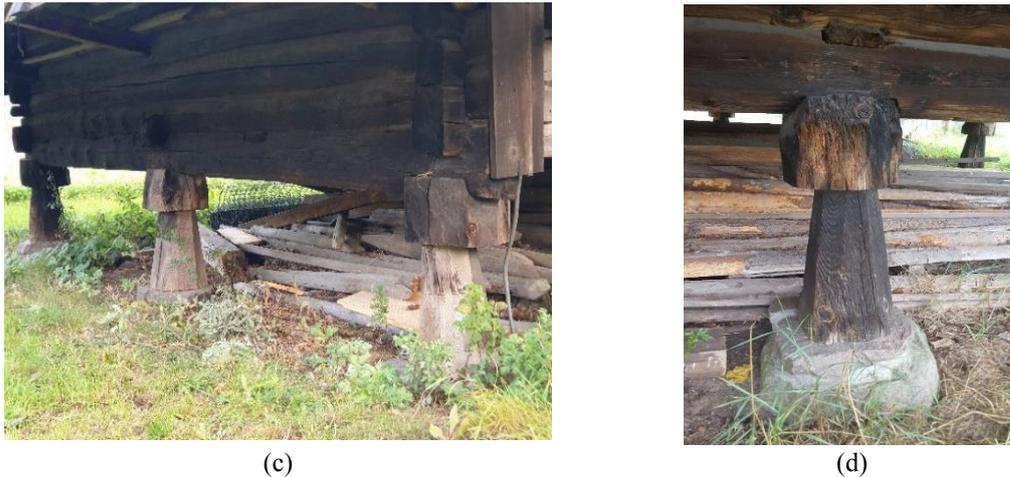
The building and its structural details are shown in Figure 6. As it is illustrated in Figure 6(d), the floor system is laid on the short timber columns which are on stone foundations. The main surrounding beams of the floor are simply connected to the columns without any constraints for rotation.

Figure 6: (a) Fadum Storehouse view, (b) Structural detail inside the coating, (c) Timber short columns under the building, (d) detail of the simply connected timber column

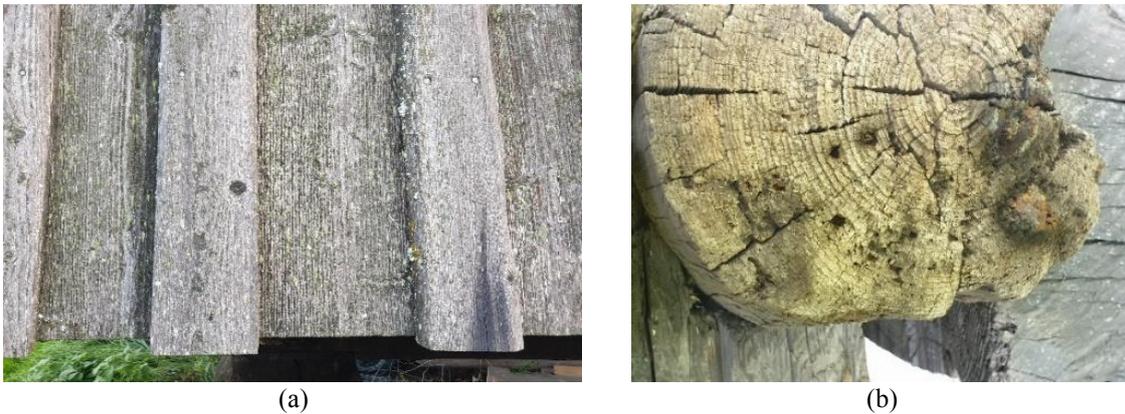
This building is generally in good condition but some deflection in main surrounding beams can be seen as well as biological damages Figure 7 shows some of the biological damages in logs and on the coating.

Figure 7: (a) Lichen attack to the coating, (b) Insect attack on the timber logs

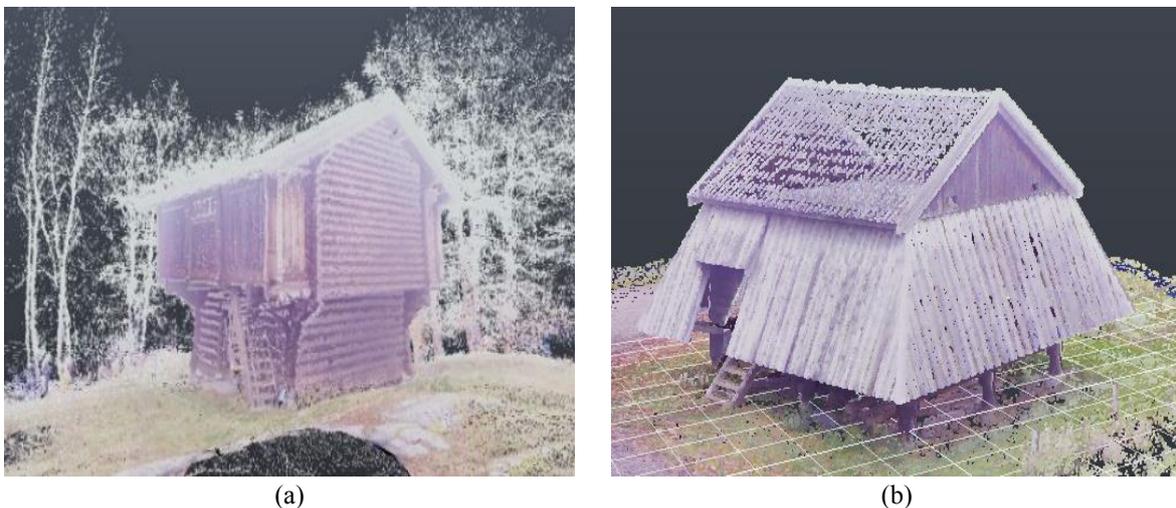
When utilising ReCap to perform the registration process, it was not possible to achieve fully automatic merging, and a manual approach was therefore chosen to complete the process. Based on this, at least three common points in two sequential scans were picked up to execute the registration and to obtain good merging results. Throughout this process, all the labelling rules and notes used in the field were taken into consideration in order to select the right scans to be merged together. The result is shown in Figure 8 for the two case studies.

Figure 8: Raw point cloud data for (a) Heierstad Loft, (b) Fadum Storehouse

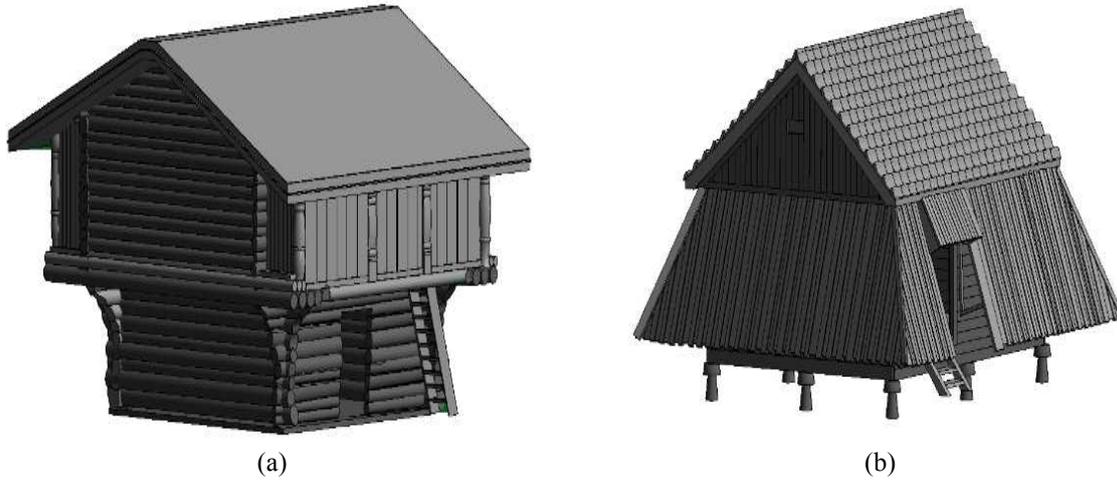
seen in Figure 9, the number of logs and their thickness have been identified and precisely depicted in the BIM file.

Figure 9: BIM drawing files of (a) Heierstad Loft, (b) Fadum Storehouse

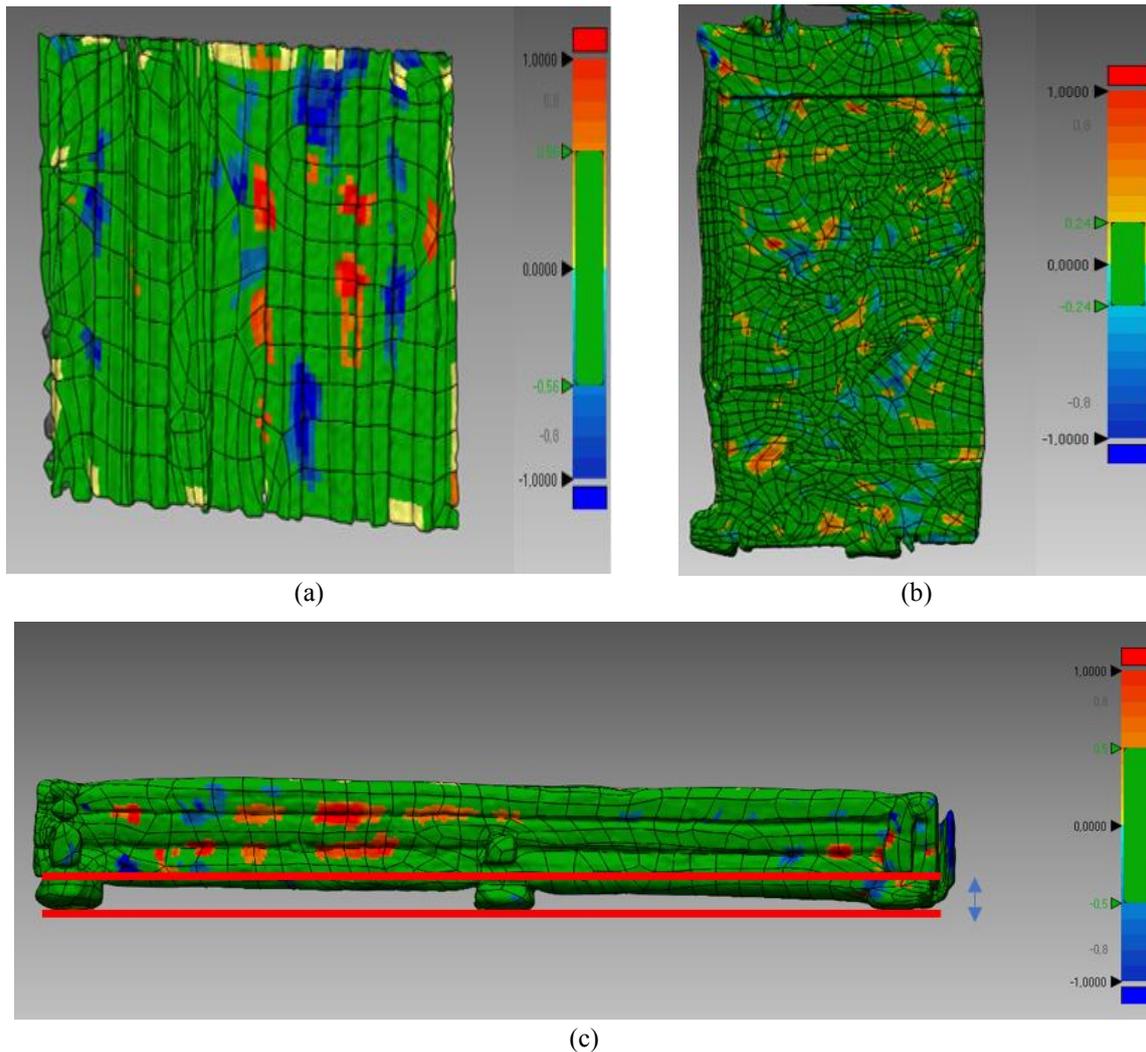
For more investigation at the component scale, some parts of the buildings have been chosen in order to convert the point clouds to the surface using Geomagic design X software package. This feature of the software will be so time consuming in order to achieve the precise model of the structures at the component scale. Figure 10(a) and (b) show some samples of the surfaces of the components and the deviation of some points from the reference surface which is produced from the mass point clouds. In order to investigate any deflection in beams on short timber columns in Fadum storehouse, precise models have been produced. Figure 10(c) shows one of the beams models as a sample. Two reference horizontal lines are added to the figure to show any deflection in the beam and settlement in short columns. No settlement in columns can be detected in this beam's supports but insignificant deflection in the beam can be detected in the right part of the beam.

Figure 10: (a) Surface of the coating of Fadum storehouse (see Figure 5(a)),(b) Surface of the coating of Heierstad Loft as it was highlighted in yellow box in Figure 3(a), (c) Precise model of the beam in Fadum storehouse (see Figure 5(c)) (units in mm).

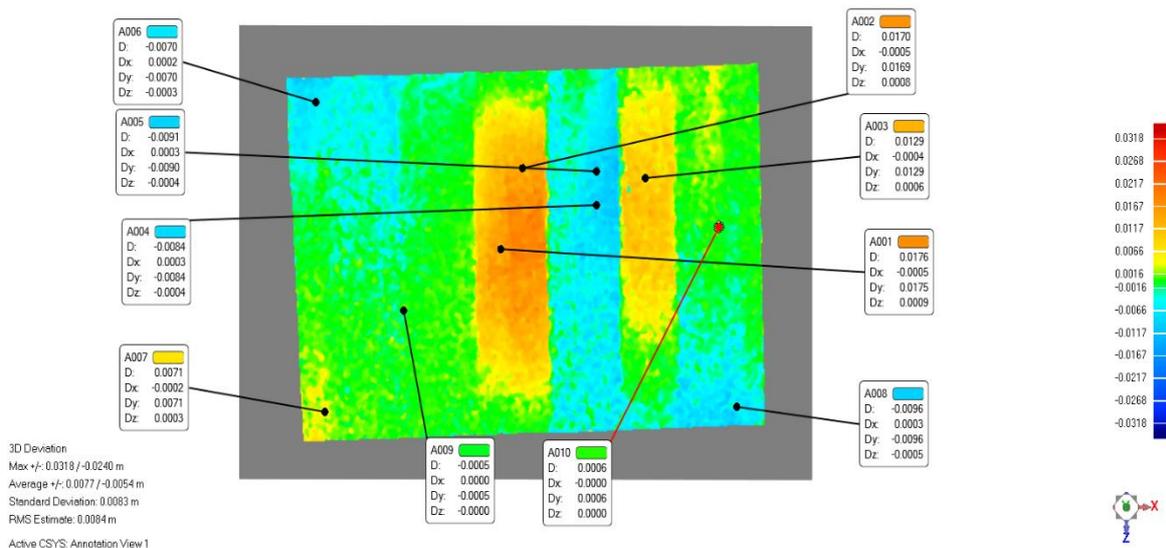
In order to investigate the flatness of timber coating, Geomagic Control X software is utilized. Point clouds are as an input for this inspection which gives precise images of the elements and the deviation of the different parts of the element to a set of reference points. Figure 11 shows the output image of the software for one covering timber panel of the Heiersted Loft building. As it is illustrated no significant protrusion can be detected in the covering and the deviations just show the differences of the vertical timber panels' flatness. This method can be used for detecting the large cracks or delamination in timber elements' surfaces.

Figure 11: Covering surface of the wall of the Heierstad Loft (see Figure 3(a)) for showing any protrusion in the element (units in mm).
