Decay assessment and 3D surface modelling of historical brick masonries in Venice

HYPERION: Development of a Decision Support System for Improved Resilience & Sustainable Reconstruction of historic areas to cope with the Climate Changes & Extreme Events based on Novel Sensors and Modelling Tools.
HORIZON 2020-LC-CLA-2018-2

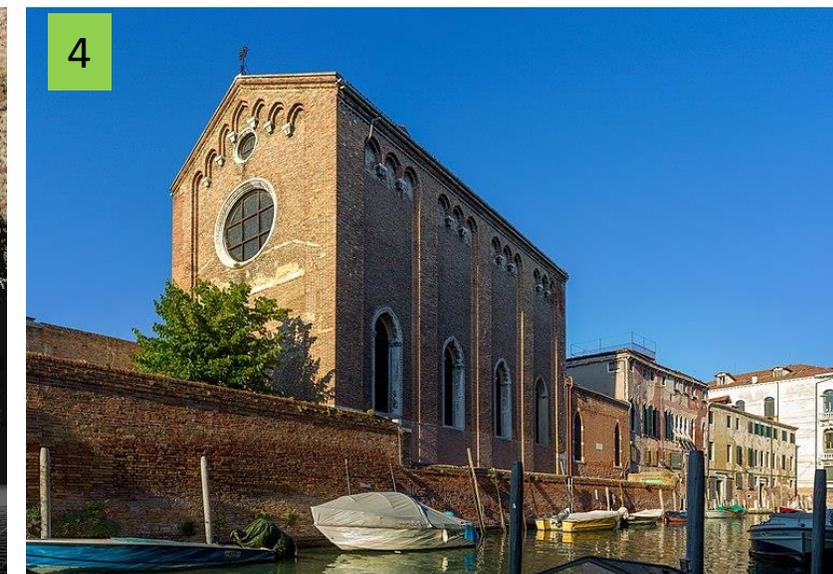
The Volto Santo chapel

Deterioration of the main façade: damage brick masonry; black crust on stones; stone esfoliation; secondary plants

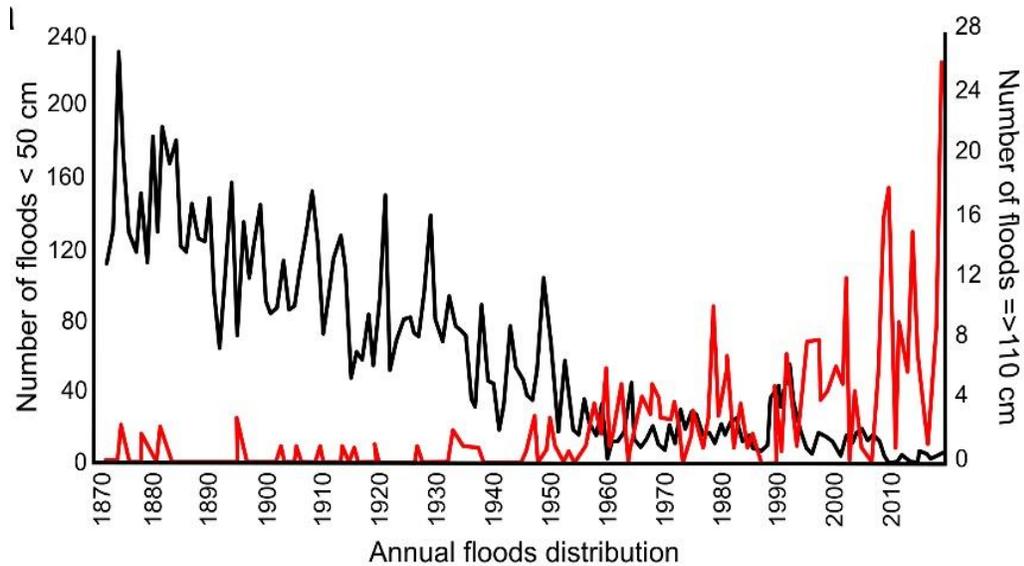
Yearly distribution of tides < 50 cm recorded in Venice from 1860 to 2020

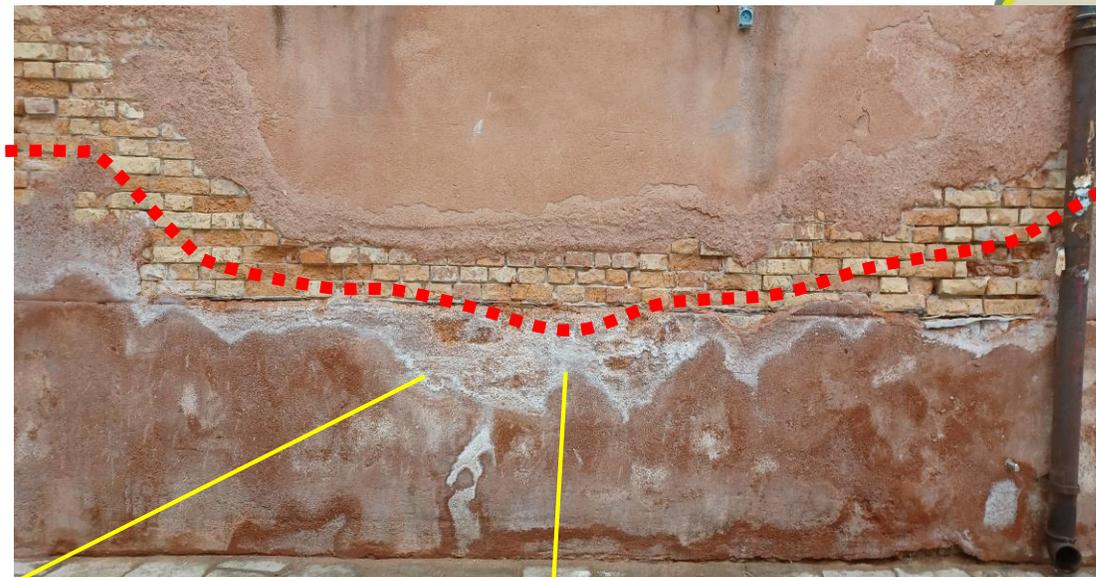
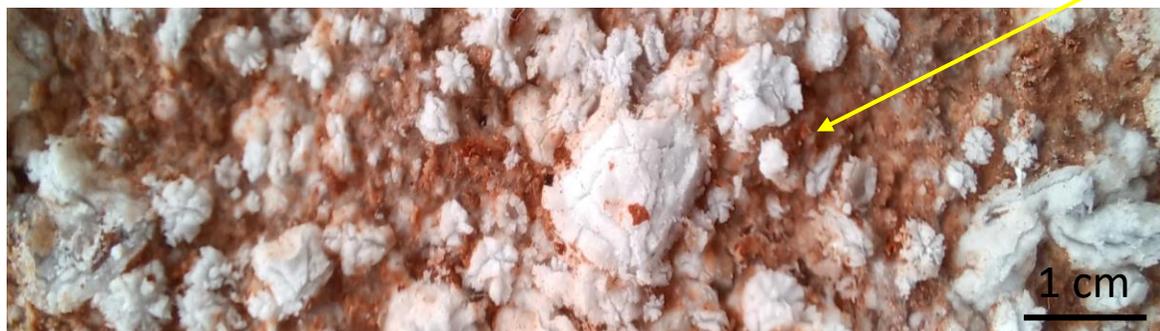
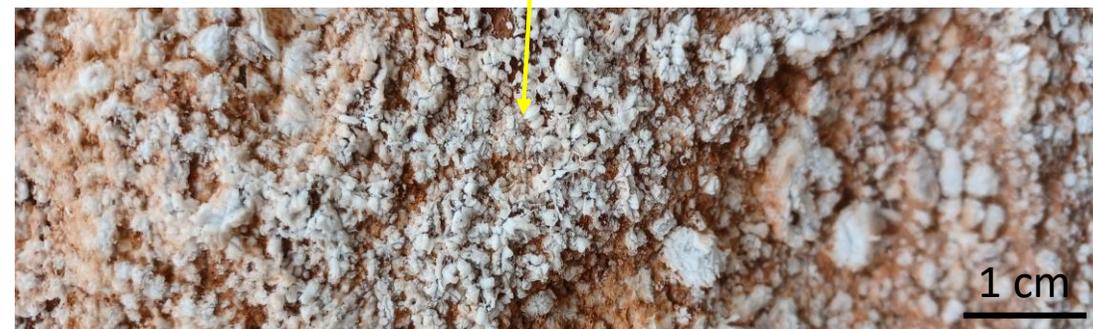
Salt efflorescence, details

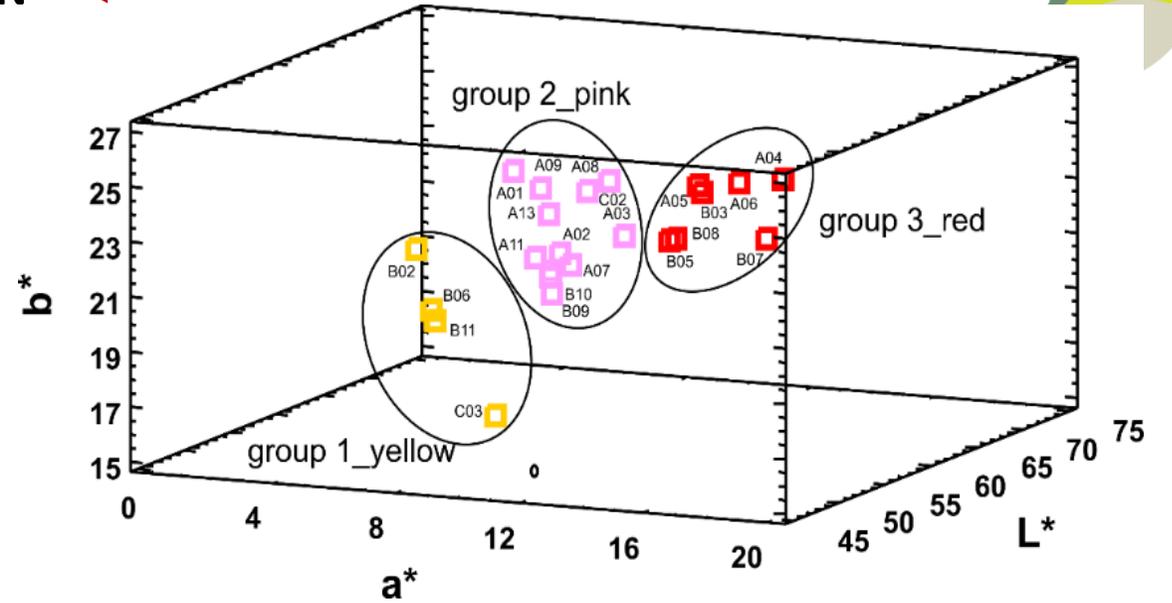
Colorimetry

The colorimetric results in the Lab space bricks (in dry condition) can be defined into three main chromatic groups: yellow-colored bricks (grou1_yellow); pink-colored bricks (group2_pink), and red-colored-bricks (group3_red).

The most abundant category of bricks is the pink-colored (with 12 samples), followed by the red- (7 samples) and the yellow-colored (4 samples).

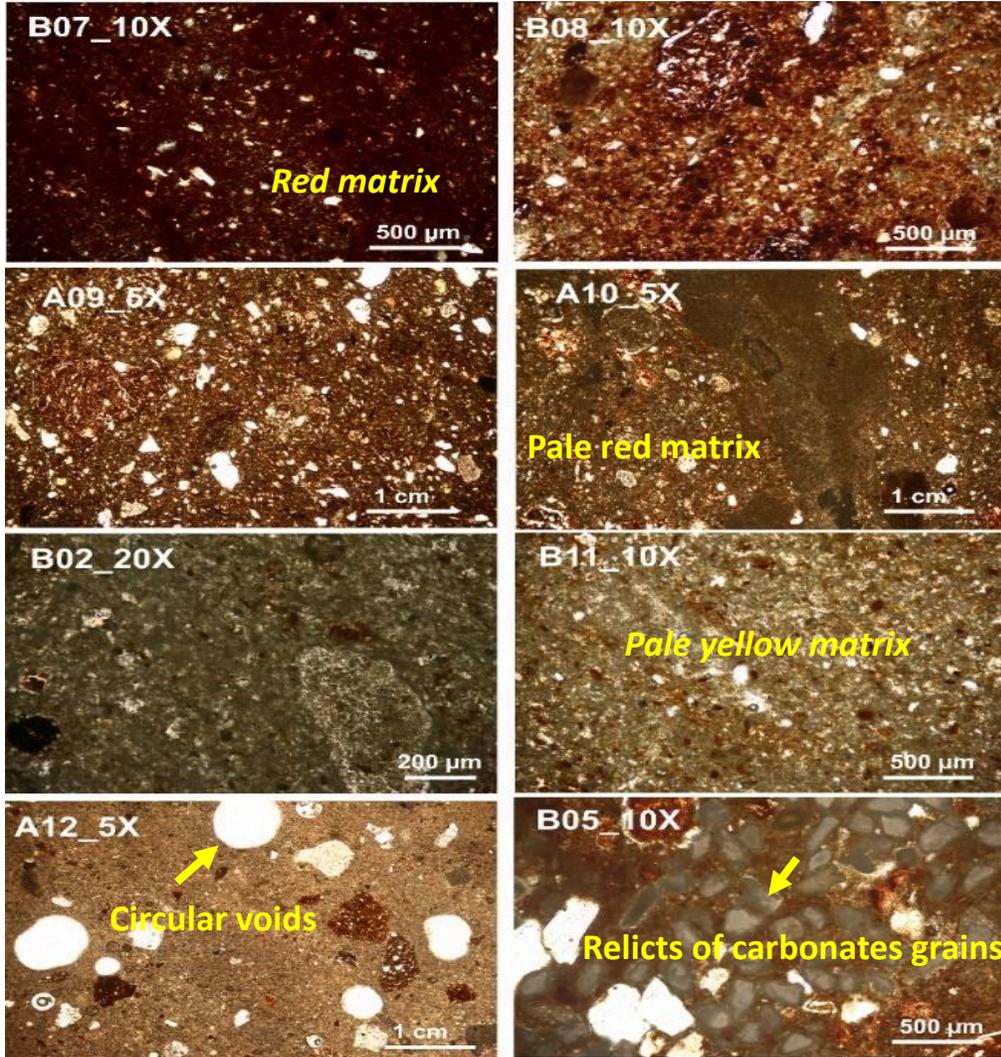
Optical Microscopy

Texture:

- Texturally bricks display similar petrological features
- Very low active groundmass with color ranged between in red or red-brown and in yellow-light brown
- Scarce sub-rounded porous are observed and shrinkage rims were likewise formed, almost filled by secondary calcite.

Mineralogy:

- Most of the crystals detected are minerals of quartz, followed by feldspar grains.
- The presence of residual carbonates (calcite and/or dolomite) suggested that firing process does not reach temperature above 800-850°C, at which they decomposed.

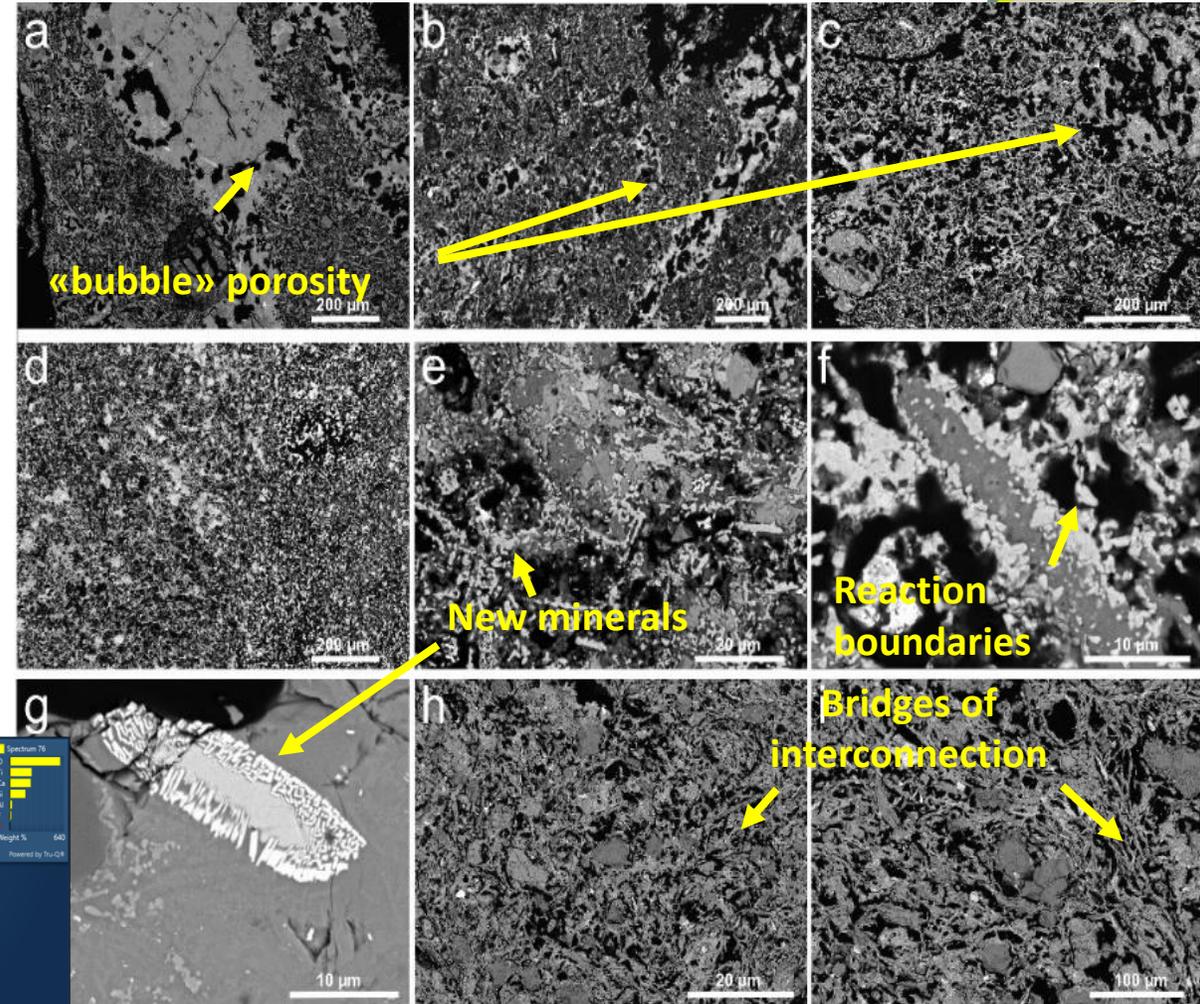
Scanning Electron Microscopy

Texture:

- The textural observation carried out with FESEM in a set of five selected samples (A4, A8, B2, B6 and B10) validated the considerations drawn from the MOP analysis. Samples are overall characterized by a high porosity, with a prevalence of micro and meso pores, and an inhomogeneous texture.

Mineralogy:

- New silicate phases with heavy elements (in particular Ti): titanite grains and fassaite.
- Mineralogy is coherent to the Venice lagoon sediments, where is also present Ti (Busà, 2010).

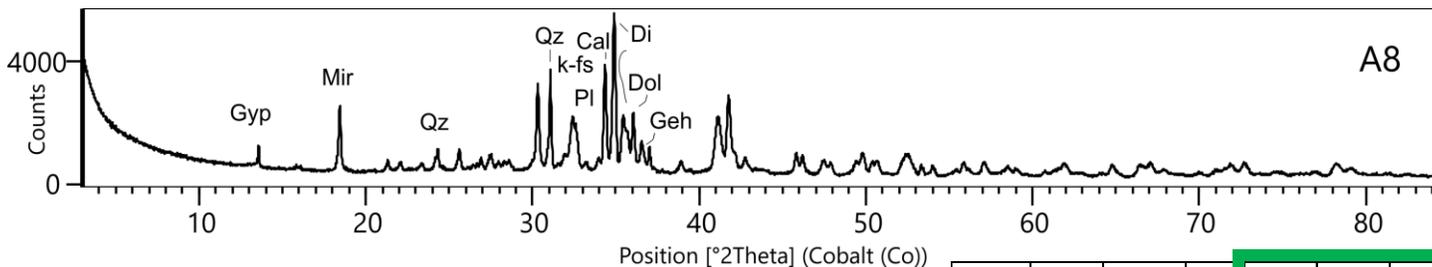
X-ray Powder Diffraction

Mineralogy and brick technology:

- Relative abundance of primary minerals (i.e. calcite and dolomite) and secondary firing minerals (i.e. diopside, gehlenite and fassaite) suggesting a certain temperature higher than 800-850°C and homogeneity in raw materials used.
- Most of samples have also peaks of calcite, some of them display dolomite and illite. The presence of these phases indicate that temperature does not exceed the 850°C.

Mineralogical assemblages in historical bricks from XRPD analysis. Mineral abbreviations after Whitney and Evans (2010): Qz = quartz; Ill = illite; Kfs = K-felspar; Pl = Plagioclase; Cal = calcite; Dol = dolomite; Hem = Hematite; Di = diopside; Gh = gehlenite; Fas = Fassaite; Gyp = gypsum; Mir = mirabilite. Relative quantity: xxx = very abundant; xx = abundant; x = medium; ** = scarce; * = rare.

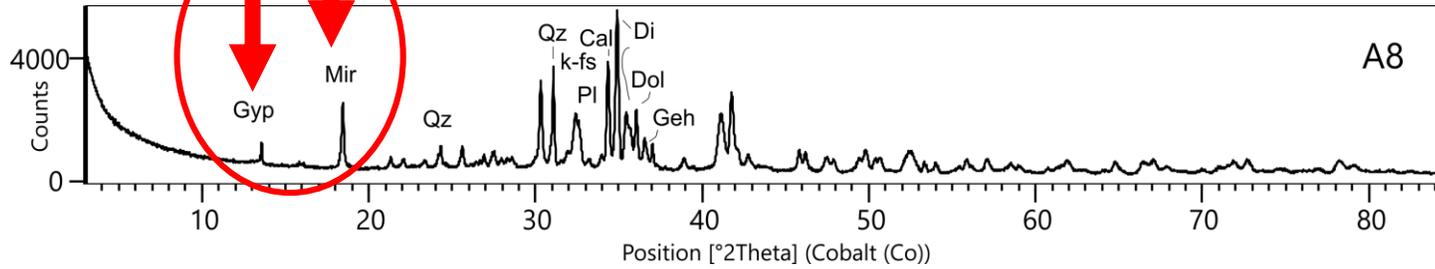
X-ray Powder Diffraction

- Gypsum or mirabilite are often found by diffraction patterns. These results are consistent with previous literature which indicate gypsum, halite and mirabilite as the main weathering products due to the salt decay process that affects Venice and the lagoon environment (Antonelli, et al., 2002; Schiavon, et al., 2008).

Mineralogical assemblages in historical bricks from XRPD analysis. Mineral abbreviations after Whitney and Evans (2010): Qz = quartz; Ill = illite; Kfs = K-felspar; PI = Plagioclase; Cal = calcite; Dol = dolomite; Hem = Hematite; Di = diopside; Gh = gehlenite; Fas = Fassaite; Gyp = gypsum; Mir = mirabilite. Relative quantity: xxx = very abundant; xx = abundant; x = medium; ** = scarce; * = rare.

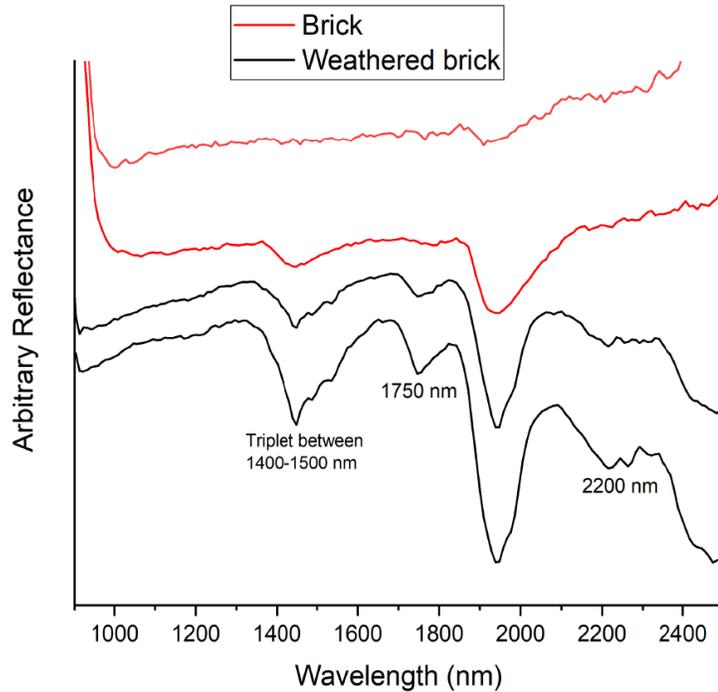
In the spectra of the weathered bricks there are many features of the sulphates spectra, absent in the original spectra. These bands are the triplet between 1400-1500 nm, the 1750 nm and the 2200 nm band.

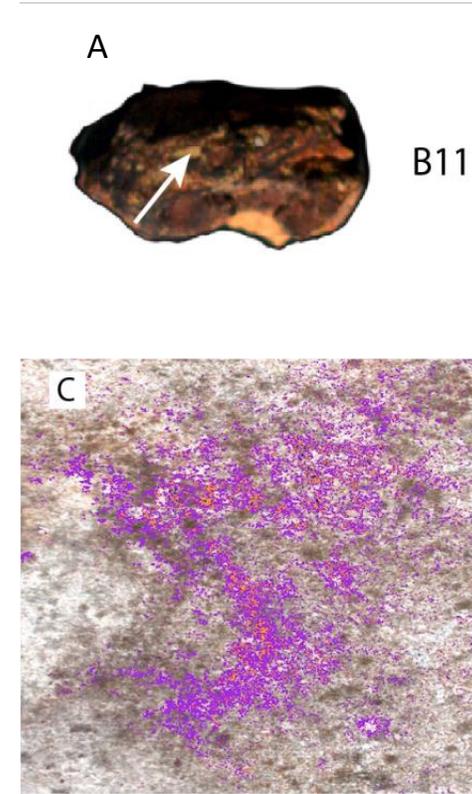
A) brick sample, white arrow indicates a greenish vein where spectra indicates the presence of biodeterioration. B) Spectra of the brick with and without biodeterioration. C-D) Biodeterioration on a Costozza tile indicated by the 680 nm band.

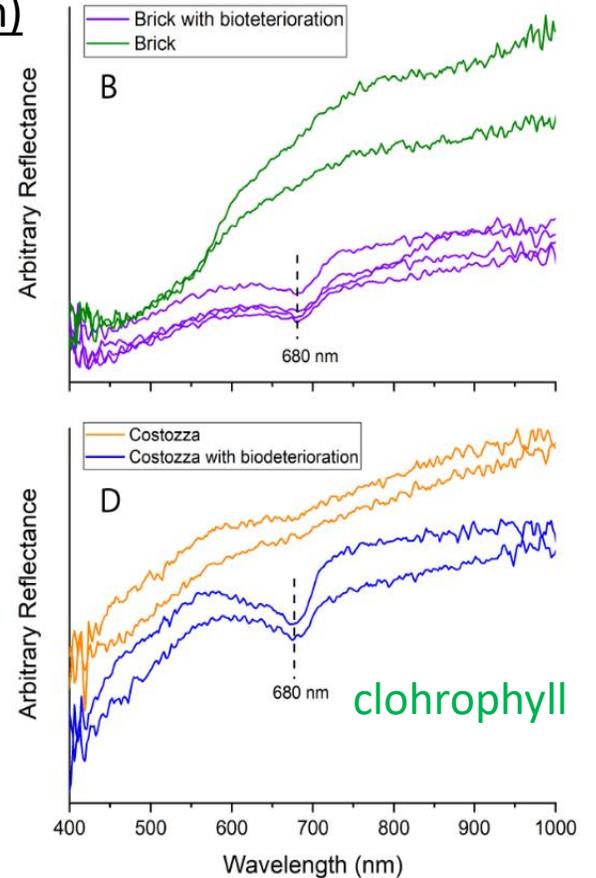
ON SITE ANALYSIS: maps of chlorophyll = biodeterioration

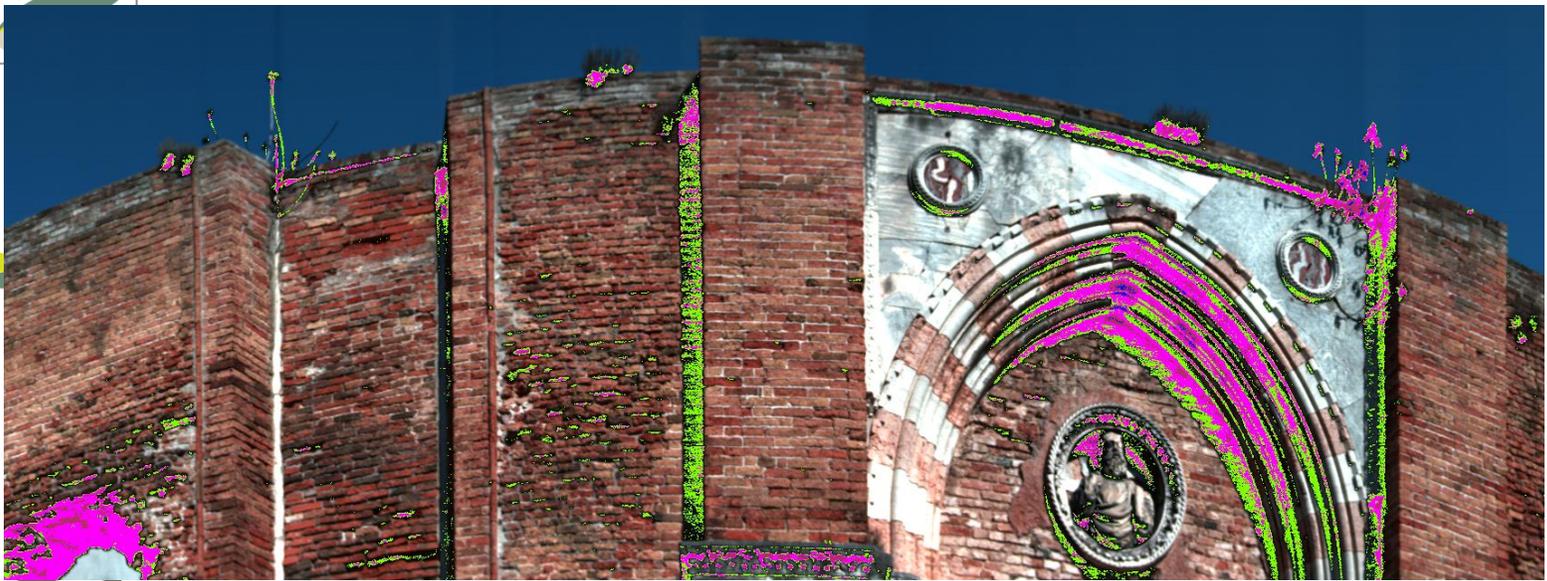
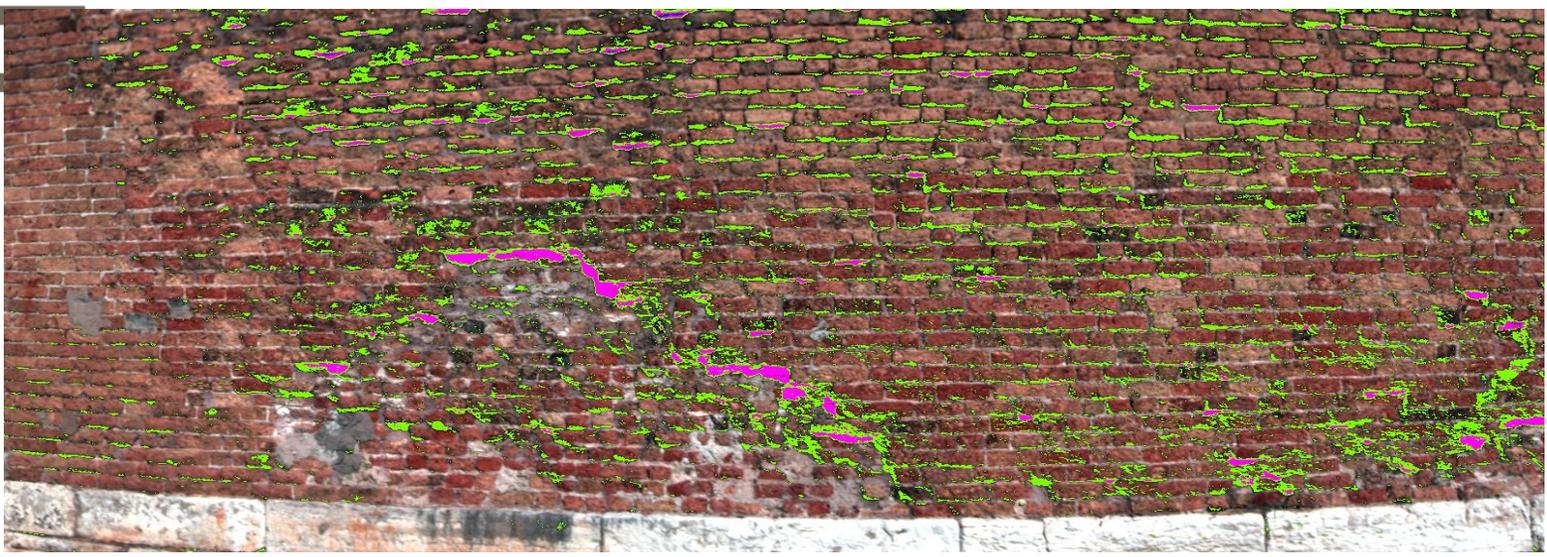
VNIR ranges-hyperspectral analysis

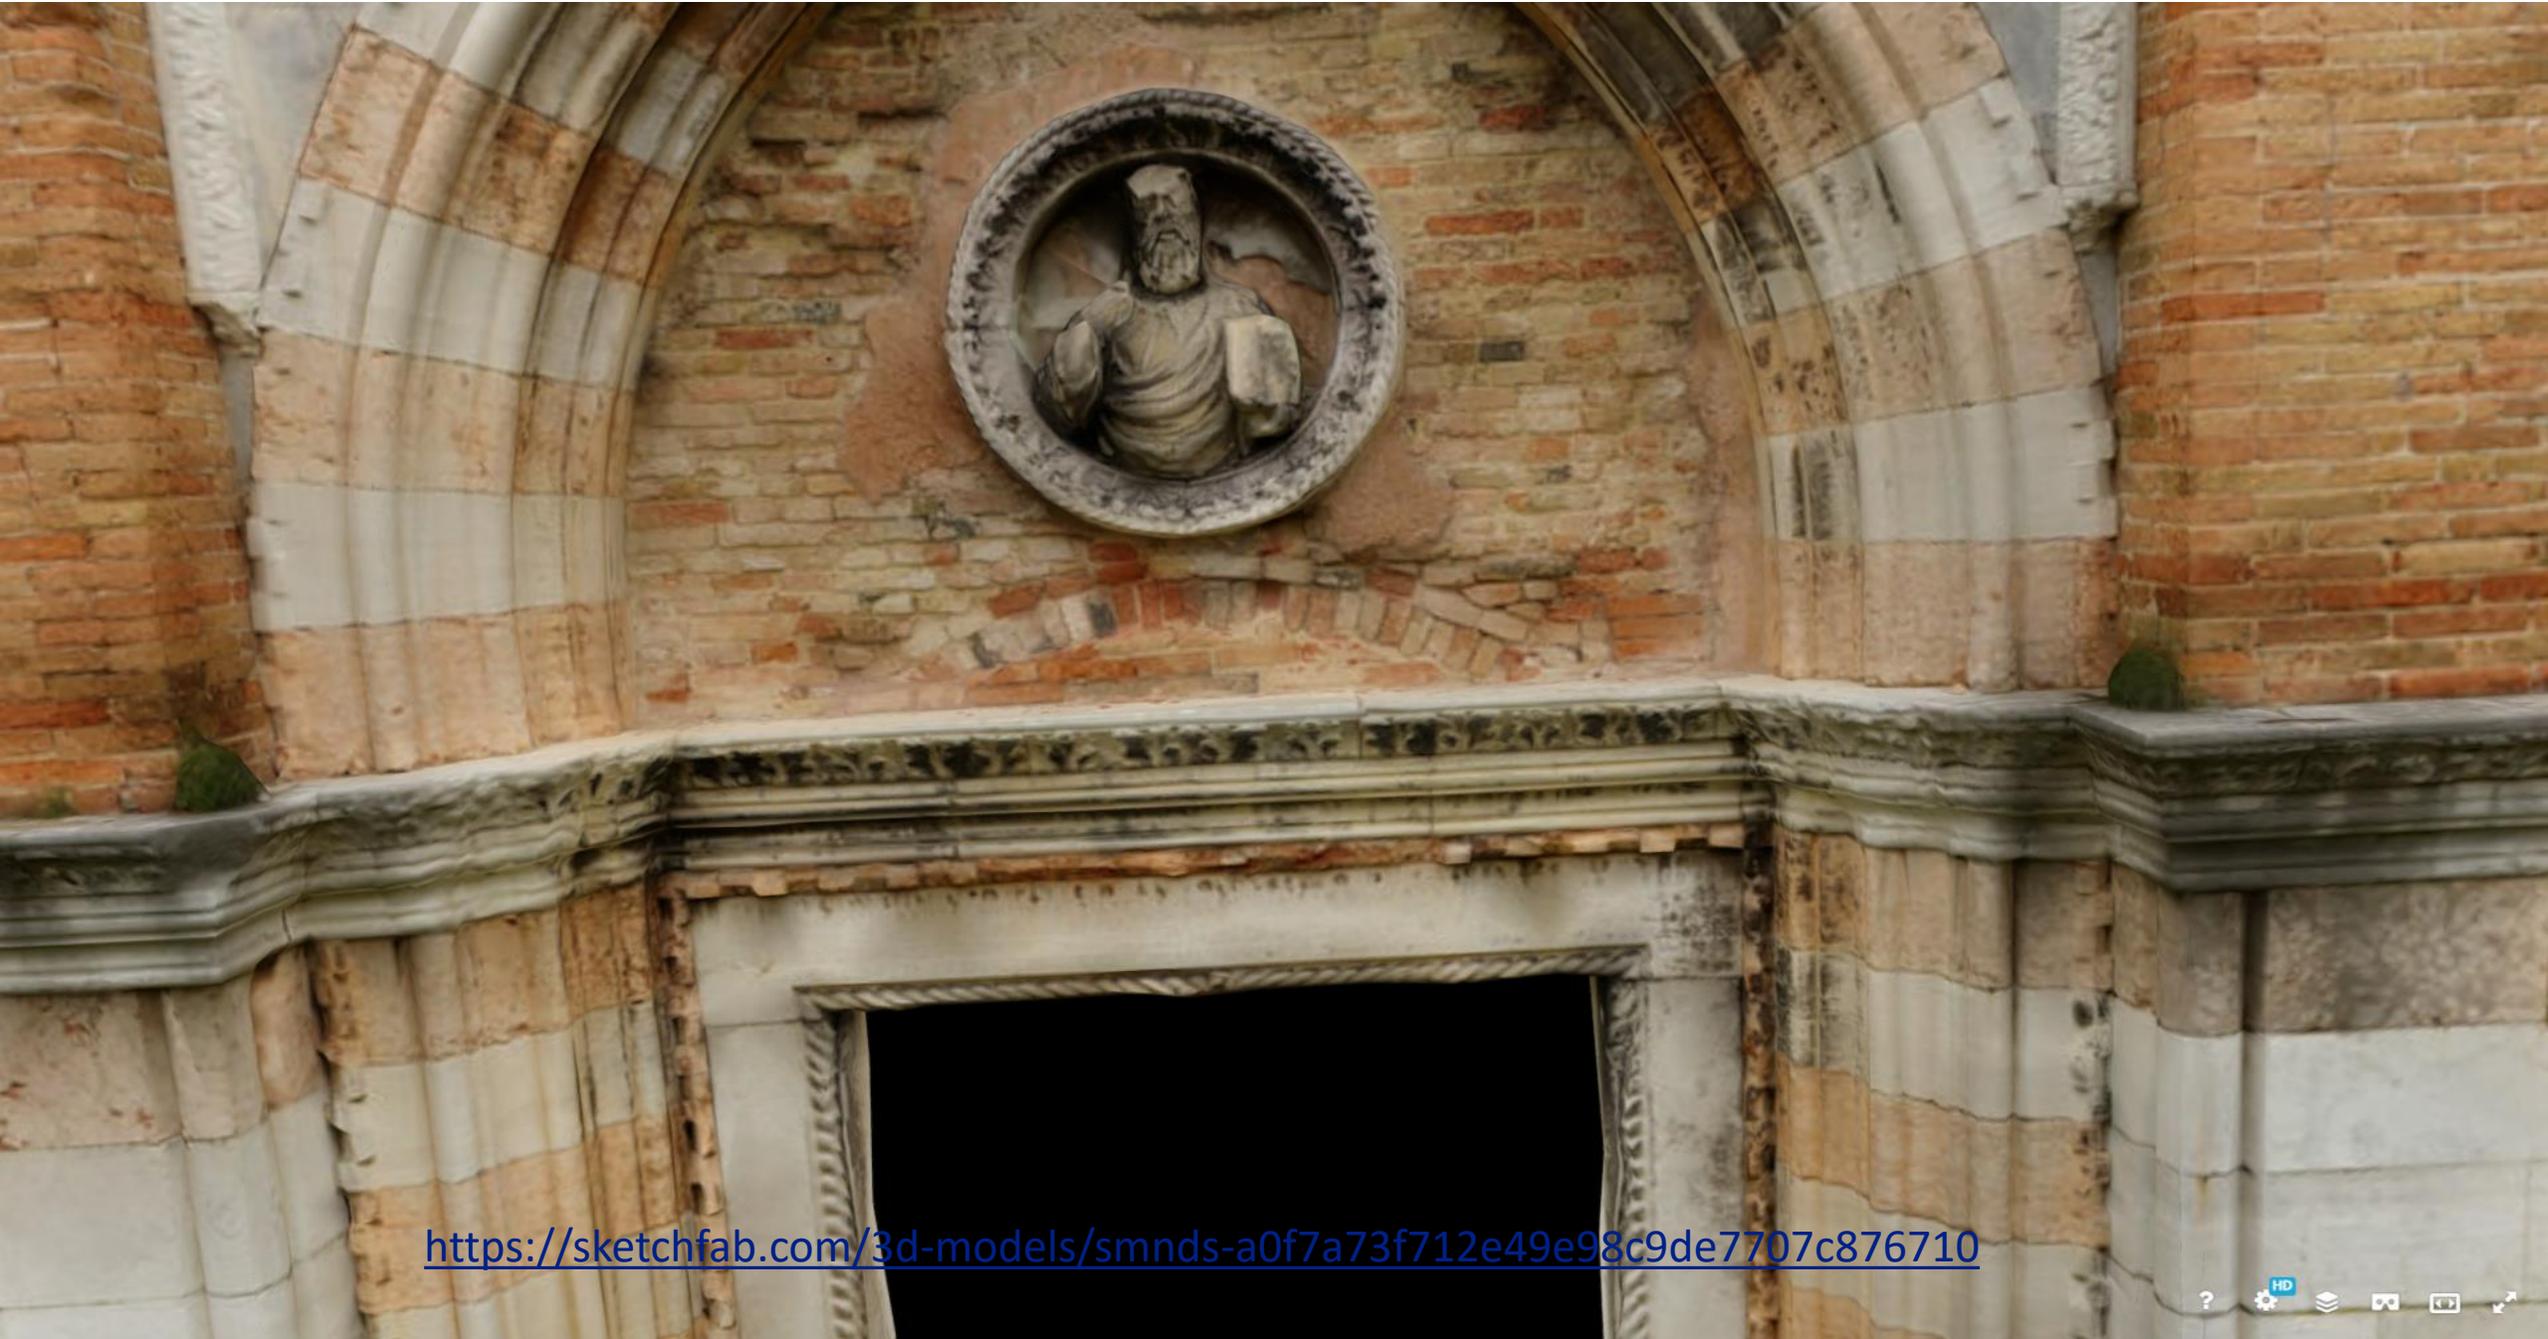
<https://sketchfab.com/3d-models/smnds-a0f7a73f712e49e98c9de7707c876710>

Deterioration of the West and East façades of Santa Maria di Servi (Venice) have been studied using photogrammetry and the resulting point cloud was managed in CloudCompare software. In order to determine the degradation patterns of the bricks, cross sections of the façades were extracted from the cloud adopting a 1 m step distance. In this way, 24 sections for the western façade and 16 for the eastern one were acquired. Descriptive coordinates of a selection of representative profiles were exported as coordinates and plotted in cumulative scatter diagrams

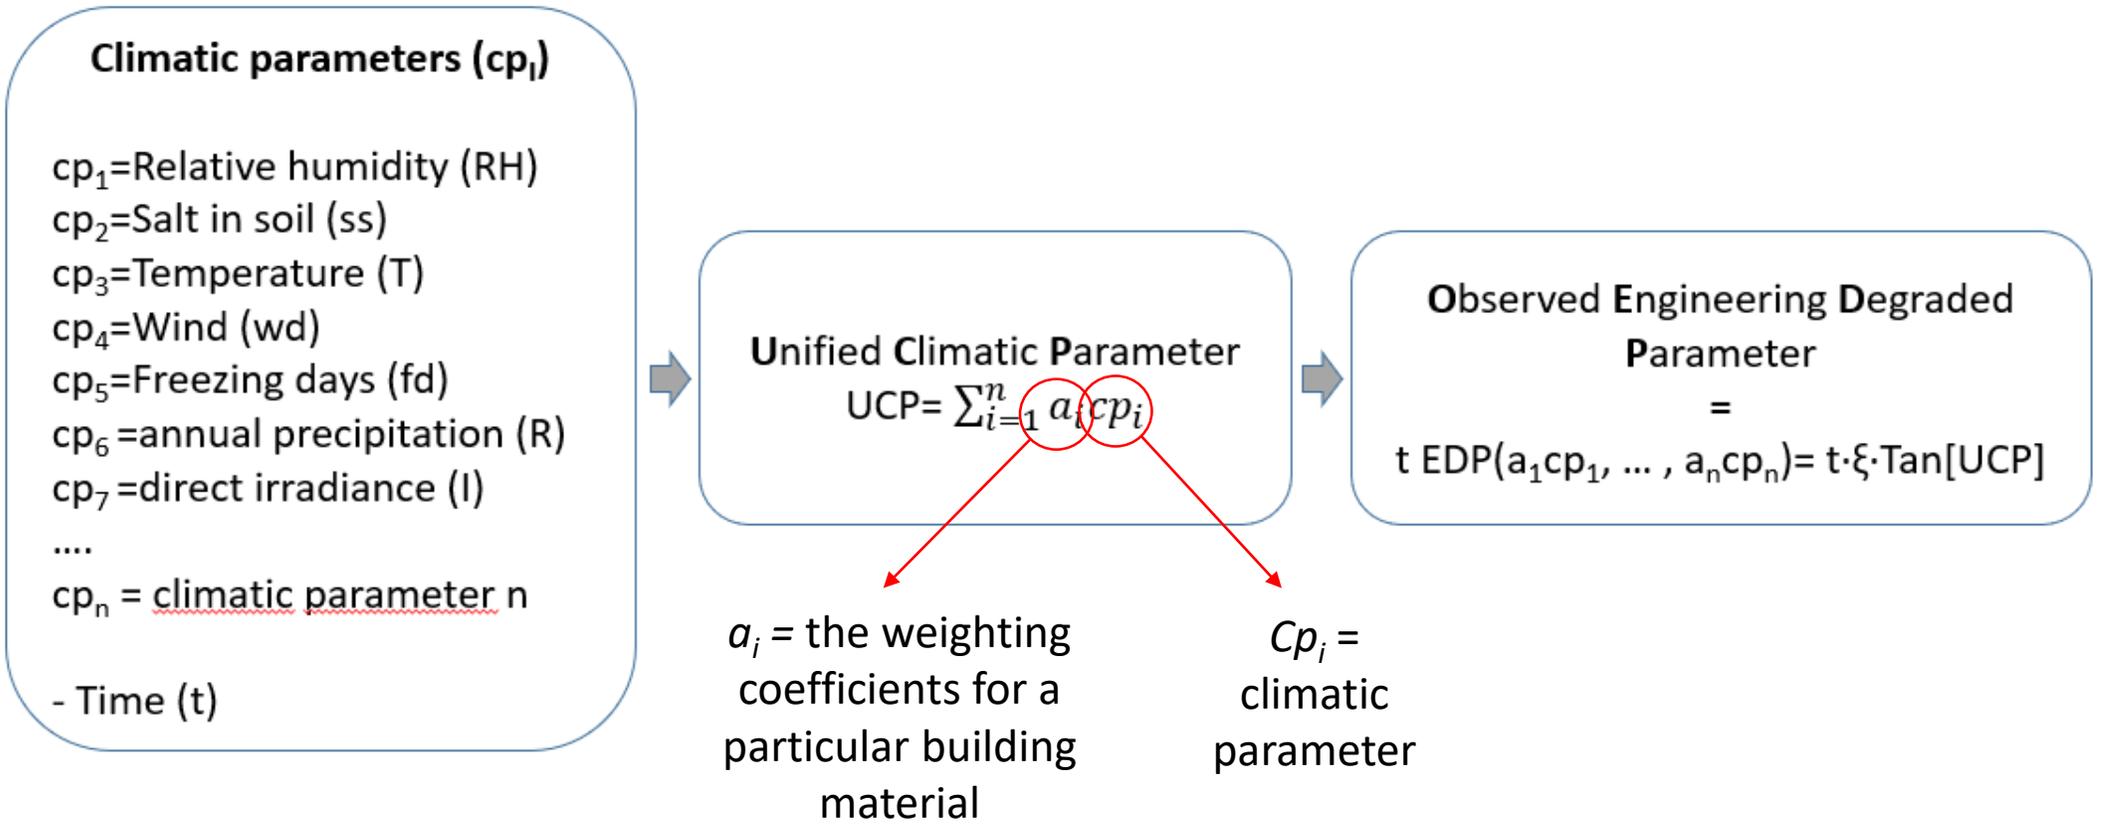
The proposed methodology consists on a system n+1 non-linear of equations which can be solved without considering laboratory data if sufficient information from degraded heritage buildings is available.

Flow chart corresponding to the empirical method

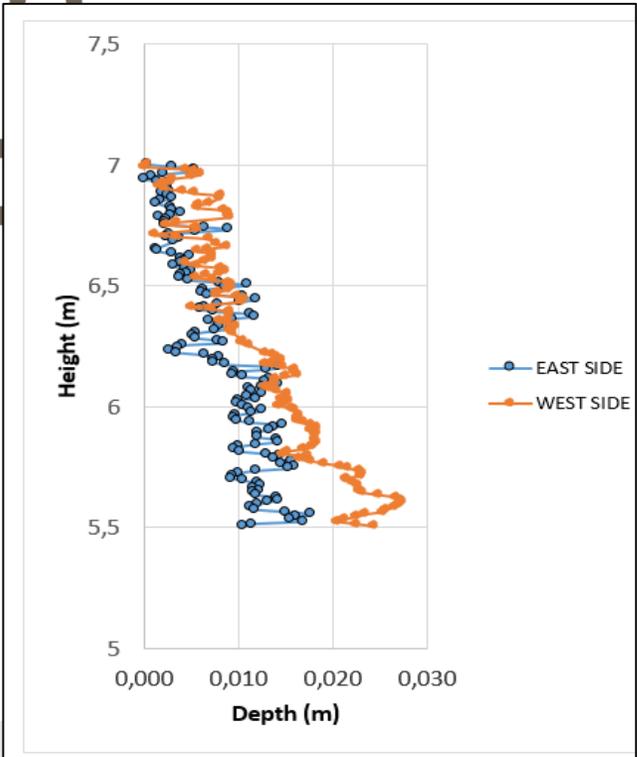
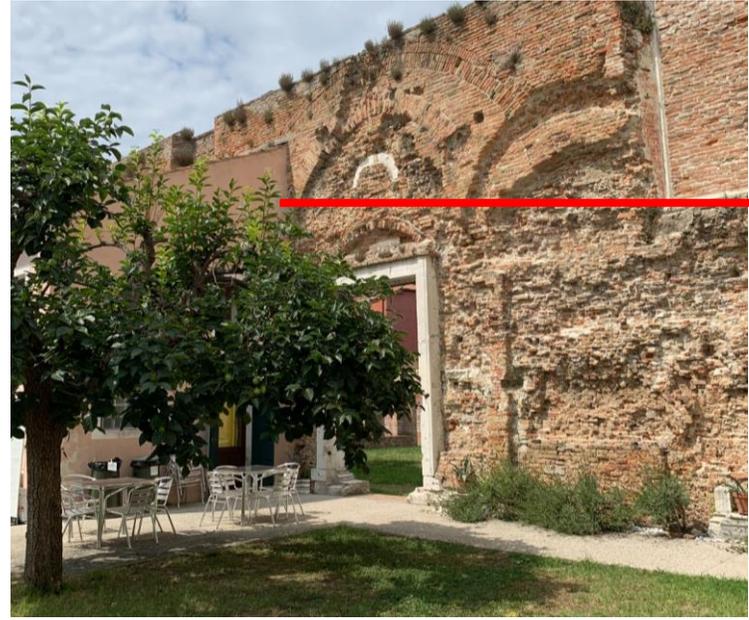
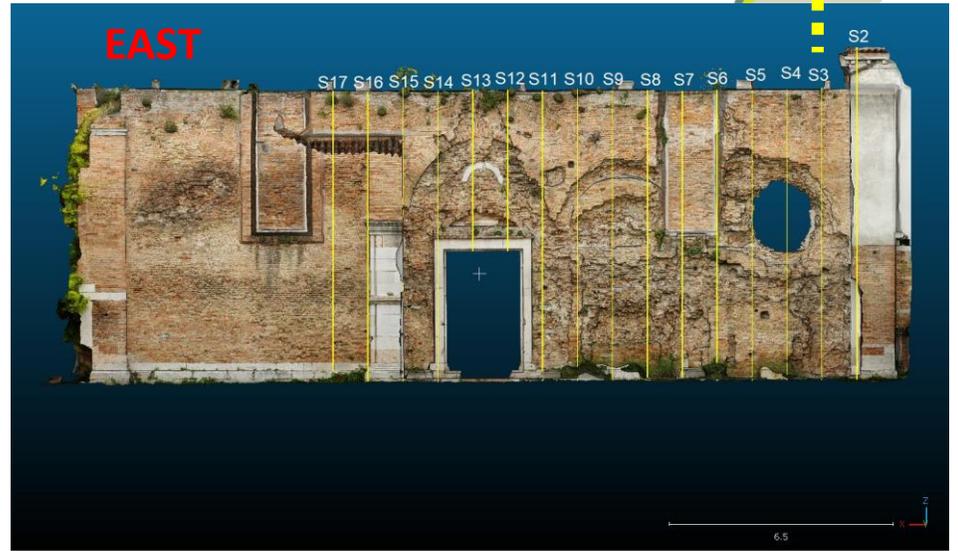
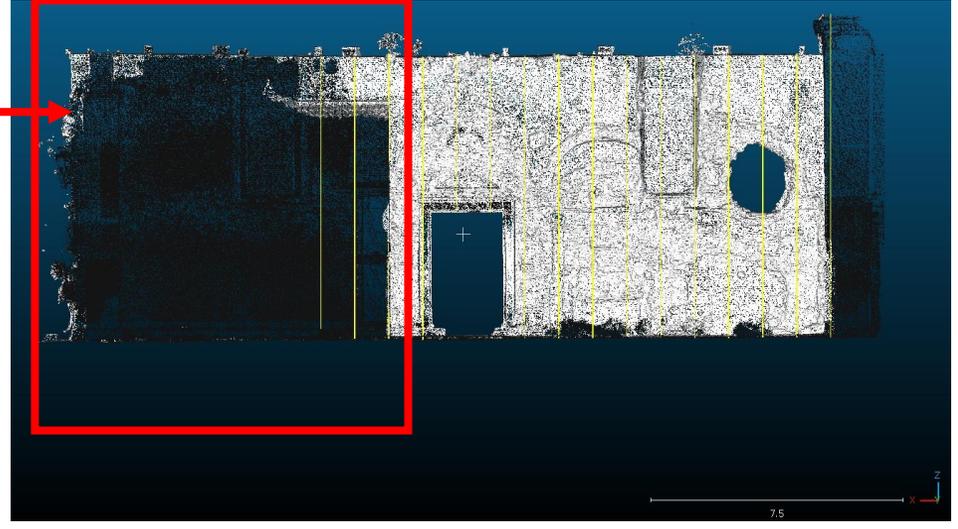
The east façade has been highly altered along history, being difficult to obtain a recession rate associated exclusively to climatic actions. Due to the above, the study is focused on the upper part of Section 3 (S3)

The difference between both sides along the selected part on the top of section S3 is 4.375 mm

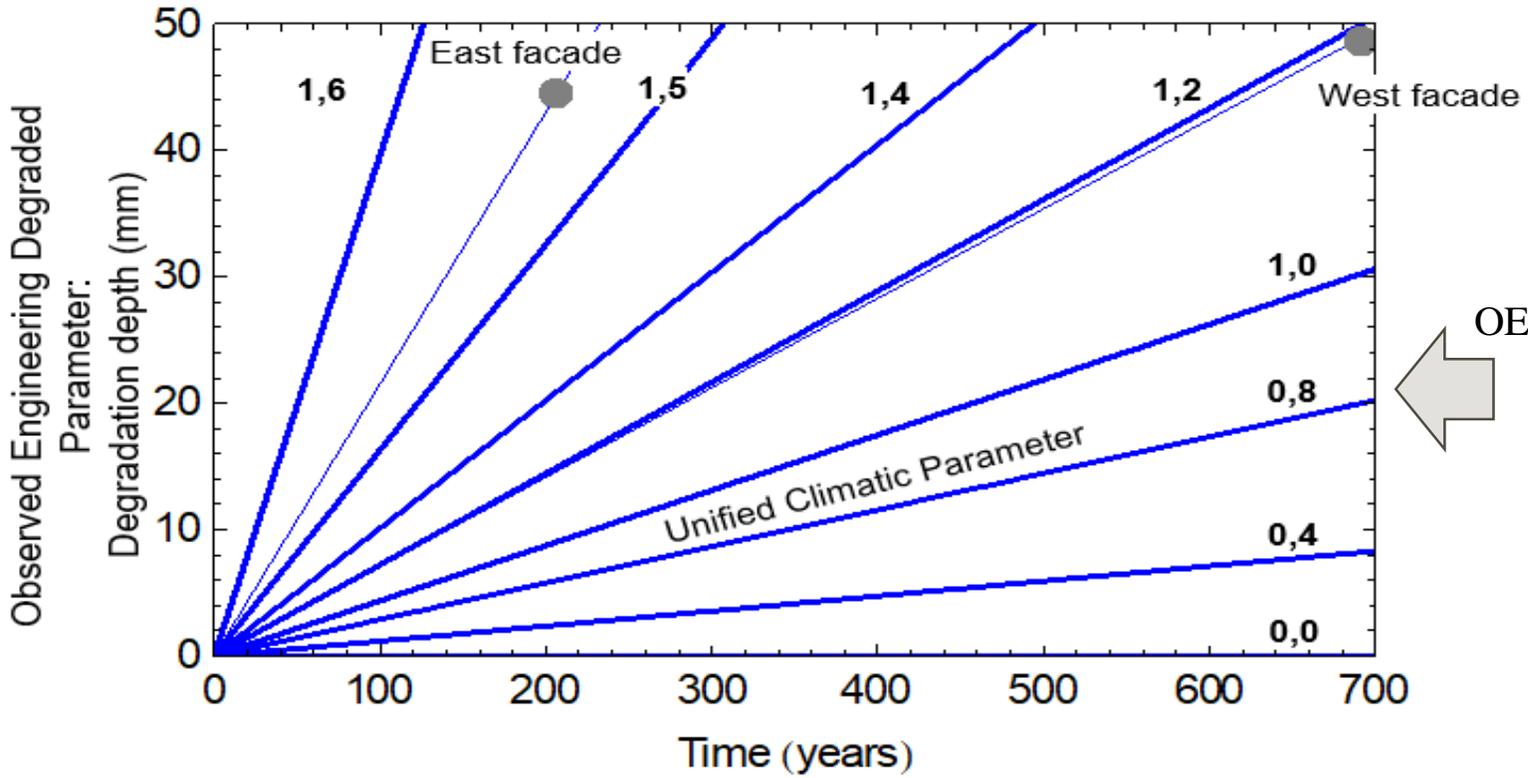
Deterioration Evolution Diagram of bricks of Sant Maria di Servi

$$OEPD = 0.0265 \cdot t \cdot \text{Tan}[UPC]$$

$$UPC = 0.000734n_{fdy} + 0.0494RH + 0.7750n_{psh}$$

The graphical representation of the OEDP as a function of time and of the UPC.

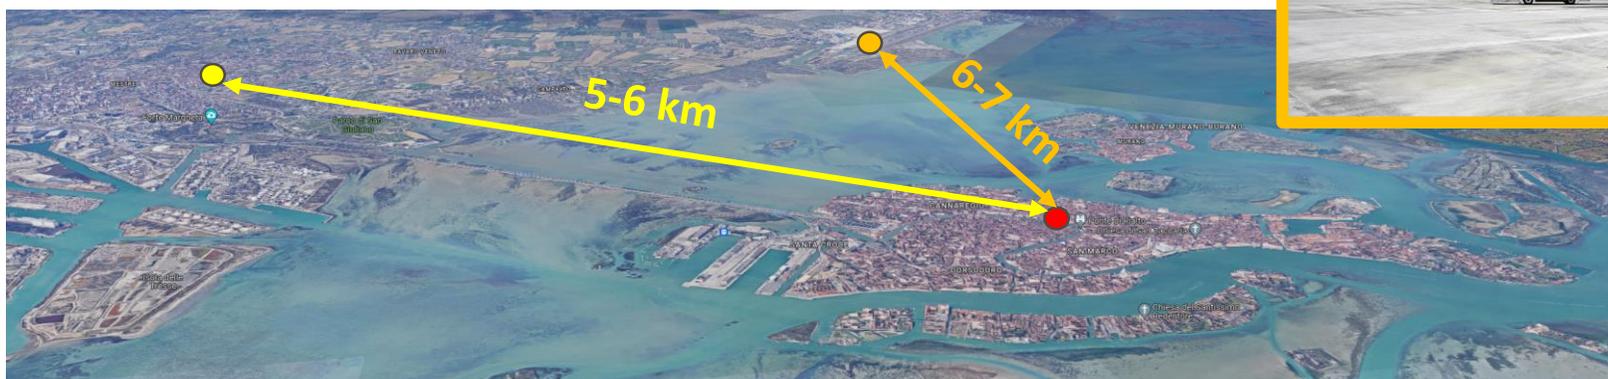
Trend of daily nitrogen dioxide concentrations in the two months of February-March: comparison between the four-year period 2016-2019 (blue line) and the year 2020 (red line)

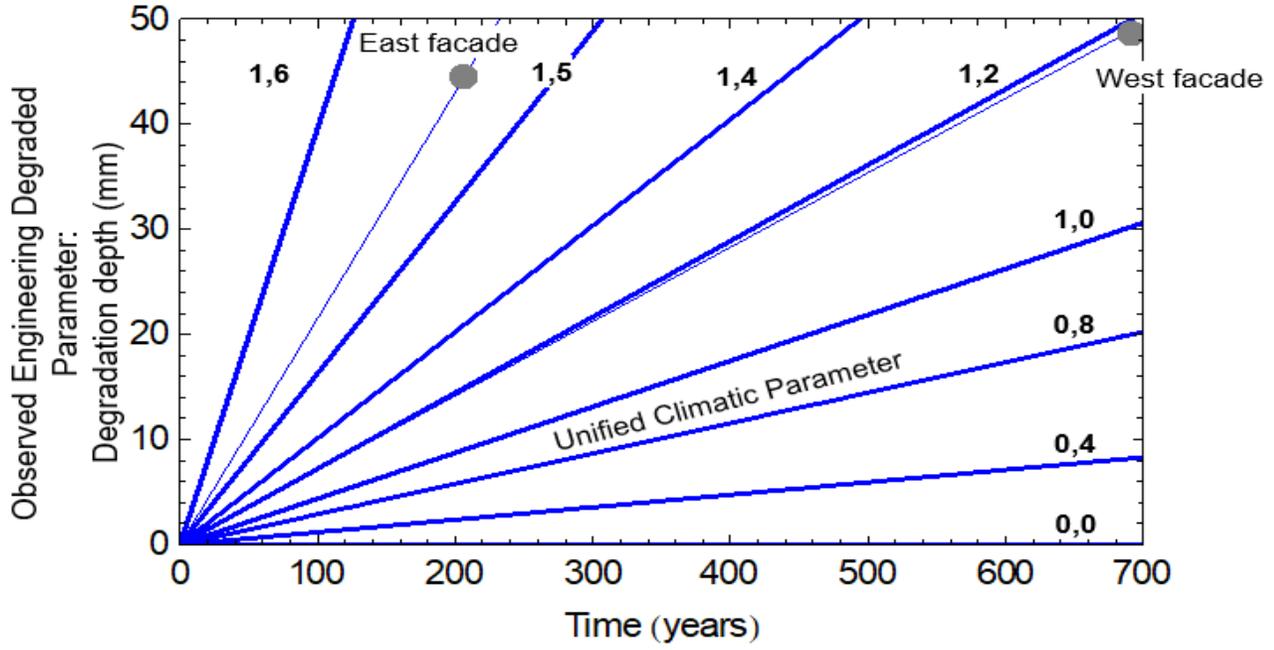
The upper part of both sides of Section 3 are compared to obtain a second equation of the recession

Deterioration Evolution Diagram of bricks of Sant Maria di Servi

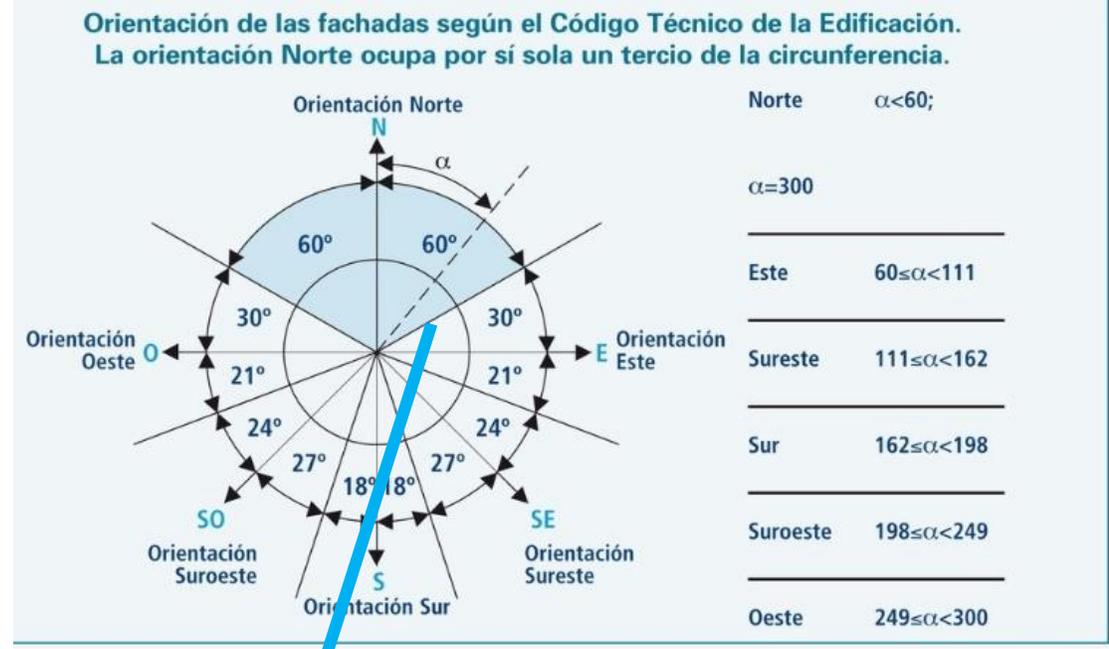
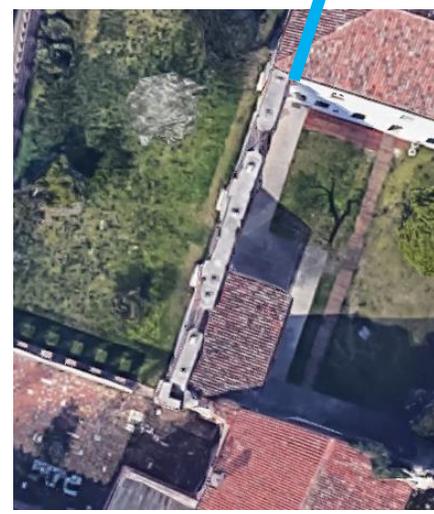
The difference between both sides along the selected part on the top of section S3 is 4.375 mm

Accounting for that the east façade has 1.81 peak hours of sunshine per day, while the west façade has 1.49 hours [21], assuming a constant recession and given that the difference between the depth of degradation at both sides of the façade is 4.375 mm (Figure 12), it can be concluded that:

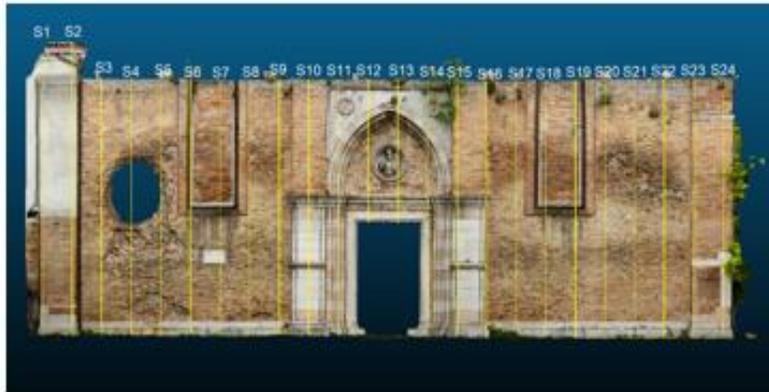
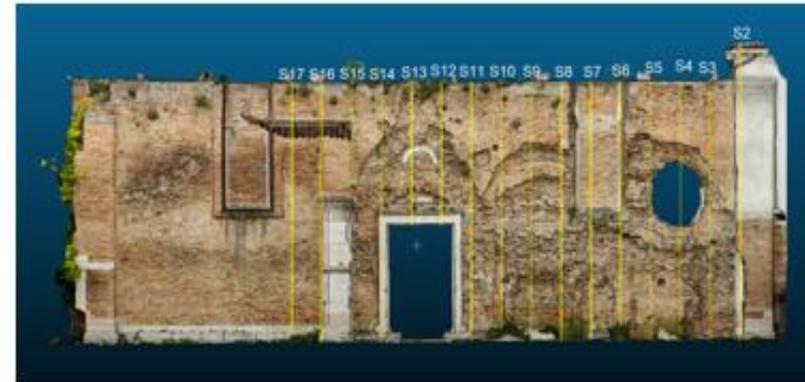
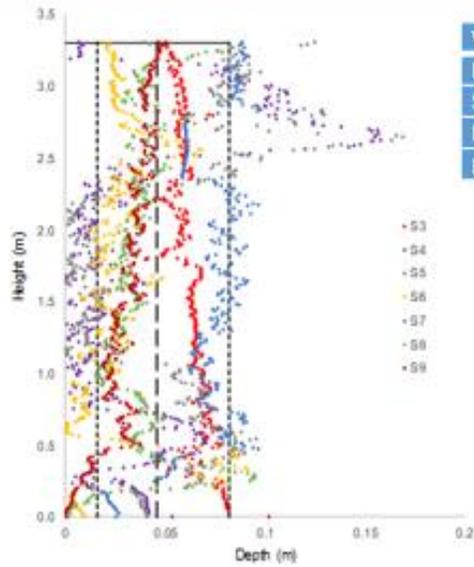
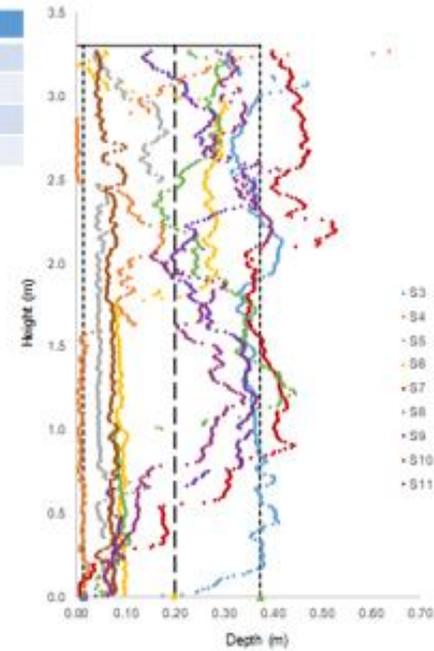
Mean degradation in the west and east facades

Values in meters	Front	Back
Mean degradation	0.046	0.201
SD	0.027	0.137
P ₅	0.016	0.016
P ₉₅	0.082	0.375
