# Hyperion

## D4.1 Classification of building materials, characterization of their main physical features and determination of their decay forms and products

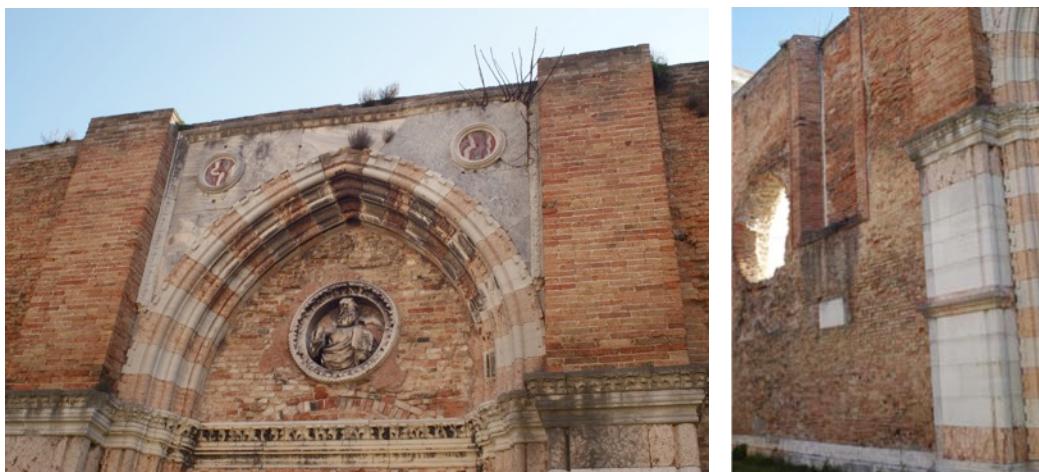
Figure 2: Photos of Santa Maria dei Servi façade in Venice

The Church of Santa Maria dei Servi (XIV century) was selected as Tier 2 building in Venice (Figure 2) in order to study the differential material loss in relation to the properties of the bricks. Bricks, indeed, being artificial materials have high variability in aesthetic qualities and intrinsic properties depending by the firing process adopted (in particular the reached temperature) and the raw materials used.

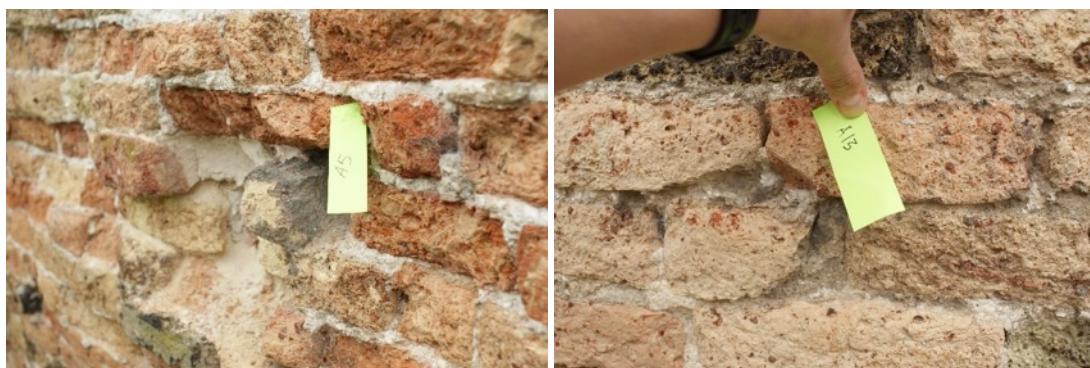
Figure 3: Samples collection on the main façade

Twenty-three samples were collected from the main façade (ANNEX 1B). Samples were collected (Figure 3) for performing the petrographic characterisation (XRPD, POM, SEM-BSE and hyperspectral analysis).

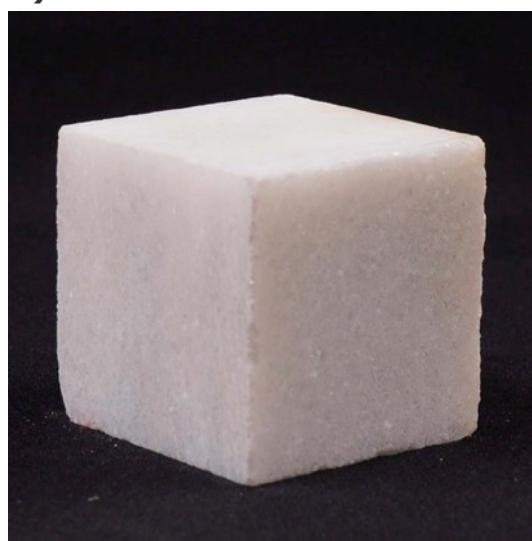
Figure 9: Cubic specimen of the Macael marble MM

*Texture:* granofelsic, heteroblastic, hialtal.

*Microstructure features:* Mosaic, heteroblastic, with 120° triple junctions. Crystal's boundaries are mainly curved and secondarily straight. It is medium grained with Maximum Grain Sizes (MGS) 1.57 mm.

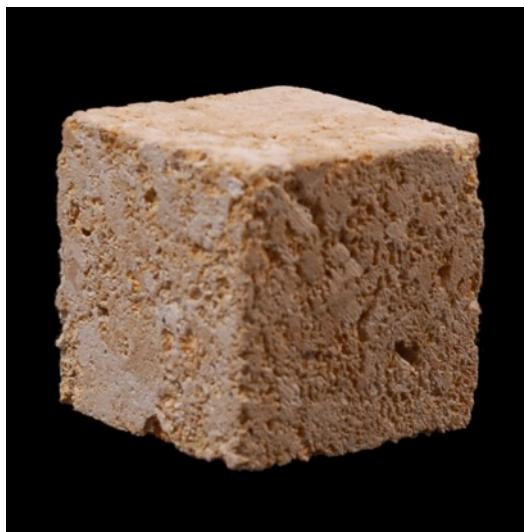
Figure 11: Cubic specimen of the Santa Pudia limestone GSP

**Description:** Fossiliferous sedimentary rock consisting of micritic calcite and limited spathic cement. Allochems are essentially bioclasts constituted by bryozoans, articulated coralline algae, echinoderms, and mollusks. The cement is present as filling of fossils voids and substitution of shells.

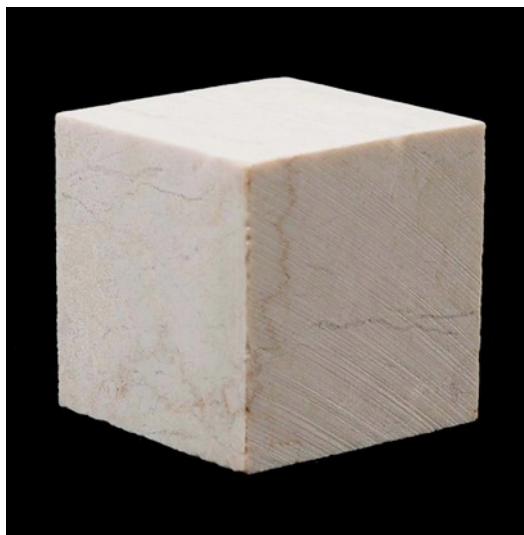
Figure 17: Cubic specimen of the Botticino limestone BL

*Description:* Compact sedimentary rock corresponding to a micritic limestone made of very fine-grained calcite crystals ( $<4 \mu\text{m}$ ) and abundant spathic dolomite crystals mainly gathered in iso-oriented veins. Stylolites are frequent, with small deposits of clay minerals often occurring along them.

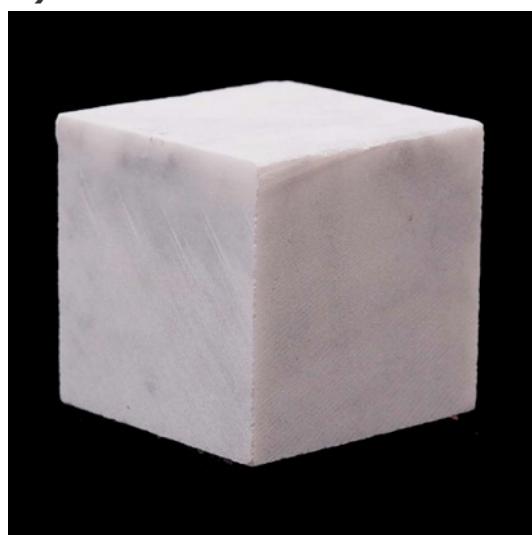
Figure 19: Cubic specimen of the Carrara marble CM

*Texture:* granofelsic, homeoblastic.

*Microstructure features:* Mosaic, with rare 120° triple junctions, mainly homeoblastic, locally partially heteroblastic. Crystals' boundaries are mainly curved and rarely straight. It is fine grained with Maximum Grain Sizes (MGS) 0.66 mm.

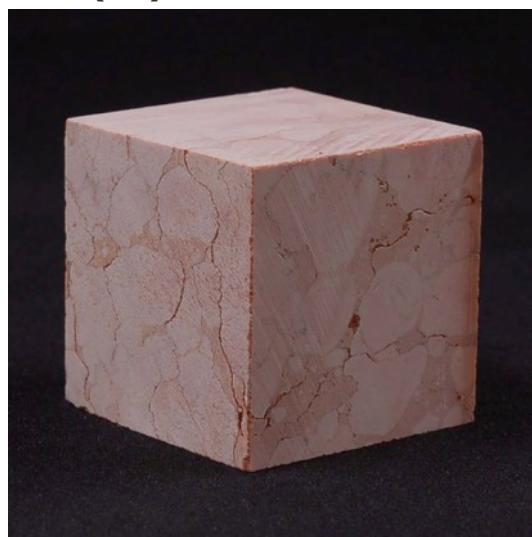
Figure 21: Cubic specimen of the Red Verona limestone RV

*Description:* Carbonate sedimentary rock corresponding to a nodular limestone with abundant bioclasts within a micritic mud and rare spathic cement. The allochem constituents are ammonites (macroscopic), fragments of bivalves (pelagic

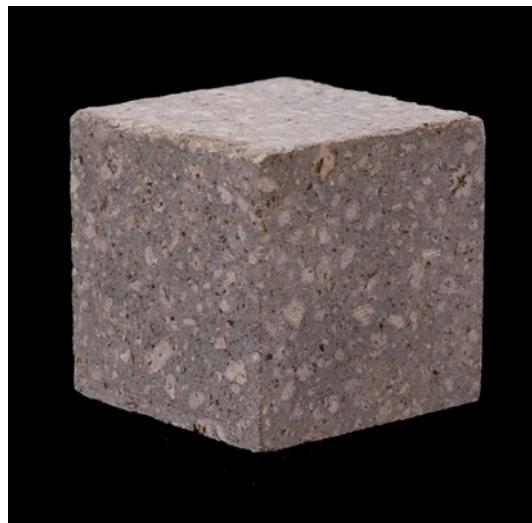
Figure 25: Cubic specimen of the trachyte Etr

*Texture:* aphanitic, holocrystalline, microcristalline, glomeroporphyritic, microlitic, pilotaxitic.

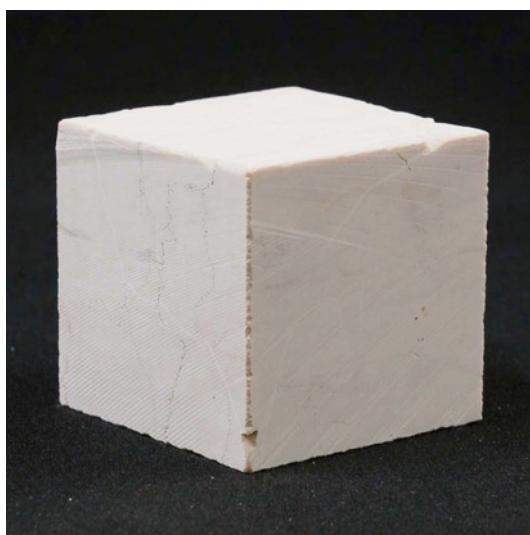
Figure 27: Cubic specimen of the Istrian stone IS

*Description:* Compact sedimentary rock corresponding to a marine limestone made of very fine-grained calcite crystals (<4 micrometers). The texture frequently features iso-oriented veins and small nuclei or cavities filled with secondary spathic calcite. Stylolites, as well as sedimentary joints, are frequent, with small deposits of clay minerals and iron oxides and hydroxides (Hematite-Limonite) often occurring along them, colored by red or yellow-ochre

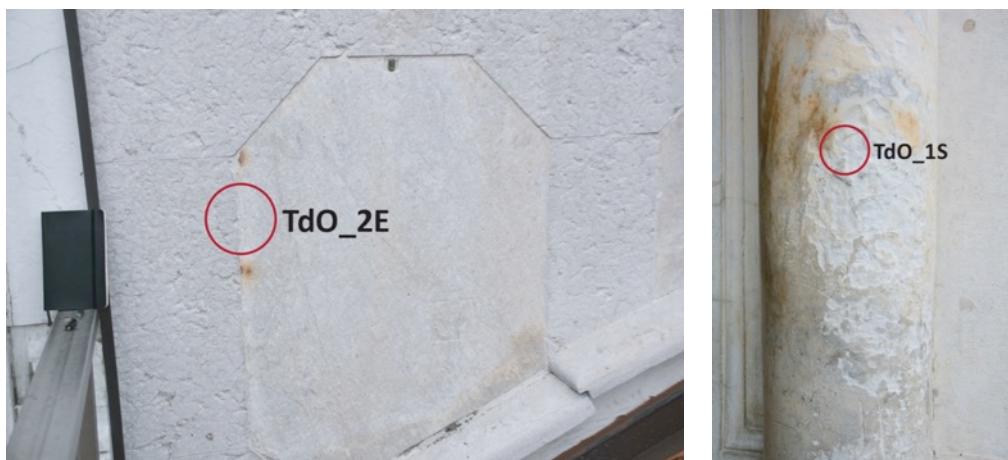
Figure 29: Sampling points of Carrara marble (sample TdO\_2E, left and TdO\_1S)

*Microstructure features:* Polygonal, with triple points, sometimes purely mosaic and homeoblastic. Crystal's boundaries are mainly straight. Crystals maximum grain size (MGS) 0.60 mm (TdO\_2E); 0.58 mm (TdO\_1S).

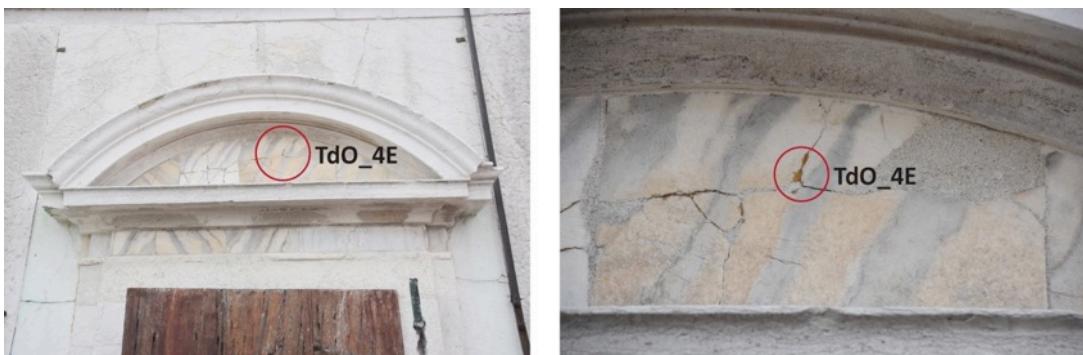
Figure 32: Sampling point of Proconnesian marble (sample TdO\_4E)

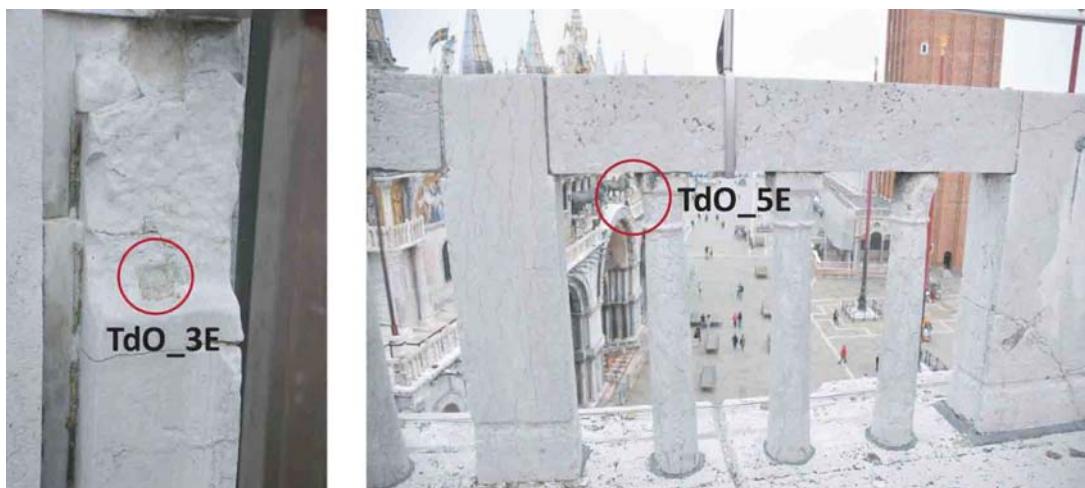
Figure 35: Sampling points of Istrian stone (sample TdO\_E3 and TdO\_5E)

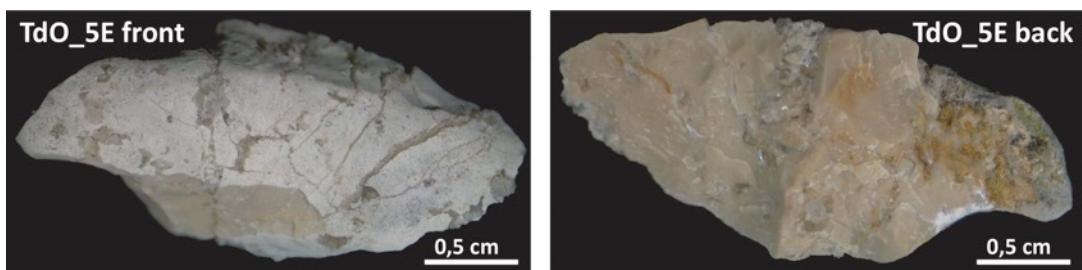
Figure 36: Stereomicroscope photos of Istrian stone (samples TdO\_5E)

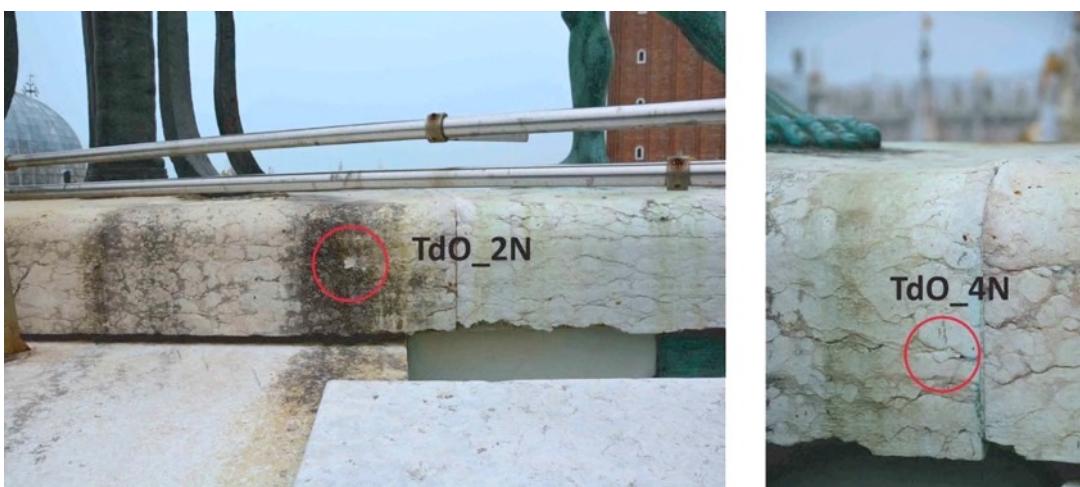
Figure 38: Sampling points of Red Verona limestone (samples TdO\_2N and TdO\_4N)

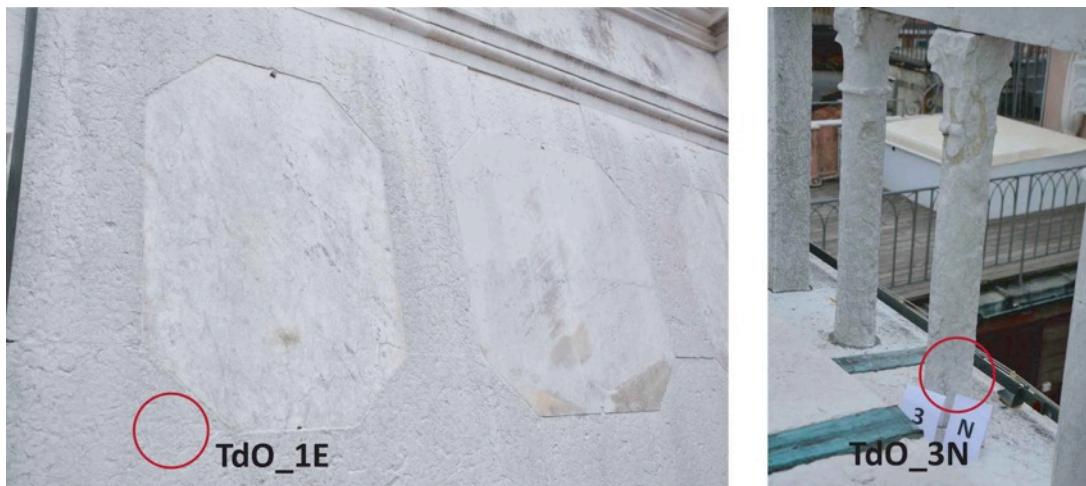
Figure 41: Sampling points of *Pietra di Prun* limestone (samples TdO\_1E and TdO\_3N)

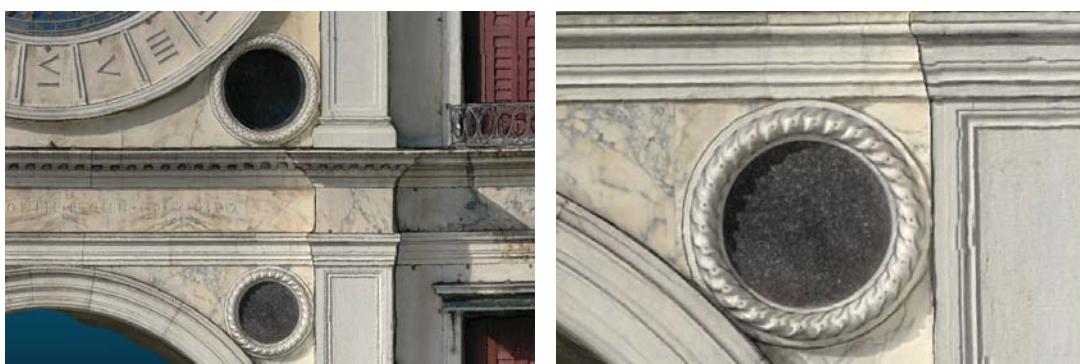
*Macroscopic description:* effusive igneous rock showing porphyric structure: pink phenocrysts of plagioclase floating in a purple groundmass. The red-purple color is due to trace of piemontite, the manganese member of the epidote group, and indicates a degree of metamorphism.

Figure 44: Circular decoration in Imperial porphyry

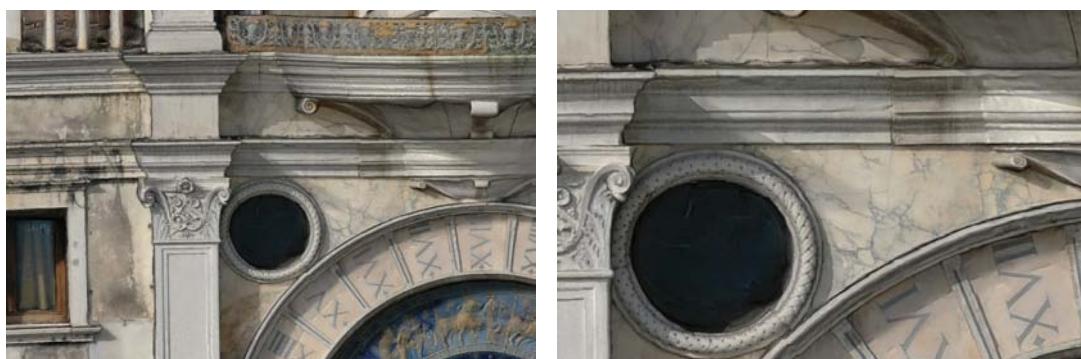
*Macroscopic description:* Brecciated calcite marble with dark purple hematite-rich matrix.

Figure 45: Shaped slabs of Pavonazzetto Toscano Marble

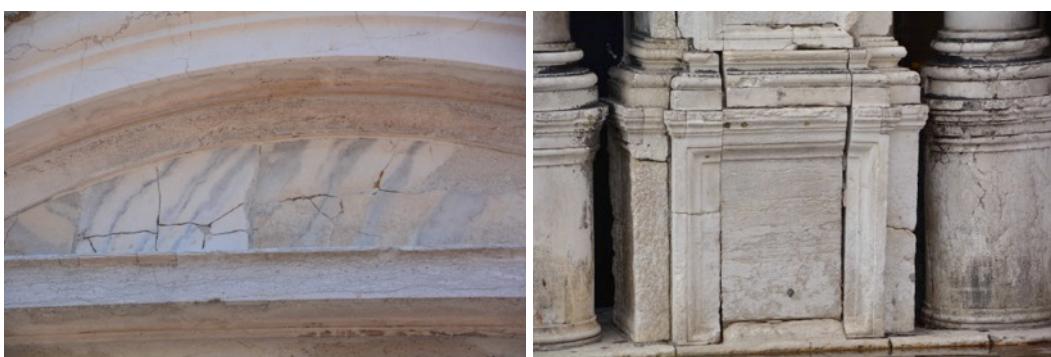
Figure 51: Fractures on the arch above a door (left) and on a pilaster strip base (right)

- **cracks**, more specifically fractures (Figure 51), with the intensity between 1 and 2 (very slight to slight), the façade more concerned by this phenomenon is the South one (ANNEX 3Aa).
- **deformations** mainly as bowing phenomenon (i.e. a convex deformation involving especially the median section (Figure 52) of the marble panels and showing very slight or slight intensity. This decay pattern is more evident in the East façade (ANNEX 3Ab). A more intense deformation (DL 3) involves the extreme NE pilaster strip (lesana) where one stone block appears to be slightly tilted (Figure 52 right).

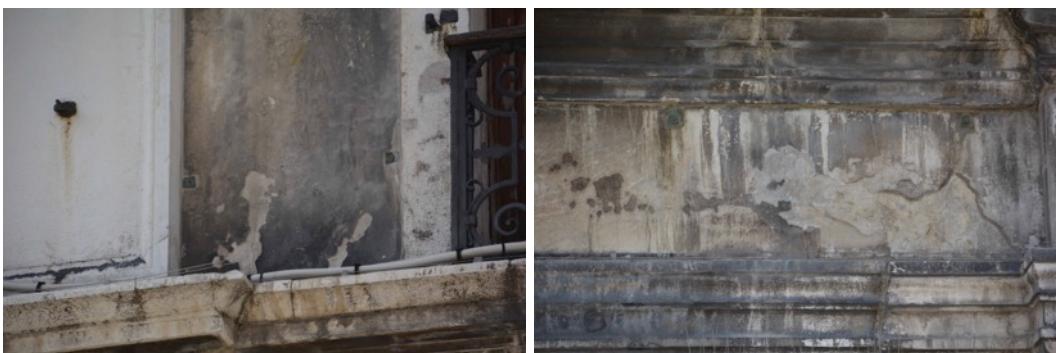
Figure 53: Blistering involving both stone substrate and superficial black crusts

- **blistering** (Figure 53) with the intensity between 1 and 2 (very slight to slight), involving only the South façade were the salts crystallization and black crusts are more intense (ANNEX 3Ba).
- **disintegration** (Figure 54) of limestone and crystalline marbles (sugaring) panels, in the last case probably due to thermal shock. These morphologies are more common on the side façades (ANNEX 3Bb, 3Bc) showing intensity of 1 or 2 (very slight to slight).

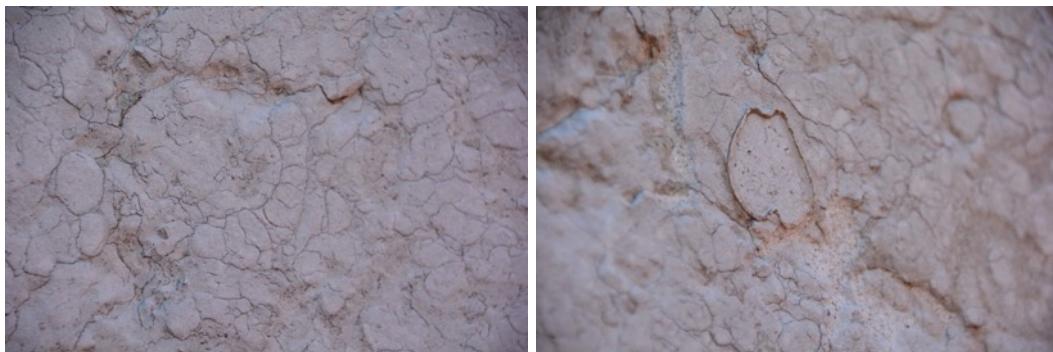
Figure 55: Differential matrix erosion on *Scaglia Rossa* slabs

- **differential erosion** with the intensity between 1 and 2 (very slight to slight), in particular as a consequence of a major recession rate (due to dissolution effect) of the fine-grained calcite portions of limestone (Figure 55) with respect to those with average-to-coarse grained carbonate. This decay morphology is more common in the East and West façades (ANNEX 3Cb, 3Cc).
- **microkarst** (Figure 56) of slight intensity (DL 2) interesting all the Istrian Stone small columns of all the balustrades (ANNEX 3C).
- **missing part** with the intensity widely varying between very slight and very severe (DL 1 to 5). In particular, some *rotae* of *hematitic cataclastic limestone* are partially or completely missing (ANNEX 3C).

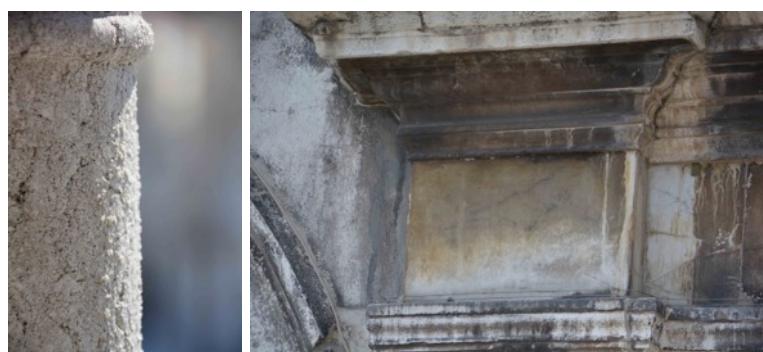
Figure 58: Efflorescence on a small column of the balustrade (left), yellowish patina (right)

- **patinas**, resulting from ageing of ancient treatments, appear as a yellowish layer (Figure 58 right) mainly on crystalline marble slabs and columns/pilasters (ANNEX 3D). The intensity of this decay product range from 1 to 3 (very slight to moderate).

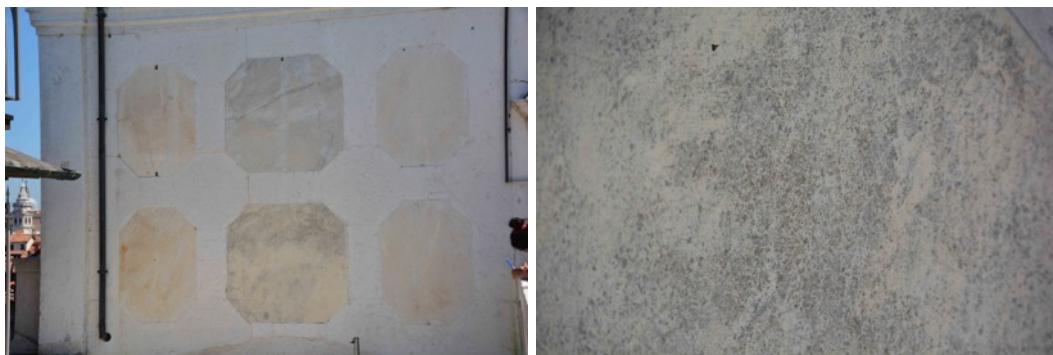
Figure 59: Marble panels showing yellowish patinas and soiling (left), detail of the soling deposit (right)

- **soiling** is the most widespread decay morphology in the whole building (ANNEX 3D). It appears as a tenuous blackish-gray layer (intensity between 1 and 4, very slight to severe) that confers a dirty appearance to the stone (Figure 59).

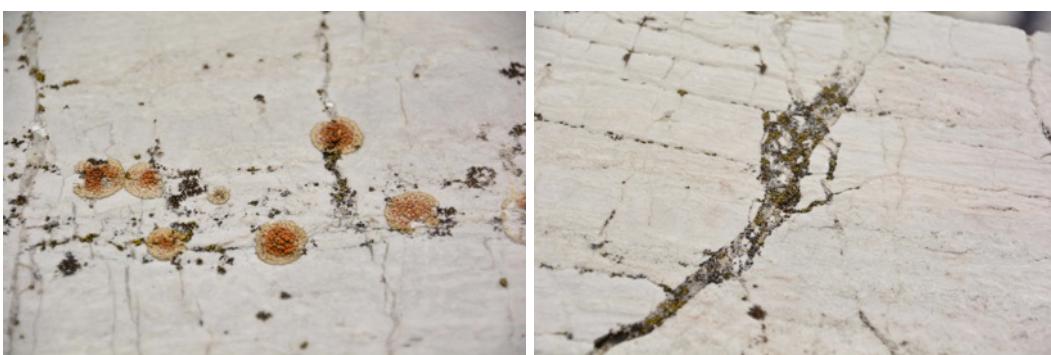
Figure 60: Lichens (left) and fungi (right) on the stone balustrade

- **lichens** and **fungi** colonization (intensity between 1 and 2: very slight to slight; Figure 60) mainly developed on Istrian stone in a homogeneous way in the three façades (ANNEX 3E).
- **moss** were rarely identified but when present are visually impactful (Figure 61); they were found mainly in the walkways between the balustrades of the two wings of the building and therefore they cannot be mapped on the elevations.

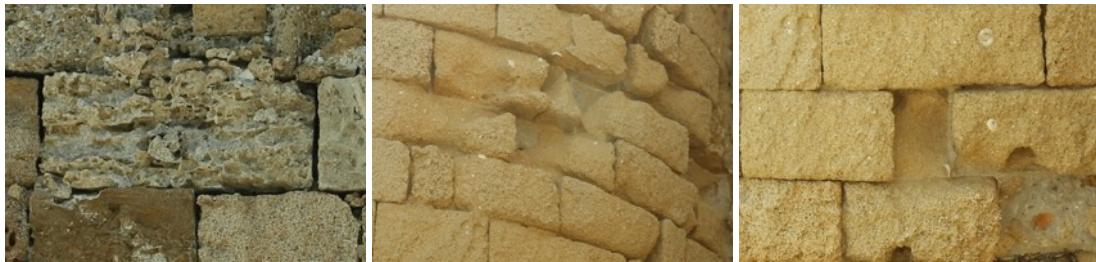
Figure 78: Example of Material loss morphologies in Nailac Pier and Saint Nikolas. From the left: alveolizations, erosion and missing part, missing parts

The only morphologies detectable from the high-resolution images received were those connected to the loss of material. In particular, both the buildings, that are mainly constituted by a porous calcarenite (Sfouggaria Stone) blocks, are affected by severe alveolizations and, subordinately, by erosion and missing parts (Figure 78). An example of alveolizations and its map is reported in Figure 79. All mappings concerning the Rhodian buildings investigated are reported in Annex 4.

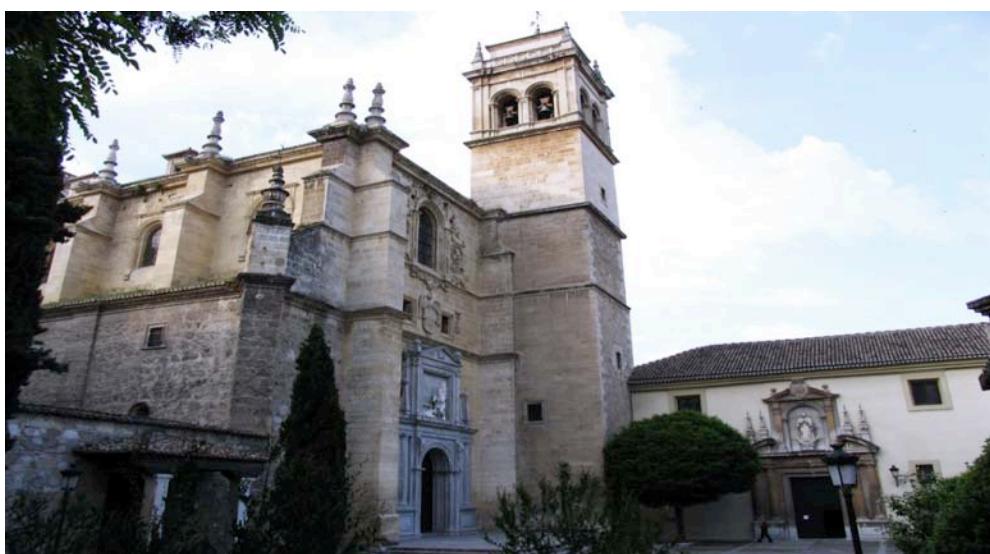
Figure 80: Main facade of San Jerónimo Monastery

As an example, the main façade is analyzed (Figure 80). In Figure 81, the measured deterioration profiles (S1, S2) of the main facade and its location are presented.
