D4.3 Analysis of microclimatic time series and assessment of systematic deviation from local time series required as input in the hygrothermal simulations

Deliverable number	D4.3
Deliverable title	Analysis of microclimatic time series and assessment of systematic deviation from local time series required as input in the hygrothermal simulations
Nature ¹	R
Dissemination Level ²	PU
Author (email) Institution	Luigi Germinario (luigi.germinario@unipd.it) UNIPD
Editor (email) Institution	Claudio Mazzoli (claudio.mazzoli@unipd.it) UNIPD
Leading partner	UNIPD
Participating partners	IUAV, OSLOMET, UGR, CVI, VFK
Official submission date:	31/08/2021
Actual submission date:	07/09/2021

This work is a part of the HYPERION project. HYPERION has received funding from the European Union’s Horizon 2020 research and innovation programme under grant agreement no 821054.

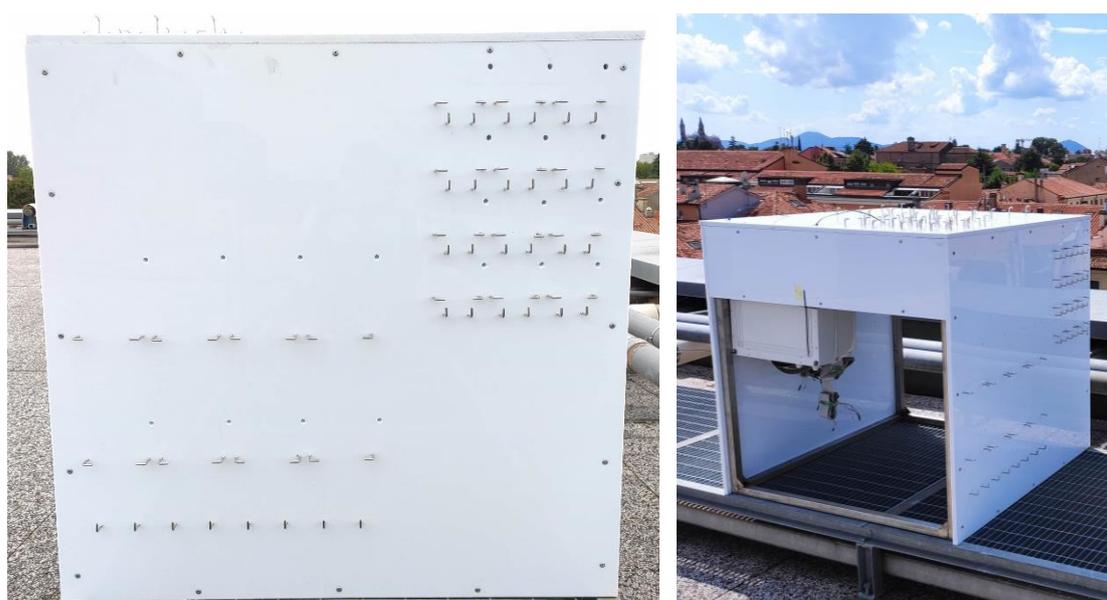
Figure 2: The 100-cm stand of one of the Cubes with the L-hooks and the control unit box.

The stand is an original design, is made of white PVC panels reinforced with a stainless steel frame underneath and has a cubic shape. Two of the stands have each side 100 cm long, the third has each size 50 cm long instead – these dimensions were chosen based on the requirements for the final installation. AISI-304 stainless steel L-hooks were used for fixing the samples to the panels (Figure 2).

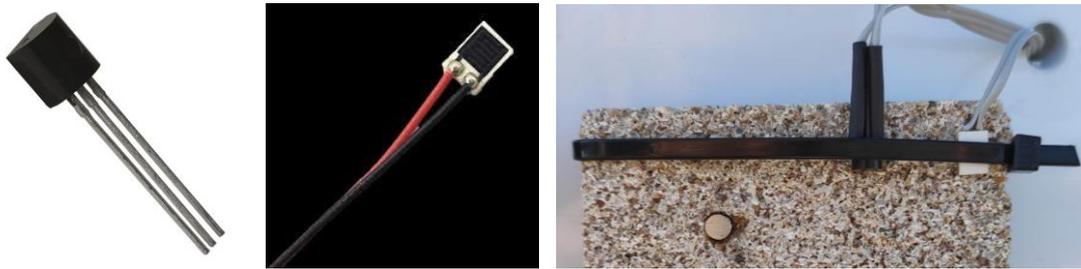
Figure 3: The temperature and humidity sensors and their mounting on one of the stone samples.

The microclimate sensors are two types, for determining temperature and humidity of the sample surfaces. The two sensors are fastened to each sample by using UV-resistant nylon-66 cable ties. The first sensor is the Texas Instruments LM60B, an analog bipolar temperature sensor operating in a range from $-25\text{ }^{\circ}\text{C}$ to $125\text{ }^{\circ}\text{C}$, with an accuracy of $\pm 2\text{ }^{\circ}\text{C}$ at room temperature and $\pm 3\text{ }^{\circ}\text{C}$ over the full range; its output voltage is linearly proportional to temperature ($6.25\text{ mV}/^{\circ}\text{C}$), with a DC offset and a nonlinearity of $\pm 0.6\text{ }^{\circ}\text{C}$. The second sensor is the Samyoung SY-DS-1, an analog resistive dew sensor operating in a relative humidity (RH) range from 0% to 100% and in a temperature range from $0\text{ }^{\circ}\text{C}$ to $60\text{ }^{\circ}\text{C}$; it is a switch-type device whose electrical resistance increases sharply in wet conditions, with maxima of 10 k Ω , 100 k Ω , and 200 k Ω at a RH of 80%, 93%, and 98%, respectively (Figure 3).

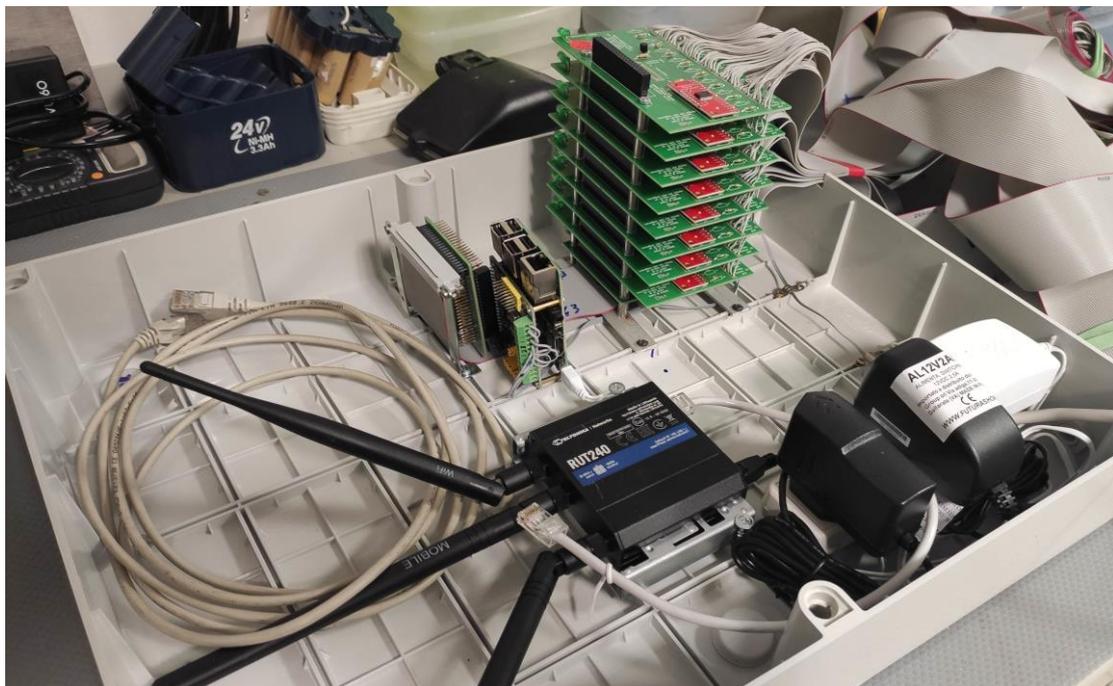
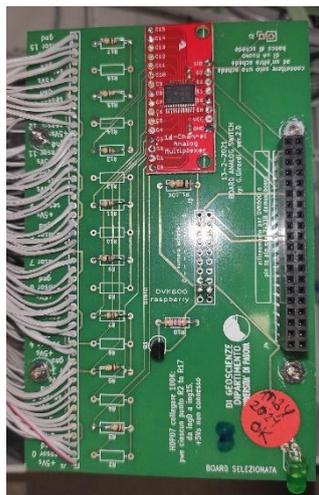
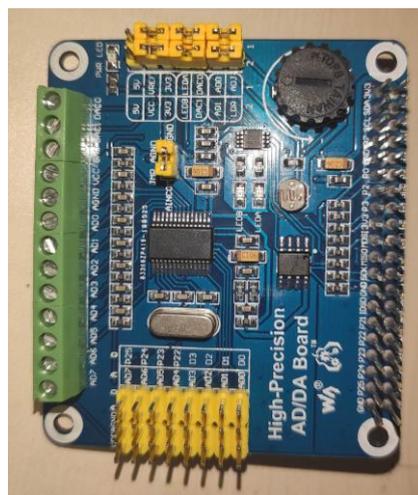
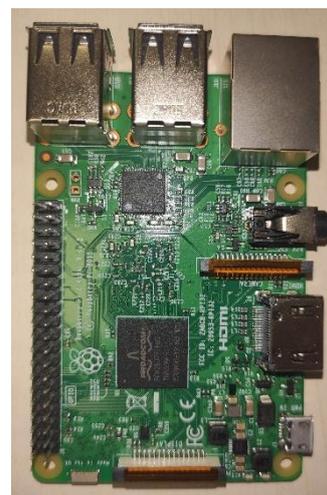
Figure 4: The control unit box and the main component boards.

Finally, the control unit allows for acquiring and storing the microclimate data from the sensors. The electronics have the following three main components: a mux/demux system, an analog-to-digital converter, and a single-board computer (Figure 4).

The mux/demux system selects and controls the analog signals of the sensors. It is an original design, and includes a series of boards each including a multiplexer with a complementary demultiplexer, connected with the sensors by ribbon cables; one board controls 16 channels, so that the small Cube has a total of 80 channels (with 5 boards), while the large Cubes have 128 channels (with 8 boards); each channel corresponds to a single temperature or humidity sensor. The system is managed by an additional controller board.

The second component in the chain is a Waveshare High-precision AD/DA board, which converts the analog signal from the sensors and the mux/demux system into a digital signal.

Finally, the converter is connected by a 40-pin GPIO (General Purpose Input Output) to a Raspberry Pi 3 Model B, a single-board computer that processes, writes, and stores the received digital signal. The Raspberry uses a 64-bit Broadcom BCM2837B0 Armv7 processor, a Linux Debian Buster operating system with Raspberry Pi Desktop, a 1-gb RAM, and a 8-gb microSD memory card. The data are continuously saved on the microSD card, periodically uploaded in the internet, and accessed on line using an Ethernet connection directly to the local network or to a Wi-Fi 4G/LTE router Teltonika RUT240 with a slot for a data SIM card.

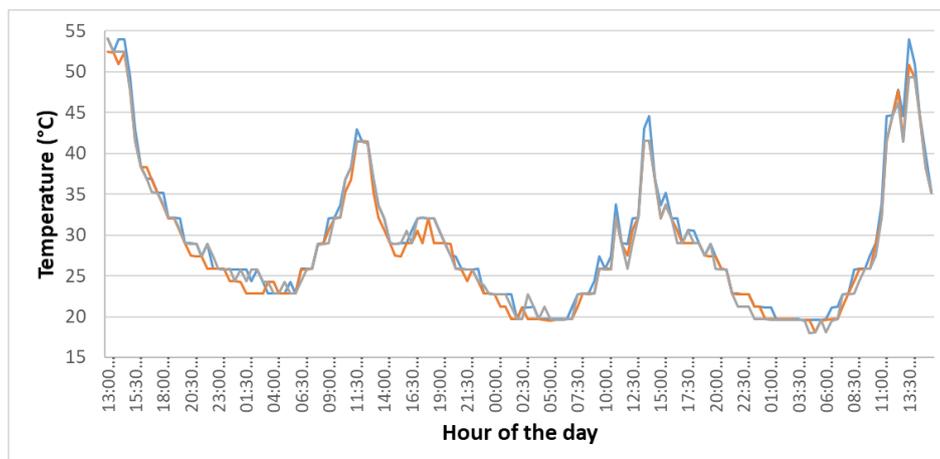
Figure 7: Test monitoring of surface temperature (registered by three sensors) of a stone sample exposed to south in Padua during three days, from 12th to 15th of July, 2021 (only the first and last part of the record refer to sunny hours, while the middle period is associated with cloudy weather).

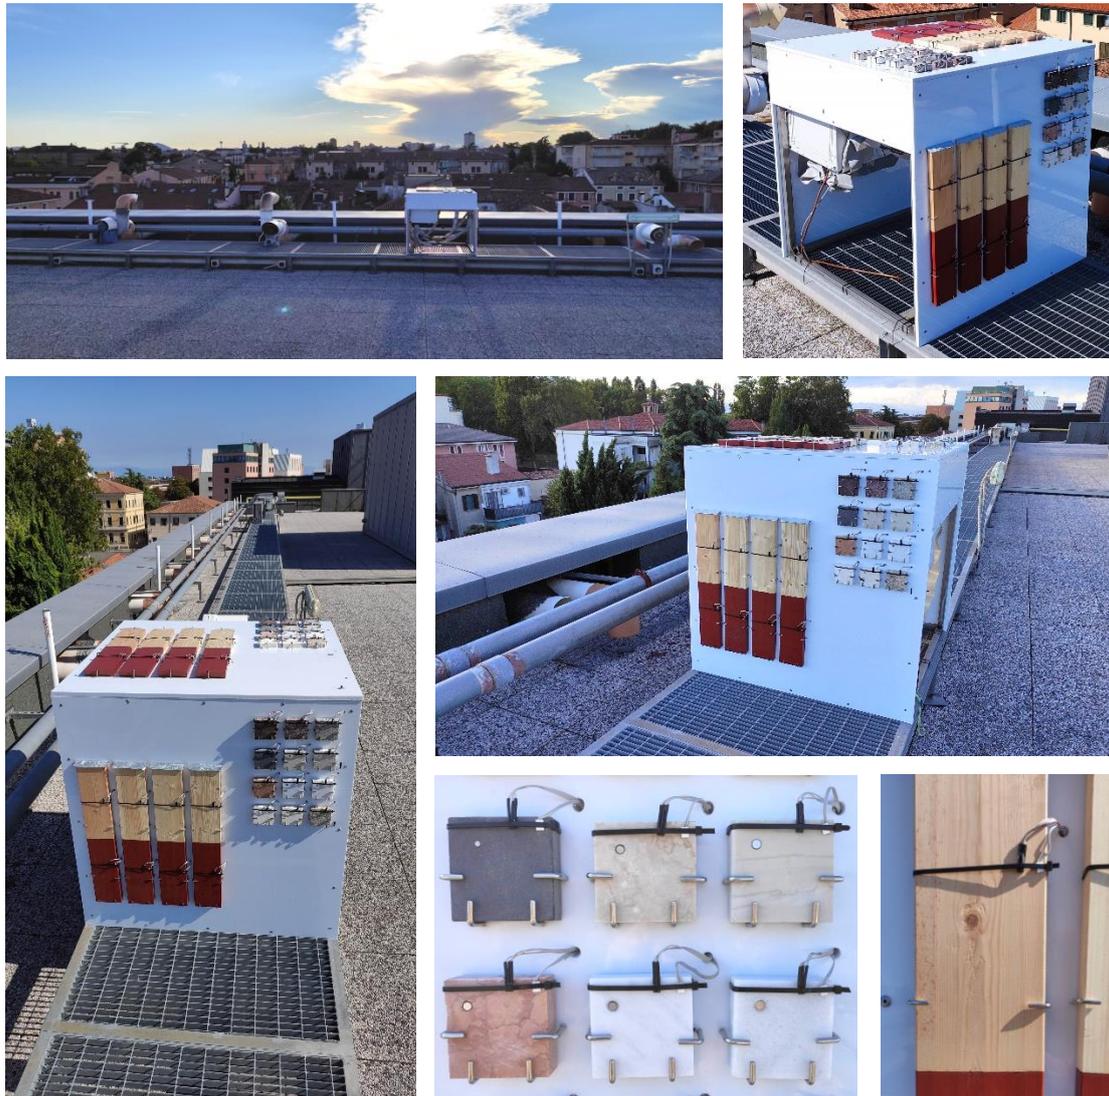
Figure 8: The Cube installed in Padua.

Every panel of the Cubes is oriented in a different direction, making possible the investigation of the microclimate variability and its link with the cardinal direction. In this regard, each Cube has one panel with samples facing north, one facing south, and one horizontal connecting panel (Figure 8).

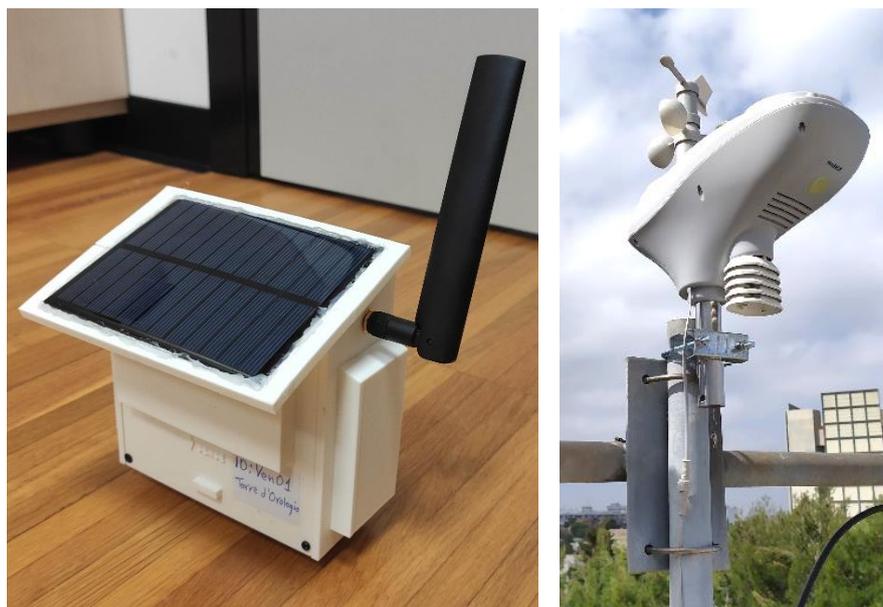
Figure 9: The Smart Tag and the weather station provided by the Hyperion partners.

the Tier 1 buildings in the Hyperion pilot areas. The Smart Tags are small-size wireless sensor-based network devices that can measure air temperature and RH; moreover, they can calculate the dew point temperature and monitor dry-wet cycles (Figure 9).

Complementary microclimate time series recorded at the study sites are to be provided by weather stations purposely installed, one in close proximity to each Cube. The weather stations for Venice and Tønsberg were provided by the Hyperion partners (brand Agenso) (Figure 9). The station for Padua, instead, was purchased to the purpose (brand Davis Vantage Pro2). All the stations are to provide time series of air temperature, RH, precipitation amount, wind speed and direction.

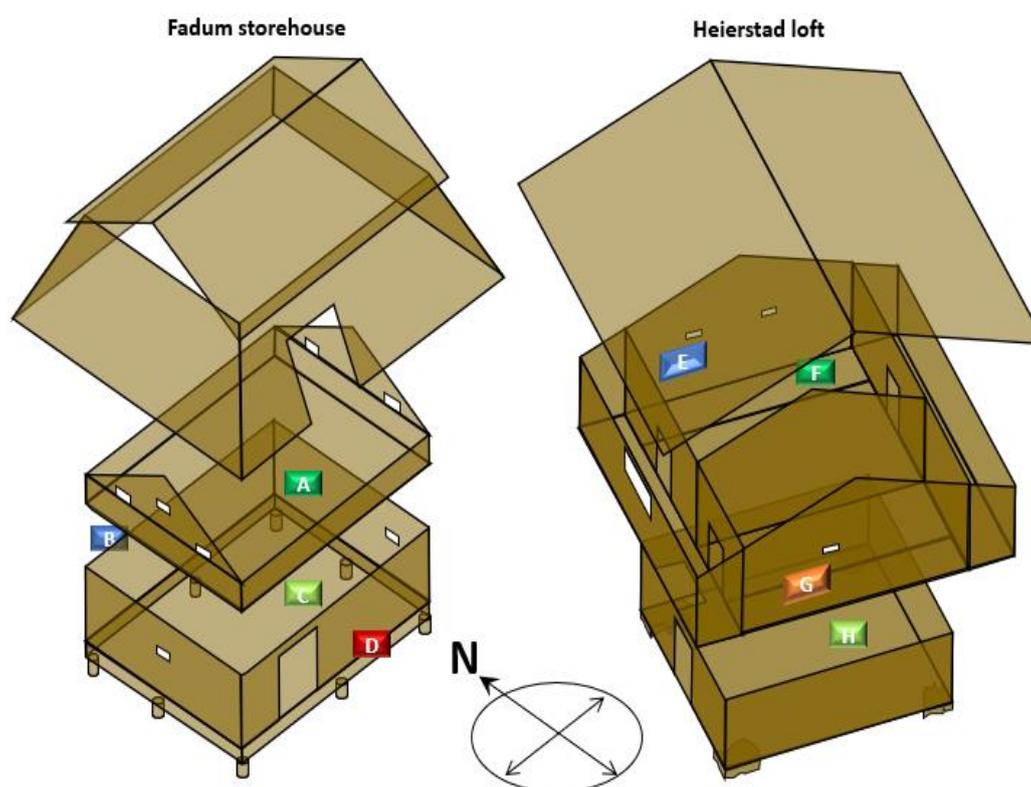
Figure 10: Positions of the air temperature and RH sensors in the Tier 1 buildings in Tønsberg.

As contingency plan for coping with the delays in the delivery of the equipment described above, a preliminary study was conducted in Tønsberg at selected Tier 1 buildings, for starting the acquisition of microclimate data with complementary sensors. The sensors measure air temperature and RH every five minutes. They were installed in the Fadum storehouse and the Heierstad loft, as shown in Figure 10. Specifically, sensors A and C were placed in the interior of the Fadum storehouse, while sensors B and D were installed on the exterior of the north- and south-oriented walls, respectively; they are shielded by the shed surrounding the building. As for the Heierstad loft, sensors F and H were placed in the interior, while sensors E and G were mounted on the exterior of the northeast and southwest walls, respectively.

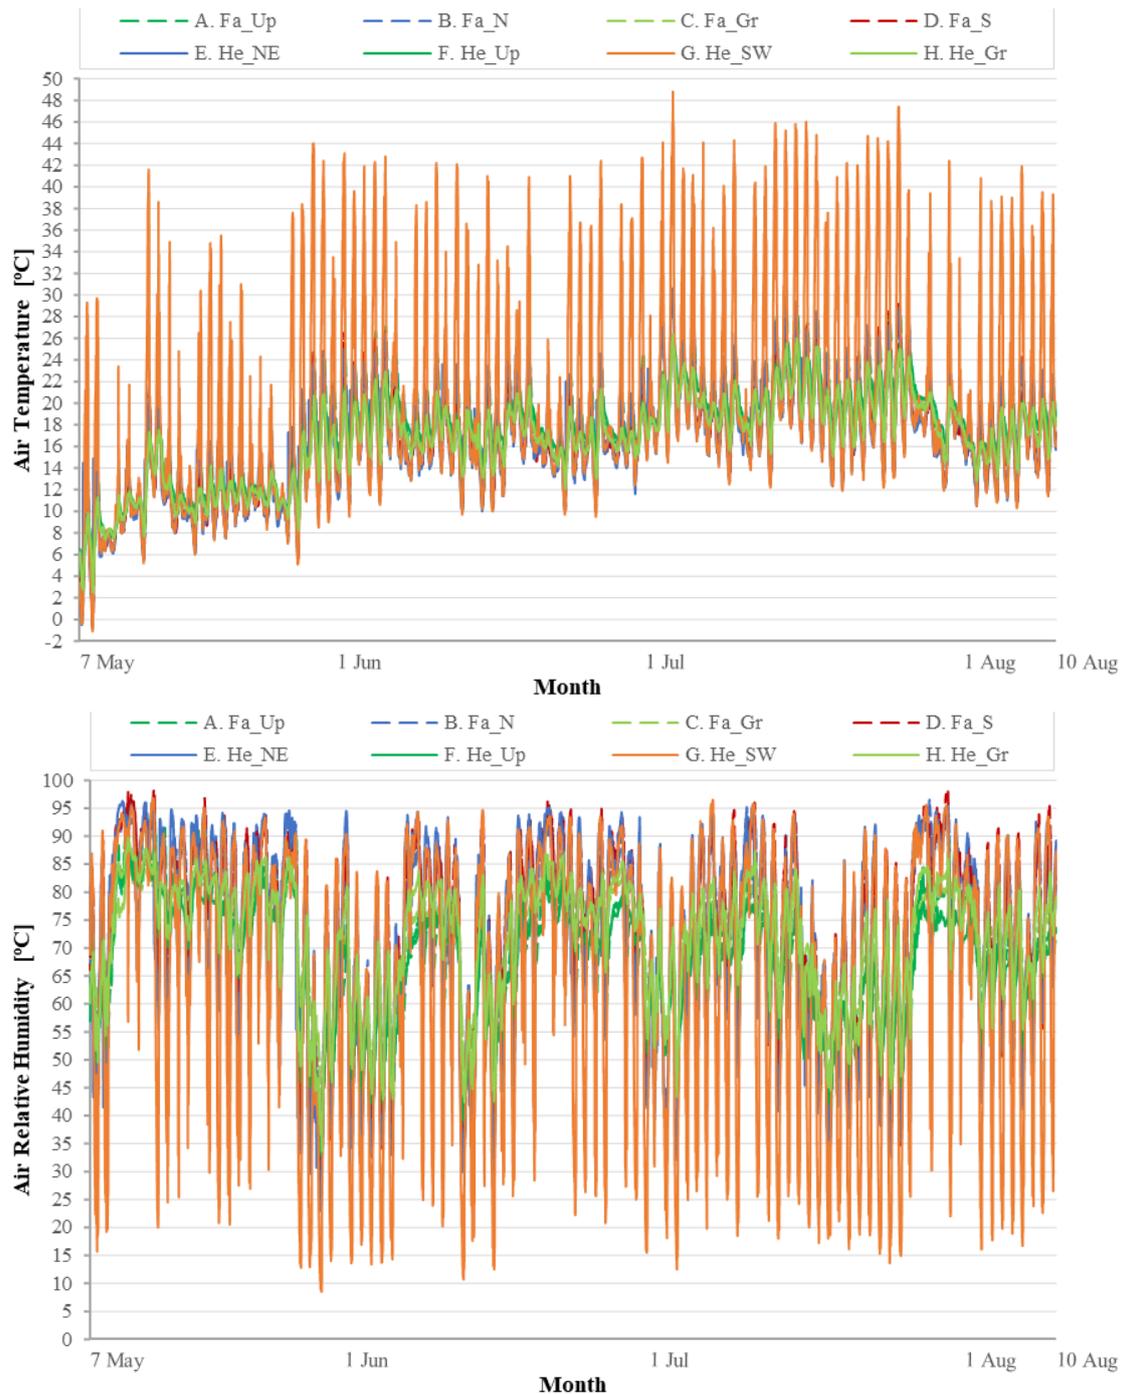
Figure 11: Air temperature and RH in the Fadum storehouse and Heierstad loft (7 May to 10 August 2021).

Figure 11 presents the air temperature and RH measures, referring to the period from 7 May 2021 until 10 August 2021. There are significant differences among the different exposure environments, i.e., among different orientations as well as between indoors and outdoors. The most significant are observed between the northern and southern surfaces. The differently oriented sides also show the most significant differences in terms of deterioration patterns (Choidis et al. 2021). The south-oriented surfaces are more exposed to solar radiation and driving rain, and record higher temperature and lower RH levels; they are also associated with the most intense weathering in terms

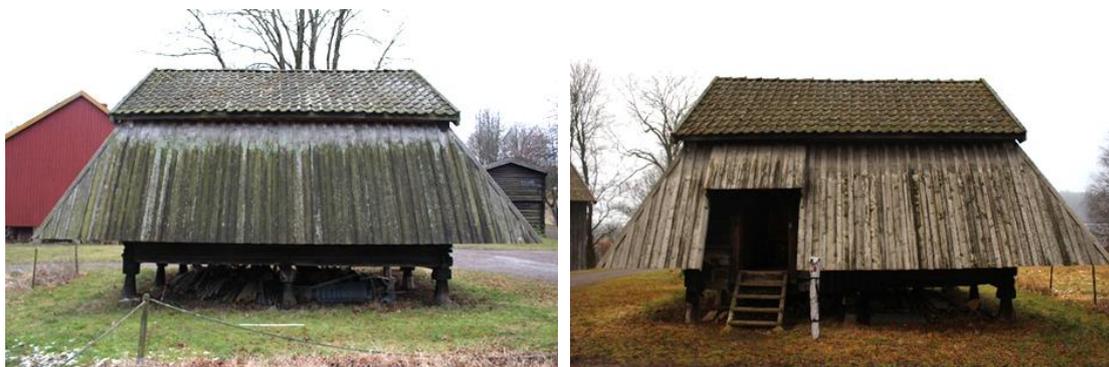
Figure 12: At the Fadum storehouse, the growth of biological organisms is more intense on the north façade (left) than on the south façade (right) (Choidis et al. 2021).

of discoloring, checks, and splits (Figures 12 and 13). On the other hand, the north-oriented surfaces are less exposed to solar radiation and remain wet longer, so their temperature is the lowest, while RH is the highest; these microclimate conditions favor the growth of biological organisms, such as algae, fungi, and lichens (Figures 12 and 13).

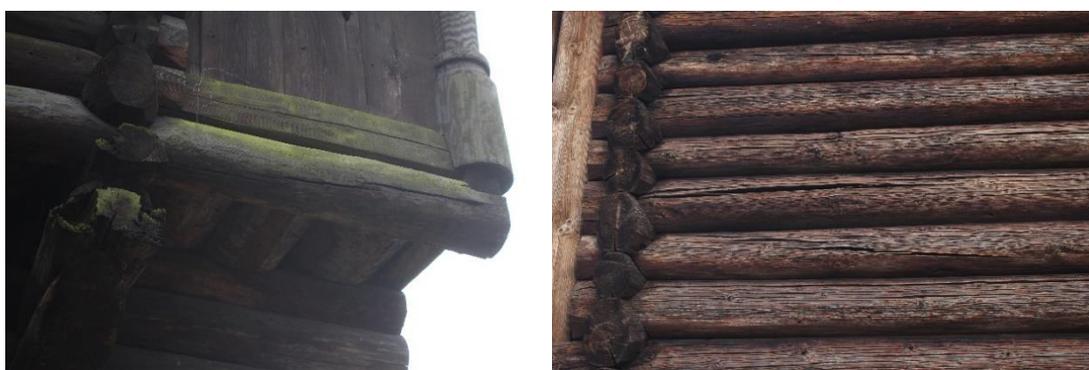
Figure 13: At the Heierstad loft, the northeast façade is colonized by algae (left), while the southwest façade has several checks, splits, and discoloring due to weathering.

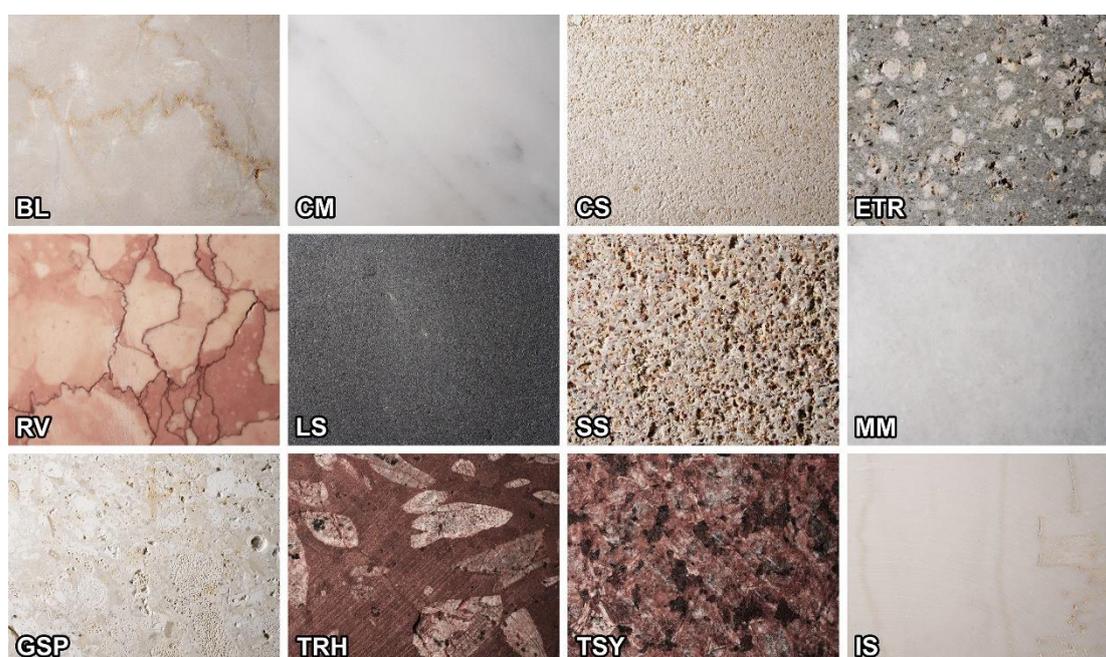
Figure 14: Photos of the stones marked by their IDs (short side = 4 cm).

All the samples were cut into 70x70x20 mm tiles. Secondly, they were drilled through and an AISI-304 stainless steel cylinder was inserted in each specimen and glued with a two-component epoxy resin Kömmerling Körapox 439. Finally, the surface of the whole tile was levelled and roughly polished with 60-grit sandpaper. A total of 108 specimens were selected for the field exposure tests and the preliminary laboratory analyses; that is, one specimen for each stone variety to be installed on each panel (facing north, south, and horizontal) of each of the three Cubes, or 12 specimens in total for each panel.

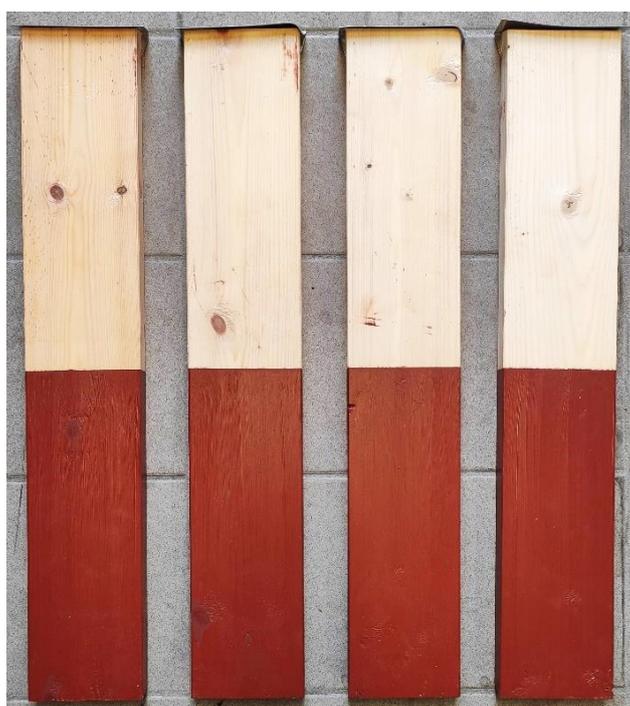
Figure 15: Photos of the wood samples with the metal flashing on the top.

The timber supplied was cut into 600x102x23 mm samples, hand-levelled on three sides, and air-dried reaching a moisture of 10-13%. The upper half of each specimen was left without finish. The lower half, instead, was treated on the surface with a red paint made from pure linseed oil (by Ottosson Färgmakeri AB, Sweden), applied in three layers; the red color is given by iron and zinc oxides. Finally, a zinc flashing was mounted on the top of the samples of the vertical panels of the Cubes, to prevent water penetration into the end grain. A total of 24 specimens were selected, that is, one specimen for each wood type to be installed on each panel (north, south, and horizontal) of each of the two large Cubes, or 4 specimens in total for each panel.

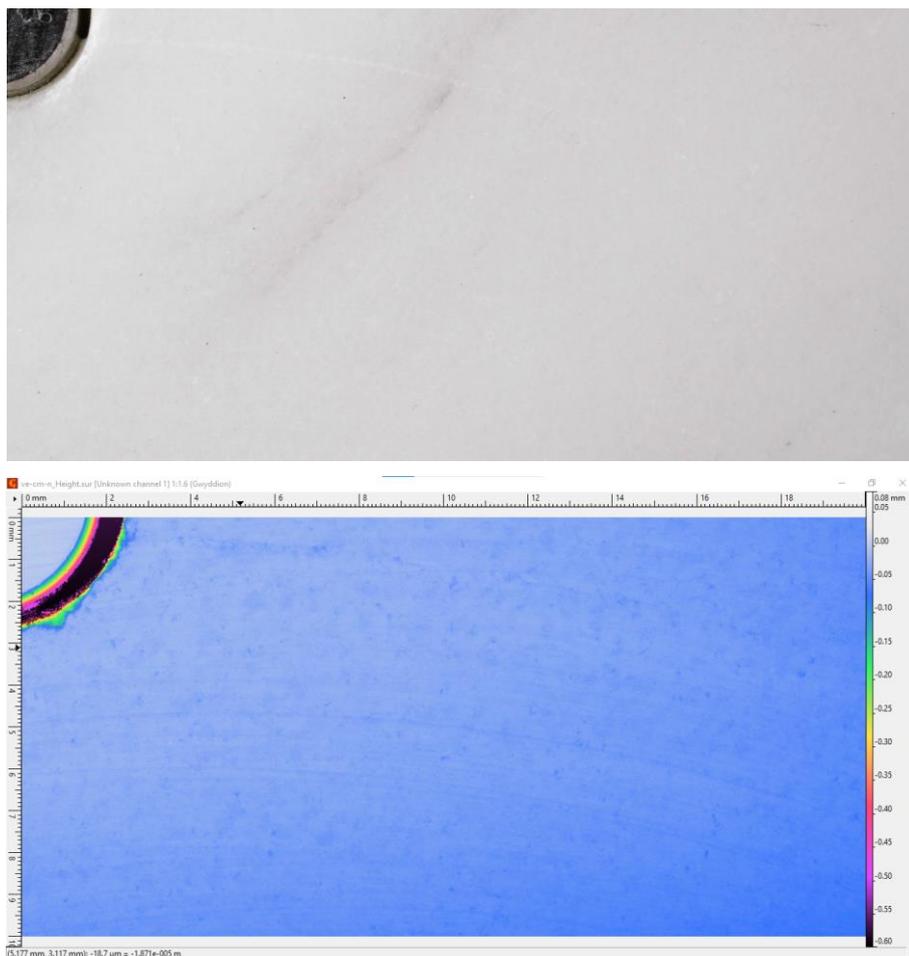
Figure 16: Macro photo and corresponding profilometric map of a sample of Carrara marble (CM). The top left corner is taken up by the reference stainless steel surface.

Apart from the surface recession quantification, the profilometry will allow for determining changes in roughness, texture, size and shape parameters, etc. The map processing is done with the freeware software Gwyddion (Department of Nanometrology, Czech Metrology Institute). In Figure 16, 17, 18, and 19 some illustrative results are shown.

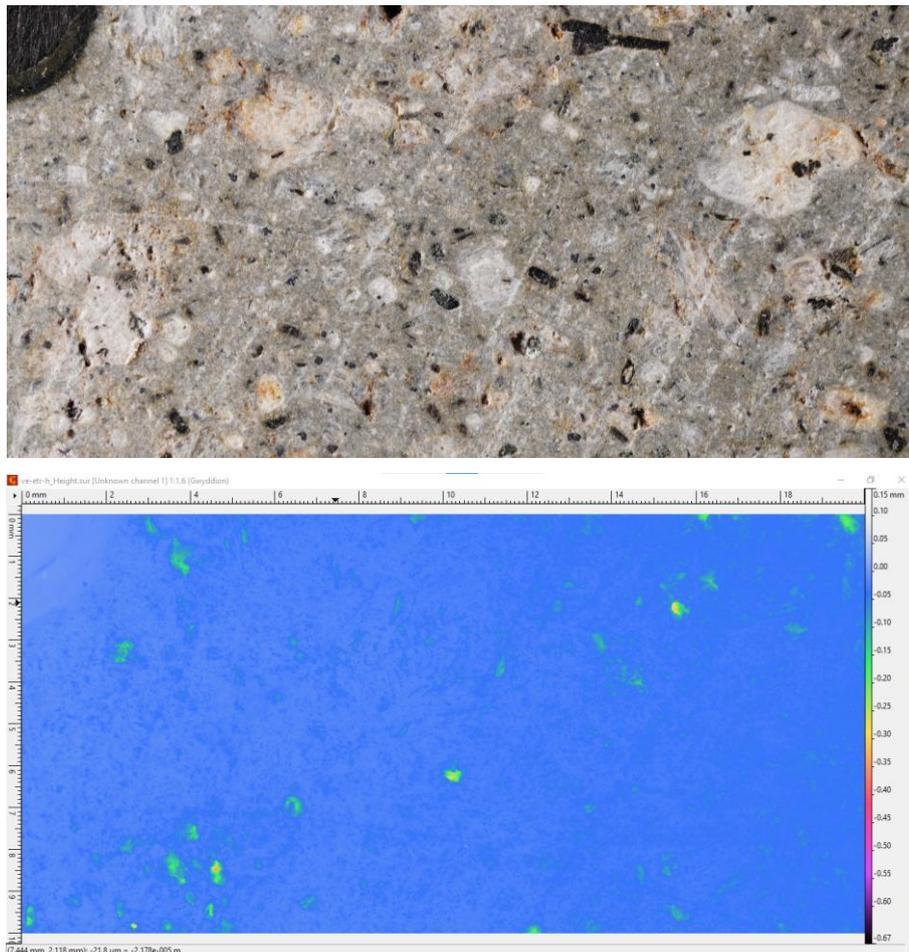
Figure 17: Macro photo and corresponding profilometric map of a sample of Euganean trachyte (ETR).

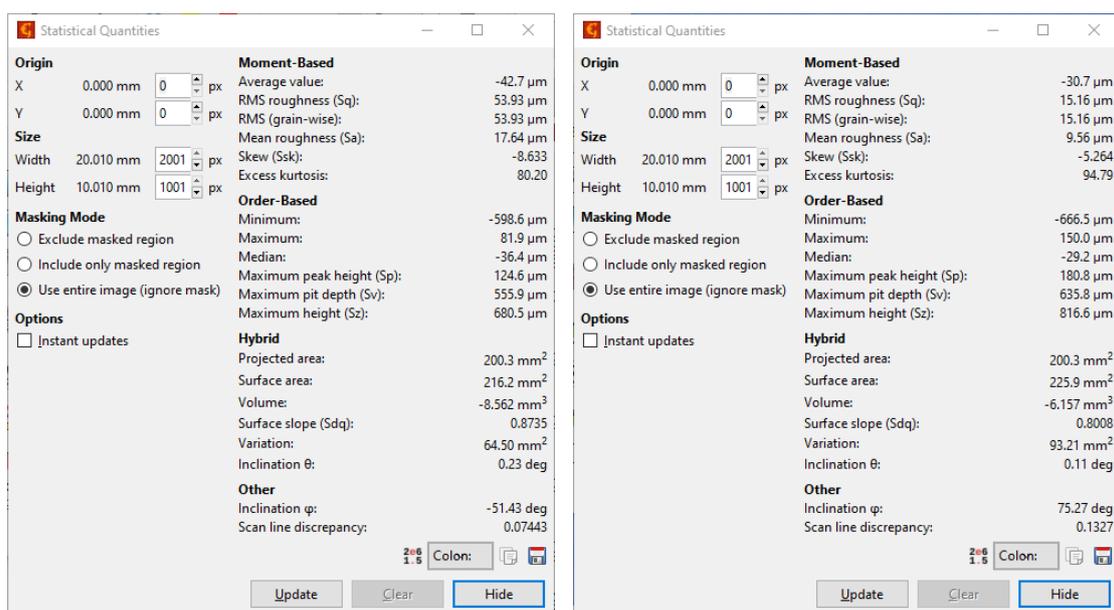
Figure 18: Example of basic statistics calculated on the maps of samples CM (left) and ETR (right).

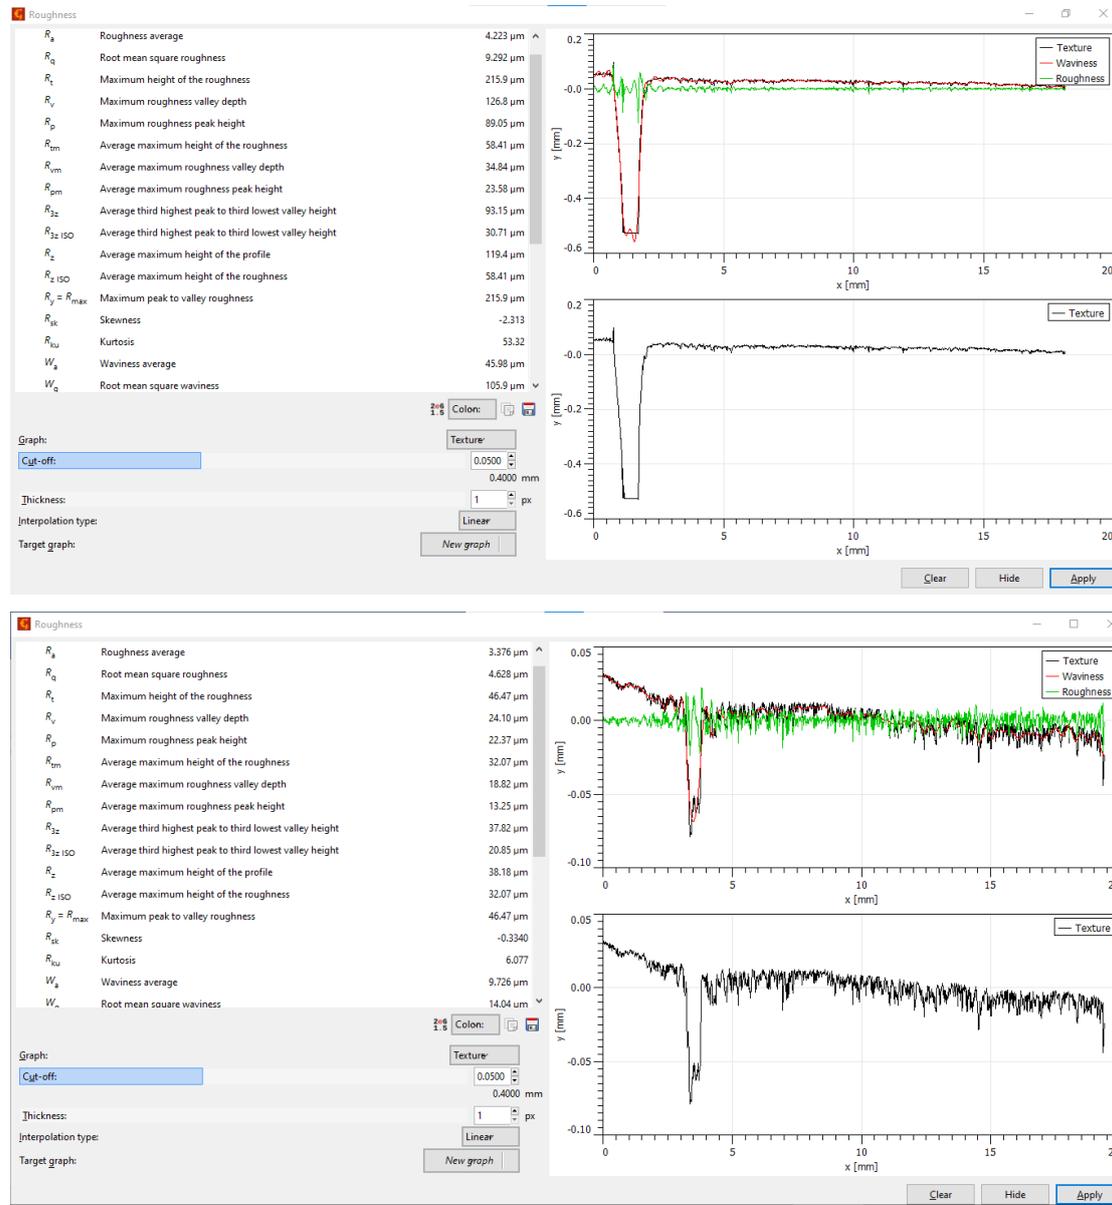
Figure 19: Statistical analysis of profiles traced on the maps of samples CM (top) and ETR (bottom), starting from the reference stainless steel surface (left) and continuing on the stone.

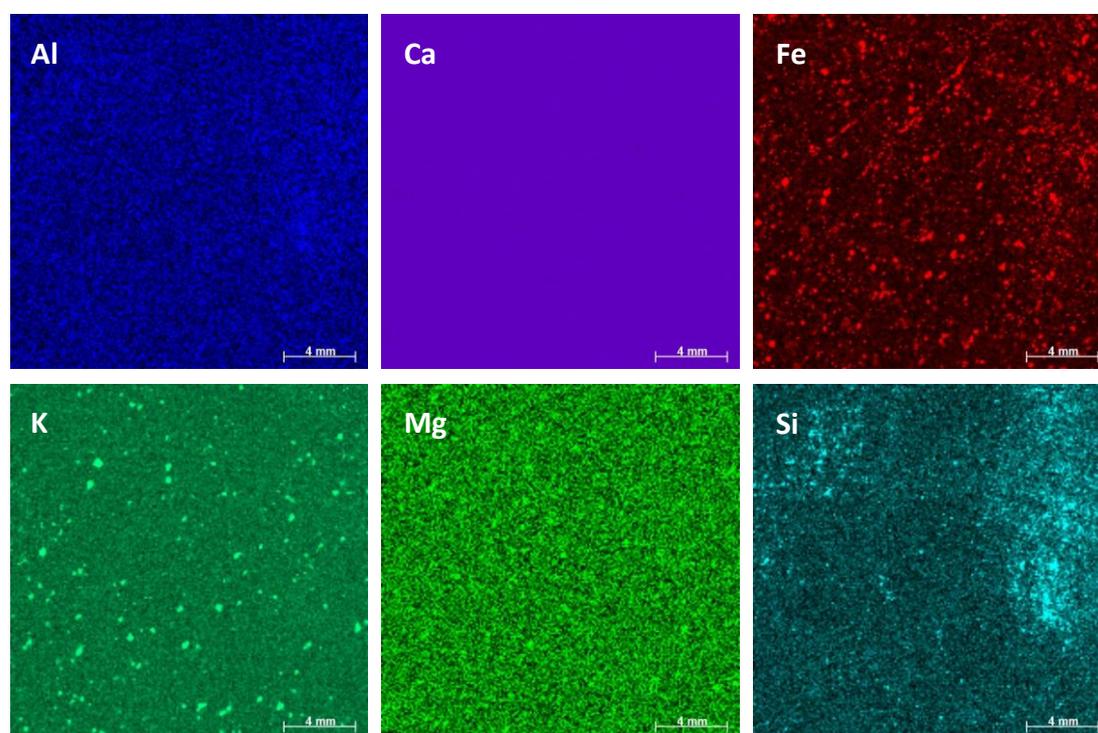
Figure 20: $\mu\text{-XRF}$ elemental maps obtained on a sample of Carrara marble (CM).

analytical conditions were applied: 20x20 mm mapped area, 200 spots measured, 20 μm spot size, 200 ms dwell time (500 $\mu\text{m}/\text{s}$ rate), with the X-ray tube operated at 50 kV and 200 μA . The following elements were detected: Na, Mg, Al, Si, P, S, Cl, K, Ca, Ti, Mn, Fe, Cu, Zn, As, Pb, Sr, Zr, Ba, Bi, Cd, Co, Cr, Mo, Ni, Sb, Sn, V. Figure 20, 21, and 22 and Table 5 show some illustrative results from representative samples.

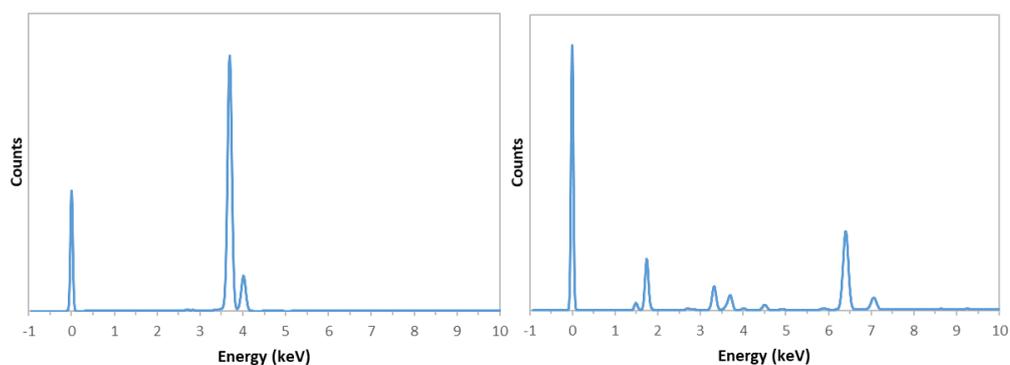
Figure 21: $\mu\text{-XRF}$ spectra of samples of Carrara marble (CM, left) and Euganean trachyte (ETR, right).

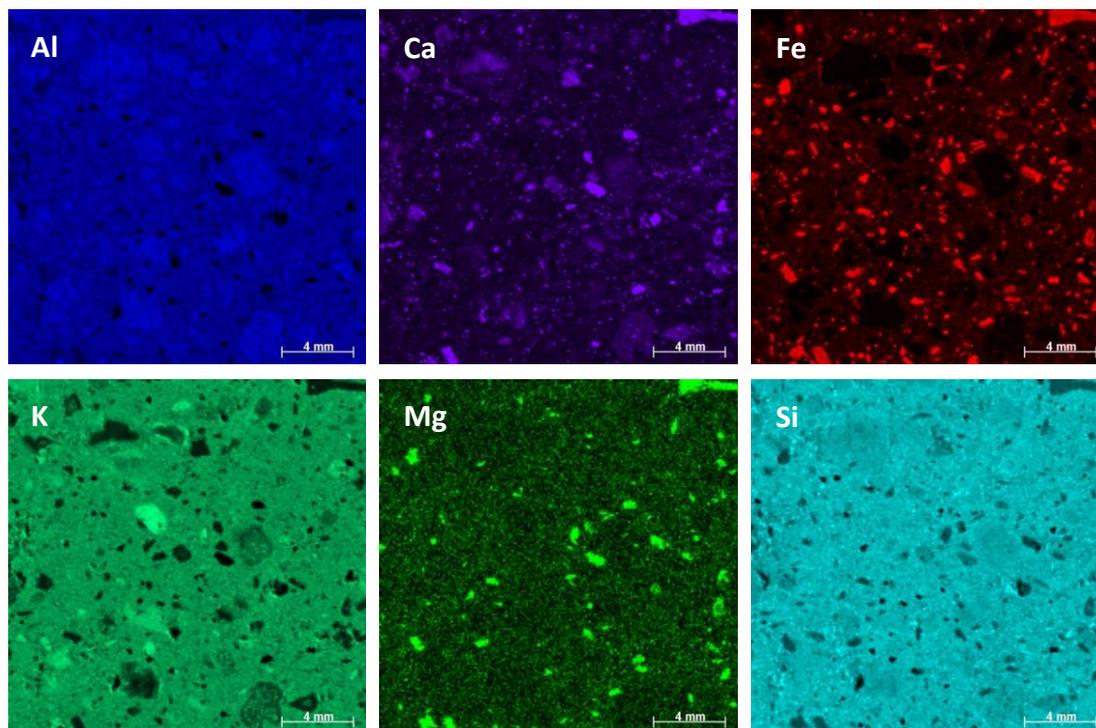
Figure 22: μ -XRF elemental maps obtained on a sample of Euganean trachyte (ETR).

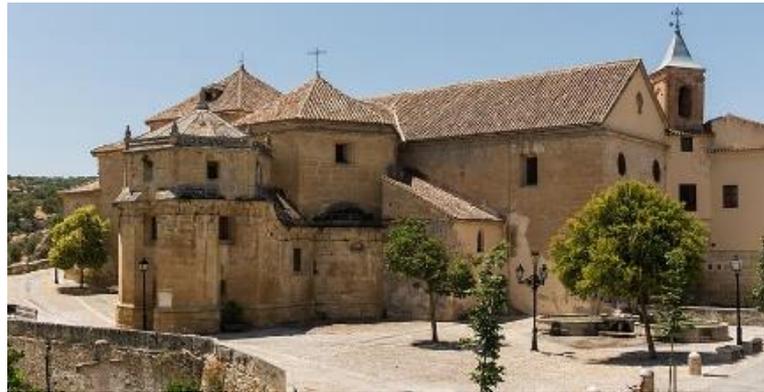
The Church of Nuestra Señora del Carmen (Figure 24) was built between 1589 and 1619. Later, in 1634 the sacristy was added. The church, which is made entirely of calcarenite stone from the Santa Pudua quarry, is divided into two modules. As can be

seen in Figure 1, one module is hexagonal in shape and is attached to the main nave of the church.

In the 1884 earthquake the suffered important damage and it was restored. The small tower in the right was built in the 19th century.

Figure 24. The Church of Nuestra Señora del Carmen in Alhama de Granada.

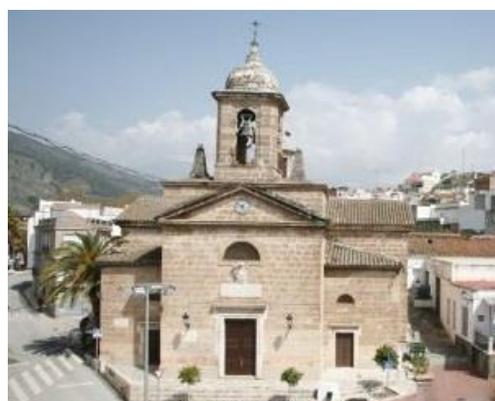
The current Church of Nuestra Señora del Rosario de Vélez de Benaudalla was built between 1778 and 1784. It was built on the foundations of two previous temples, the first of which was ruined by a fire. The church has a Neoclassical style being the plant of the church a cross that is inscribed within a square. It is made up of three naves.

As can be seen in Figure 25, also this church is made of calcarenite.

Figure 25. The Church of Nuestra Señora del Rosario of Vélez de Benaudalla.

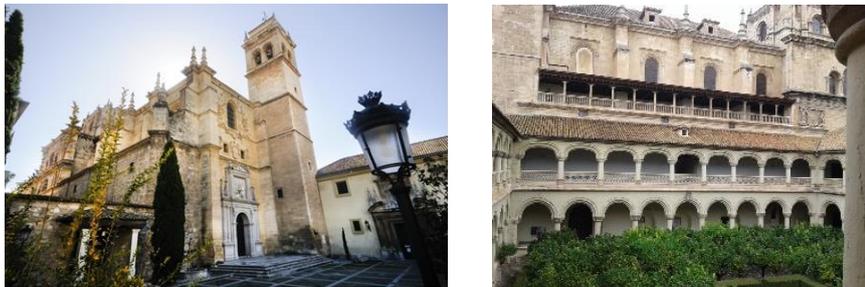
The church, which was started to build in 1519, has a Latin cross plan with a polygonal apse. At the foot of the church is the tower, finished in 1565, which was demolished in its upper half at the beginning of the 19th century and rebuilt in the 20th century. As can be seen in Figure 26, one of the lateral facades of the church is attached to a cloister.

The church is also made of Santa Pudia calcarenite (Figure 26).

Figure 26. The Church of San Jerónimo monastery of Granada.

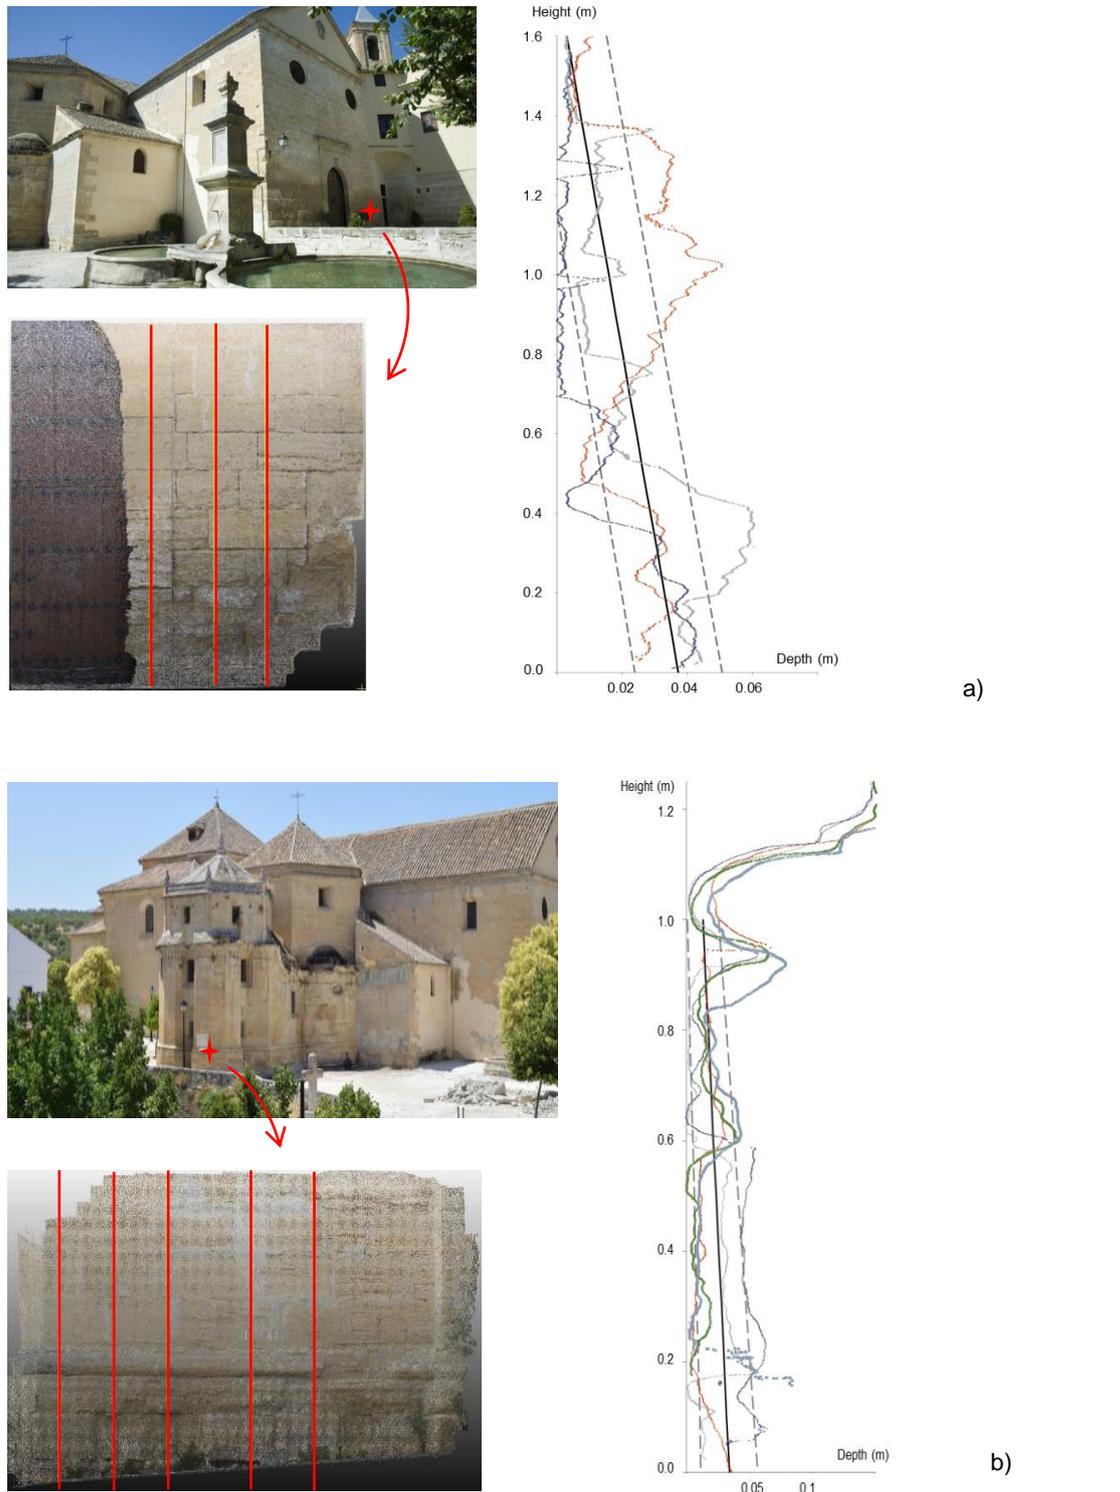
Figure 27. Recession patterns of Alhama de Granada. a) Main façade (NW orientation). b) Lateral façade (NE orientation).

Figures 27 to 29 show the degradation profiles of the building studied. In Figures 27 to 29 the mean values adjusted by linear regression (least-square) are represented with a black line. The level of dispersion is quantified through the standard deviation SD and the values of the SD (i.e. mean \pm SD) are also indicated in Figures 27 to 29 with dashed lines.

In the church in Figure 27 three sections located at the right side of the main entrance door and five sections of the lateral façade are analysed (Figures 27a and 27b, respectively). As can be seen in Figure 27b, in the lateral façade degradation is concentrated below the small stone ledge existing at around 1 m above the ground level. In both façades of the church of Nuestra Señora del Carmen of Alhama de Granada a triangular degradation pattern are obtained (Figure 27).

The mean area affected by degradation for the cases studied is summarized in Table 6 (see Figures 27 to 29). In this table, the approximate age and the height affected by deterioration have also be summarized.

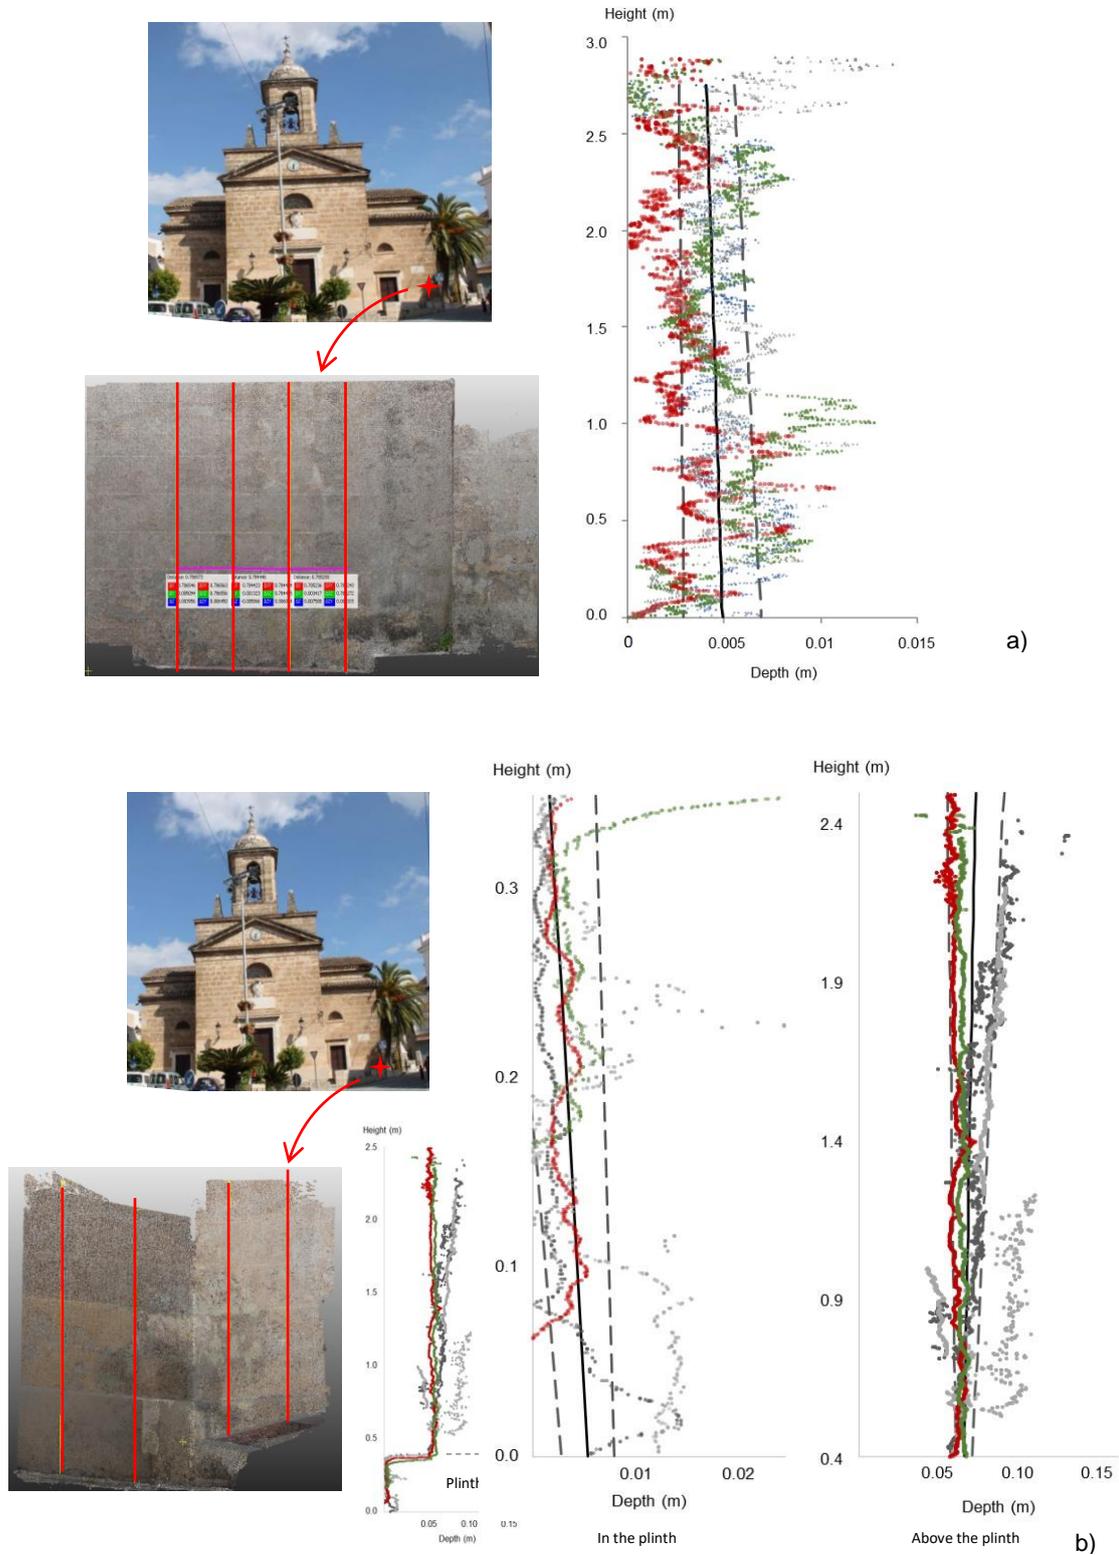
Figure 28. Recession patterns of Vélez de Benaudalla. a) Main façade (SE orientation). b) corner (S orientation).

In the case of the Church of Nuestra Señora del Rosario of Vélez de Benaudalla four section in the middle of the main façade and another four sections around the right corner of the main façade are studied (Figures 28a and 28b). Around the corner there is an around 0.4 m height plinth. In this zone, the adjustment has been divided in two: in the plinth and above it (see Figure 28b). As can be seen in Figure 28, degradation in
