D4.3 Analysis of microclimatic time series and assessment of systematic deviation from local time series required as input in the hygrothermal simulations

Deliverable number	D4.3
Deliverable title	Analysis of microclimatic time series and assessment of systematic deviation from local time series required as input in the hygrothermal simulations
Nature ¹	R
Dissemination Level ²	PU
Author (email) Institution	Luigi Germinario (luigi.germinario@unipd.it) UNIPD
Editor (email) Institution	Claudio Mazzoli (claudio.mazzoli@unipd.it) UNIPD
Leading partner	UNIPD
Participating partners	IUAV, OSLOMET, UGR, CVI, VFK
Official submission date:	31/08/2021
Actual submission date:	07/09/2021

This work is a part of the HYPERION project. HYPERION has received funding from the European Union’s Horizon 2020 research and innovation programme under grant agreement no 821054.

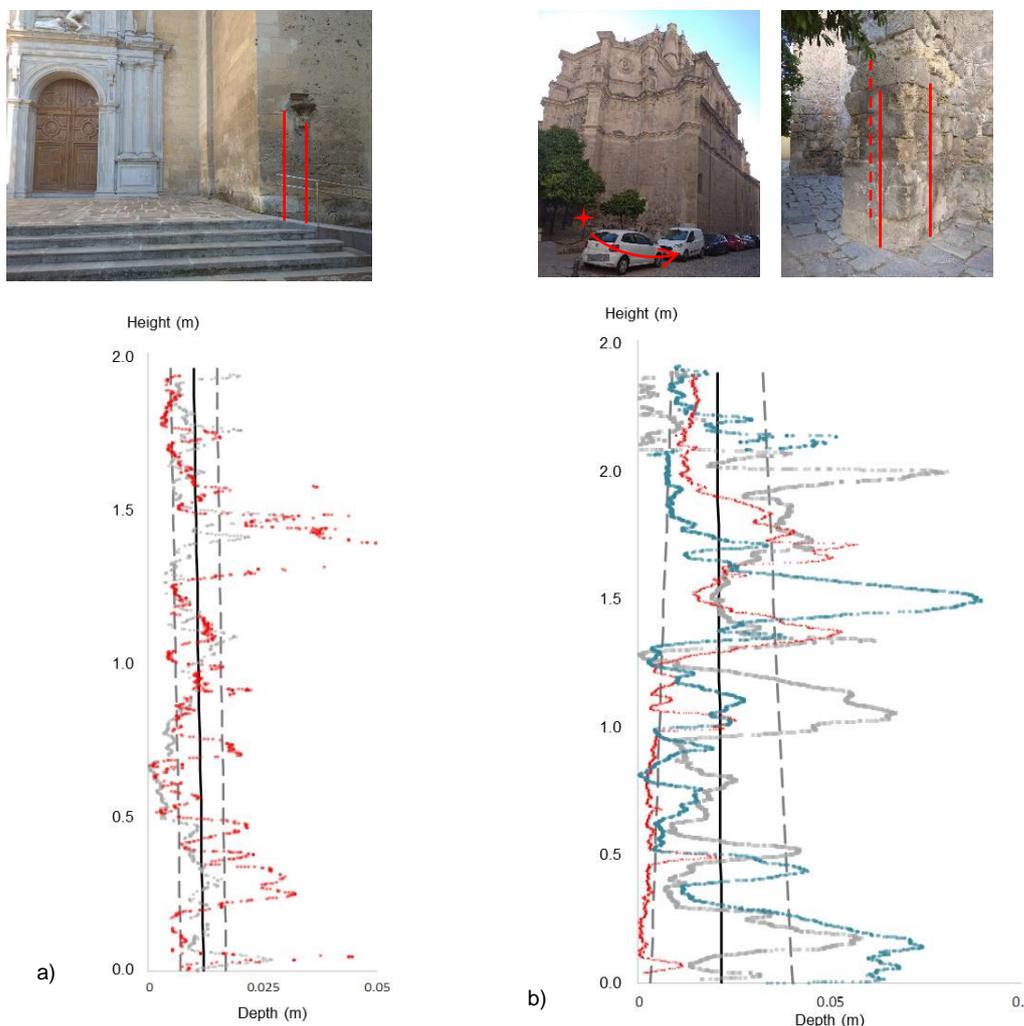
Figure 29. Recession patterns of San Jerónimo. a) Main façade (NW orientation). b) buttress (SE orientation).

Figures 27 to 29 show the degradation profiles of the building studied. In Figures 27 to 29 the mean values adjusted by linear regression (least-square) are represented with a black line. The level of dispersion is quantified through the standard deviation SD and the values of the SD (i.e. mean \pm SD) are also indicated in Figures 27 to 29 with dashed lines.

Regarding the Church of San Jerónimo, two section in the right side of the main façade and three sections in one of the buttress located behind apse are studied. In the case of the buttress one section at each of the three faces of the element are selected (Figure 29b). As can be seen in Figure 29 degradation match square pattern in both cases. It is interesting to remark that very close to the buttresses there is a group of trees (see Figure 29b) which impedes the lower part of the apse is exposed to the sun, which lead to keep moisture in this zone.

The mean area affected by degradation for the cases studied is summarized in Table 6 (see Figures 27 to 29). In this table, the approximate age and the height affected by deterioration have also be summarized.

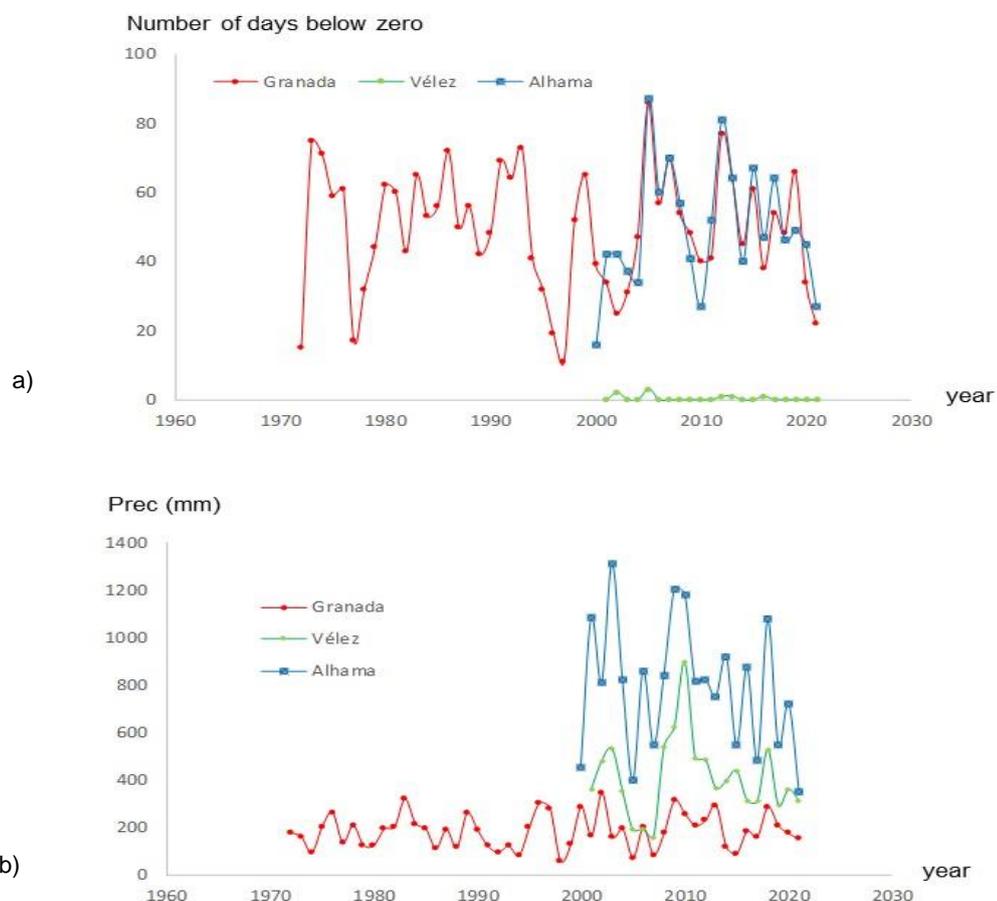
Figure 30. Available records of the number of days per year with temperature below zero (a) and of annual precipitation (b) obtained from the official web site [AEet, Junta de Andalucía].

In Figures 30a and 30b the available records obtained from the official web site [AEet, Junta de Andalucía] are represented. Figure 30a shows the number of days with temperatures below zero per year along the historical series while Figure 30b summarizes the total annual precipitation. Table 7 summarizes the average value of this measured for the three locations studied.
