D4.4 Deterioration of the building materials under extreme events required in the CH vulnerability assessment

Deliverable number	D4.4
Deliverable title	Deterioration of the building materials under extreme events required in the CH vulnerability assessment
Nature ¹	R
Dissemination Level ²	PU
Author (email) Institution	Chiara Coletti (chiara.coletti@unipd.it) Jacopo Nava (jacopo.nava@unipd.it) UNIPD
Editor (email) Institution	Claudio Mazzoli (claudio.mazzoli@unipd.it) UNIPD
Leading partner	UNIPD
Participating partners	UNIPD – IUAV – UGR – OSLOMET
Official submission date:	31/08/2021
Actual submission date:	07/09/2021

This work is a part of the HYPERION project. HYPERION has received funding from the European Union's Horizon 2020 research and innovation programme under grant agreement no 821054.

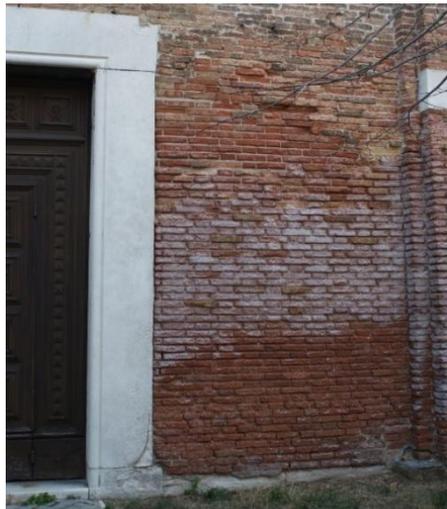
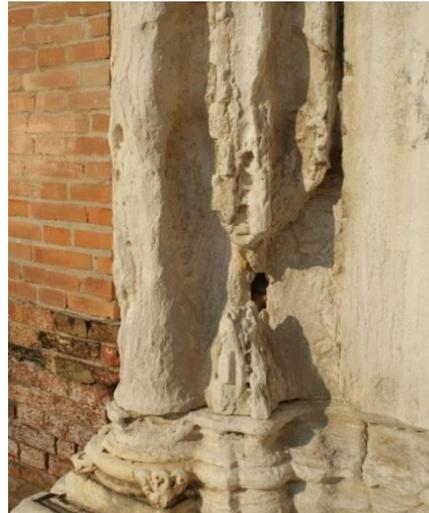
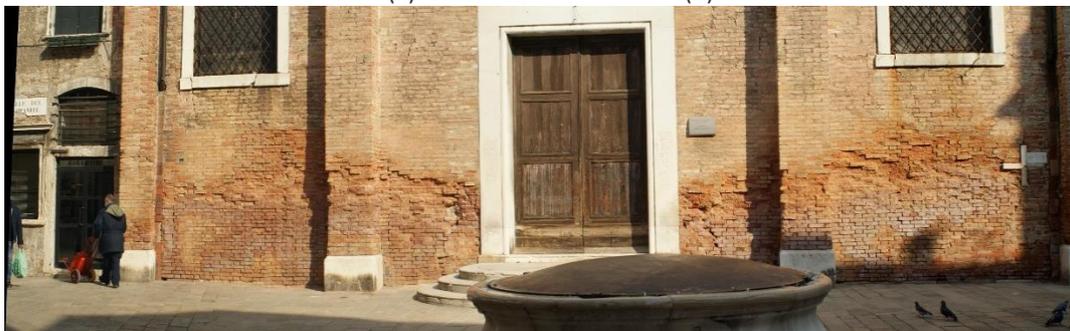
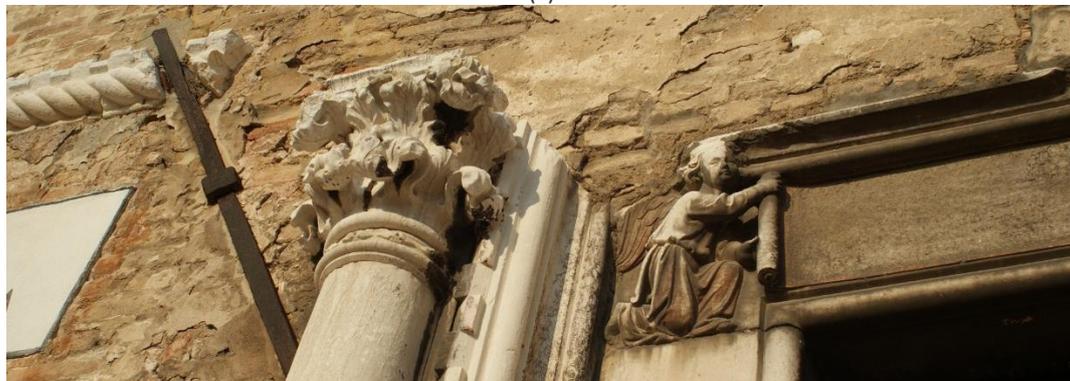
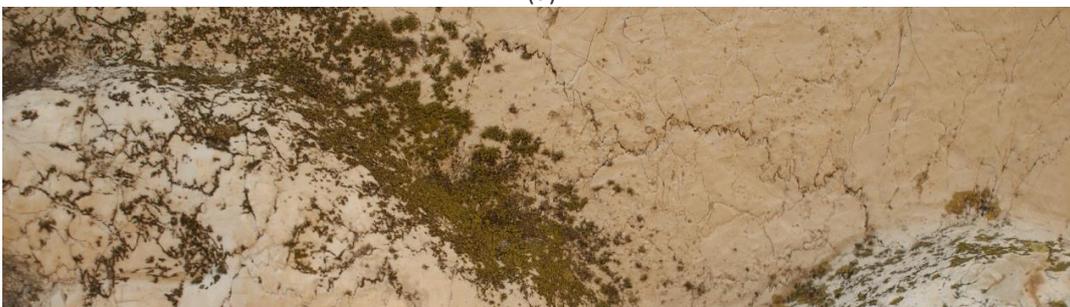
Figure 2: a, b and c) effect of capillarity rise and salt crystallization; d) black crusts; f) detail of biological decay on stones.

Moreover, buildings in Venice (as in many other cities developed along the coastline) are affected by salt crystallization that in this specific case, considering the effects of sea level rise, is becoming the main damage factor. Indeed, the historical basements made of Istria stone (compact limestone) are often submerged and the brick walls (highly porous) are exposed to water capillary rise, that in a lagoon environment causes aloclastism and differential decay (Figs. 2 a, b and c). Moreover, monuments in Venice clearly display other typical decay forms, such as black crusts (Fig. 2d) and biological growth and fouling in the intertidal zone (Fig. 2e).

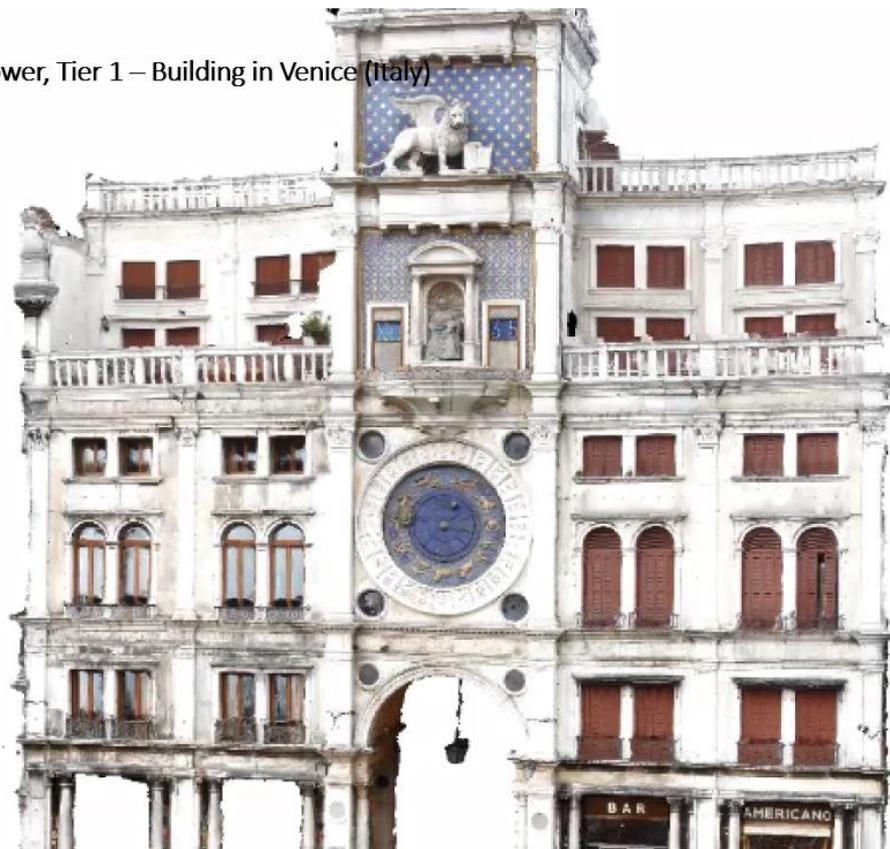
Figure 5: Photogrammetry of Clock Tower in Venice

In Figure 5 is reported the photogrammetric reconstruction of the Clock Tower obtained by drone flights.

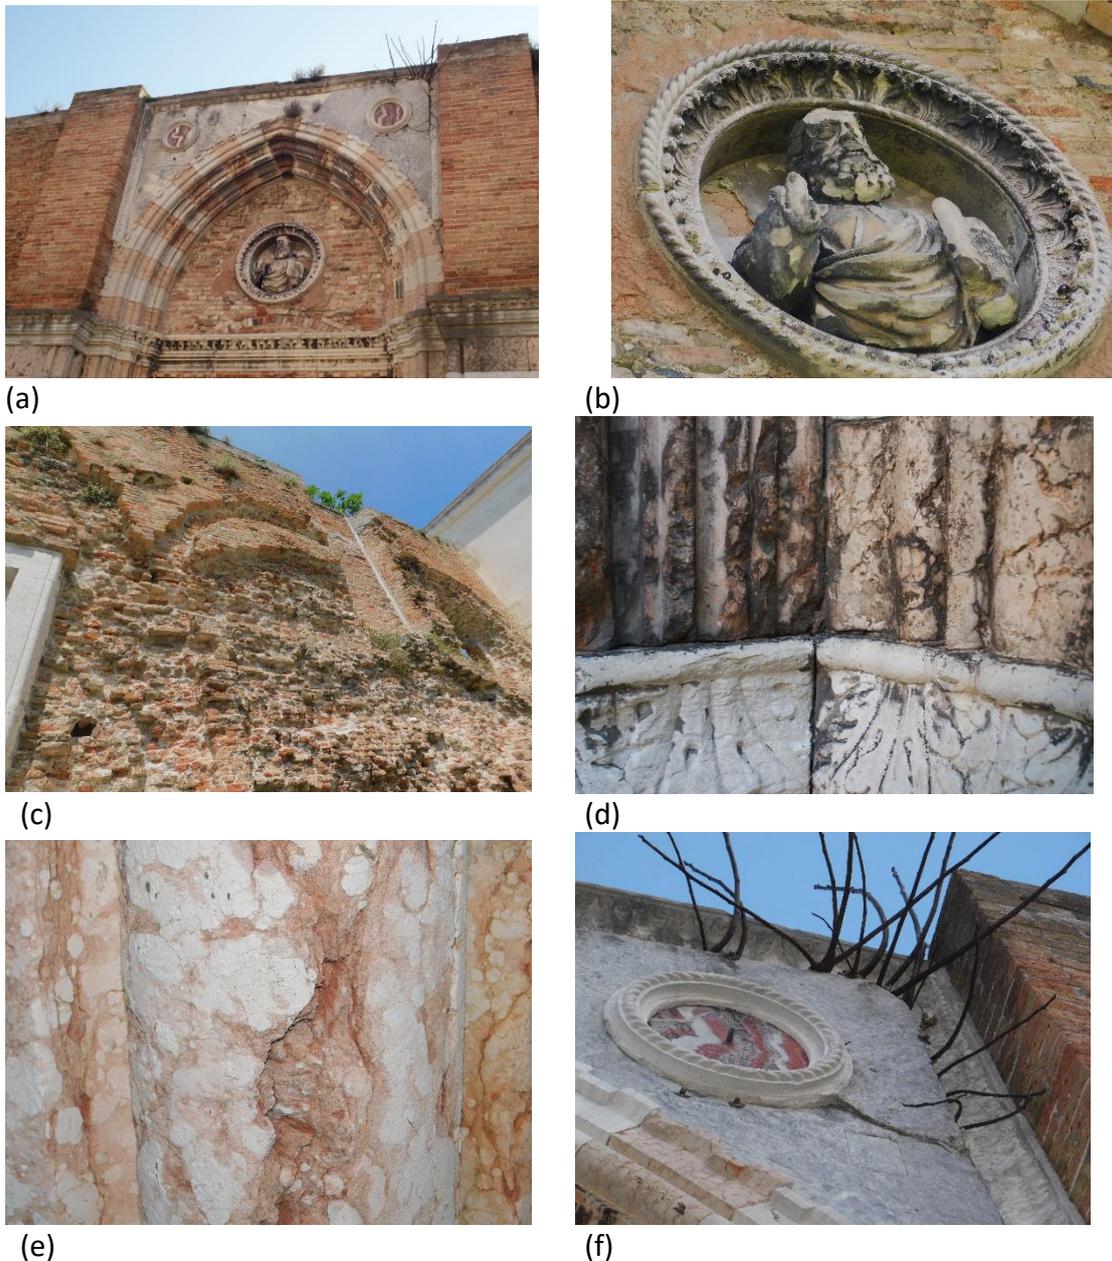
Figure 10: a, b) details of the Santa Maria dei Servi façade in Venice; c) damaged brick masonry; d) black crust on stone gate; e) stone (red verona marble) exfoliation; f) fractures and slab displacement caused by secondary plants.

The ruins are mainly affected by black crusts, detachments and loss of material, with different characteristics depending on the material type (e.g. stone or brick), and biocolonization with moss and secondary plants growth (Figs. 10a-f).

Decay assessment is relevant to define the main causes and process of decay, as well as the distribution of their patterns on the façade. Vegetation grows mainly on the top of the façade; black crusts interest mainly elements made of carbonate rocks (see Fig. 10 a and d) and more complex architectural features (Fig. 10b).

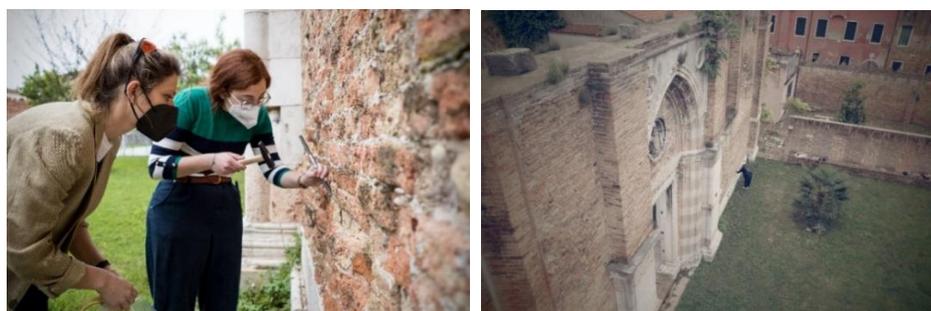
Figure 11: Samples collection on the main façade.

Samples (bricks and mortars/grouts) were collected from the main façade (Fig. 11) to analyze mineralogy and decay (XRPD, POM, SEM-BSE and hyperspectral analysis).

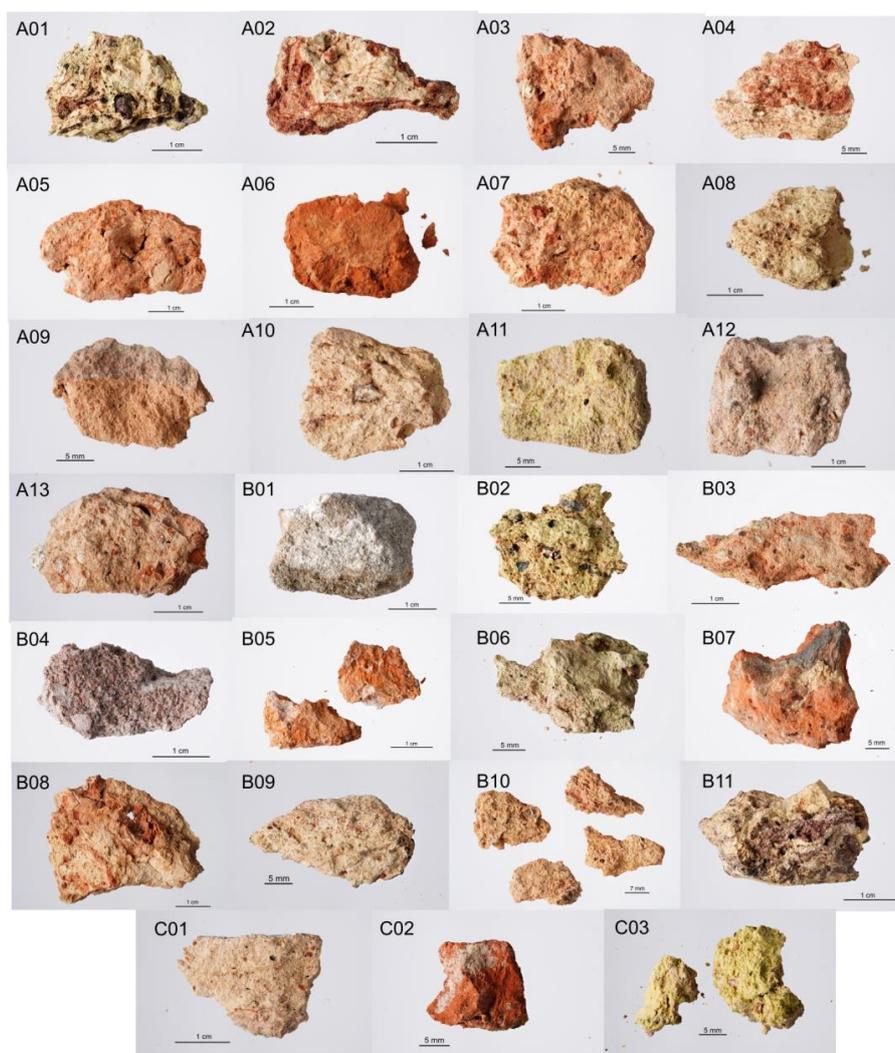
Figure 12: Samples (23 bricks and 4 mortars/grouts) collected from the main façade of the Santa Maria dei Servi.

Macroscopically, bricks are inhomogeneous (Squassina 2011) both in color (from red to yellow/green) and texture (fine homogenous texture, mixed layered and with clay agglomerates) (Fig. 12). Mortars/grouts also display differences from place to place, with evidence of modern interventions.

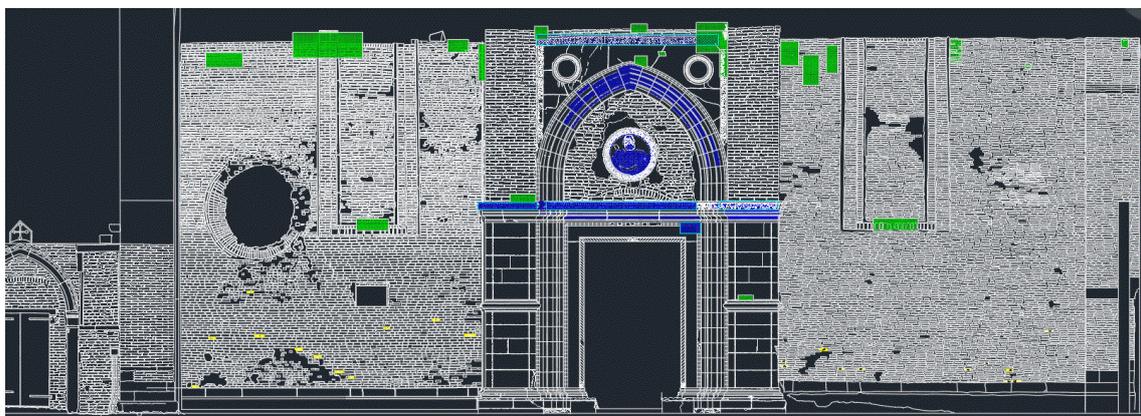
- the collected samples, layered in yellow;
- the main location of black crusts, layered in blue;
- the main location of biodeterioration (in particular secondary vegetation), layered parts in green.

Figure 20: (a) main facade (east); (b) secondary façade (south); (c) apse.

During the on-site survey and with the support of high 3D resolution images the decay assessment of the façade was performed. In Figure 20 are reported:

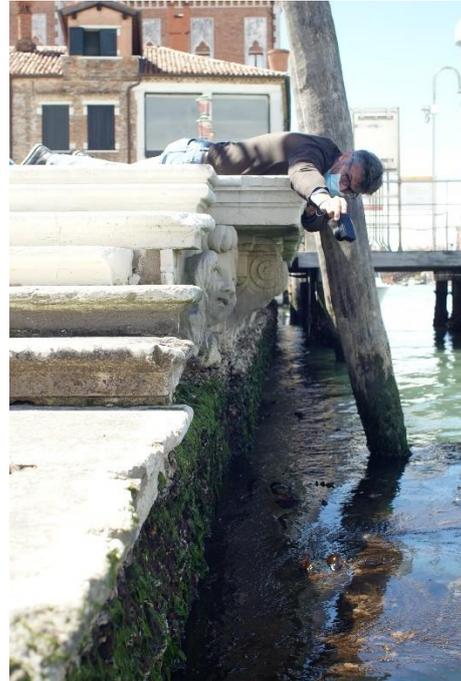
Figure 21: a) eastern side of the staircase of Madonna della Salute; b) western side of the staircase of Madonna della Salute; c) 3D reconstruction of the east angle; d) 3D reconstruction of the east angle in false colour for measuring roughness; f) preliminary results of roughness of the east angle (Fig. 16d).

In figures 21a and b are reported the west and east angles of the staircase of Madonna della Salute. Figure 21c reports the photogrammetric reconstruction of its eastern side, while figs. 20 d and 20 f show some preliminary results on the roughness study of the statue. These images clearly reveal a significant increase of roughness towards the bottom due to a gradient of surface damage and to the presence of algae.
