## D6.5 Dynamic link to hazard and resilience assessment

Deliverable D6.5 “Dynamic link to hazard and resilience assessment” documents the work performed in Task 6.5 “Linking degradation and damage information into a dynamic hazard and resilience assessment” during the period of months 22 to 30 of the project’s duration.

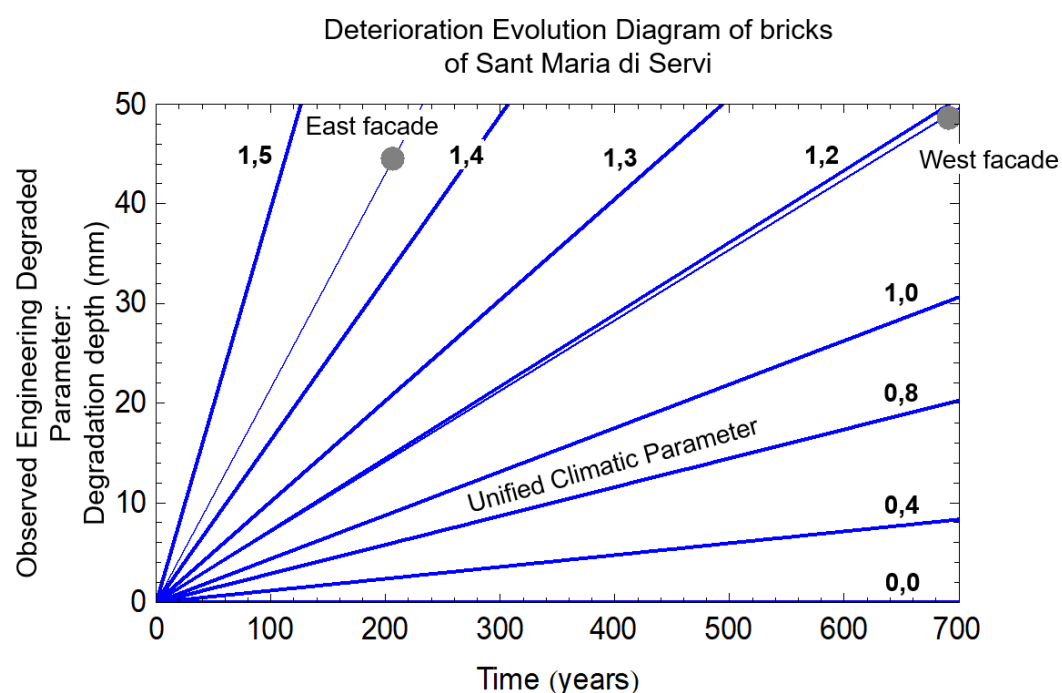
Figure 4. Deterioration Evolution Diagram of the bricks of Santa Maria di Servi (Venice).

In this case the OEDP is the degradation depth of the façade of Santa Maria di Servi (Venice) as a function of time (years) and of the UPC. In this example the UPC is a linear function of freeze-thaw days per year, relative humidity and peak hours of sunshine per day. Due to this last parameter, the two façades of the same building present different level of degradation.

Figure 4 shows an example that will be developed later:

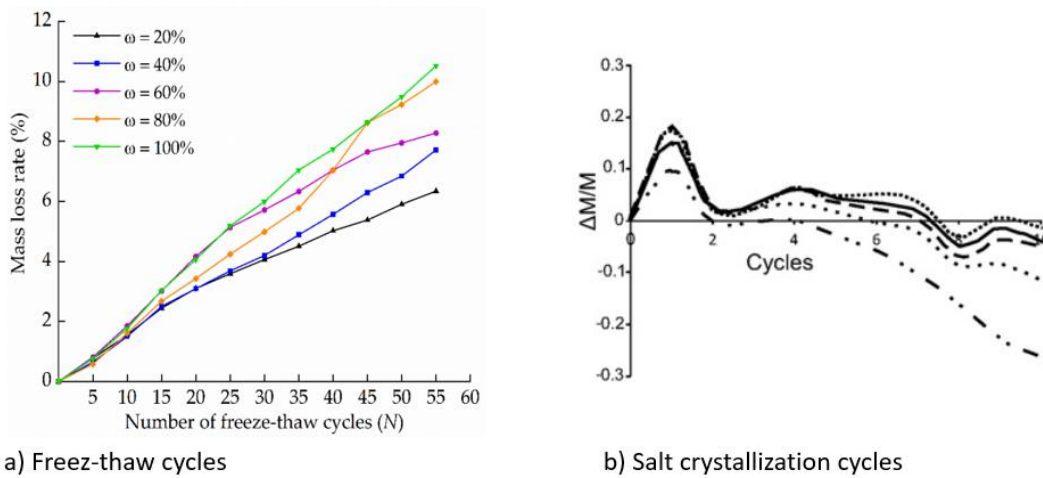
Several studies are available in the literature that relate climatic parameters with material degradation. In particular, for bricks (Coletti *et al.*, 2016), (Yue *et al.*, 2022), some degradation processes has been studied such as: freeze-thaw action for different relative humidity, or salt-crystallization. Figure 7a shows an example of mass loss rate as a function of the number of freeze-thaw cycles and the relative humidity, (Yue *et al.*, 2022). Figure 7b shows an example of mass loss rate for salt-crystallization cycles (Coletti *et al.*, 2016).

Figure 7. Mass loss rate for bricks. a) for number of freeze-thaw cycles and relative humidity (Yue *et al.*, 2022), b) for salt-crystallization cycles (Coletti *et al.*, 2016).

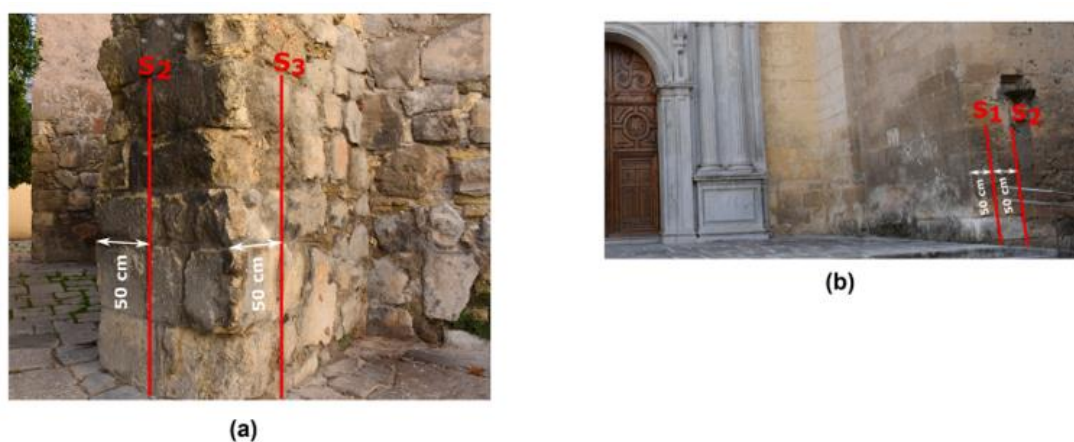
Based on photogrammetry, a degradation pattern of the calcarenite in different parts of the Monastery was studied as described in (Jalón *et al.*, 2020). Figure 9 shows some of the locations where the photogrammetric study was done. Figure 10 shows the degradation patterns, average value and different percentiles.

Figure 9. Location of the degradation profiles in the building: (a) buttress (section S1 located on the hidden side in the picture), (b) main façade.

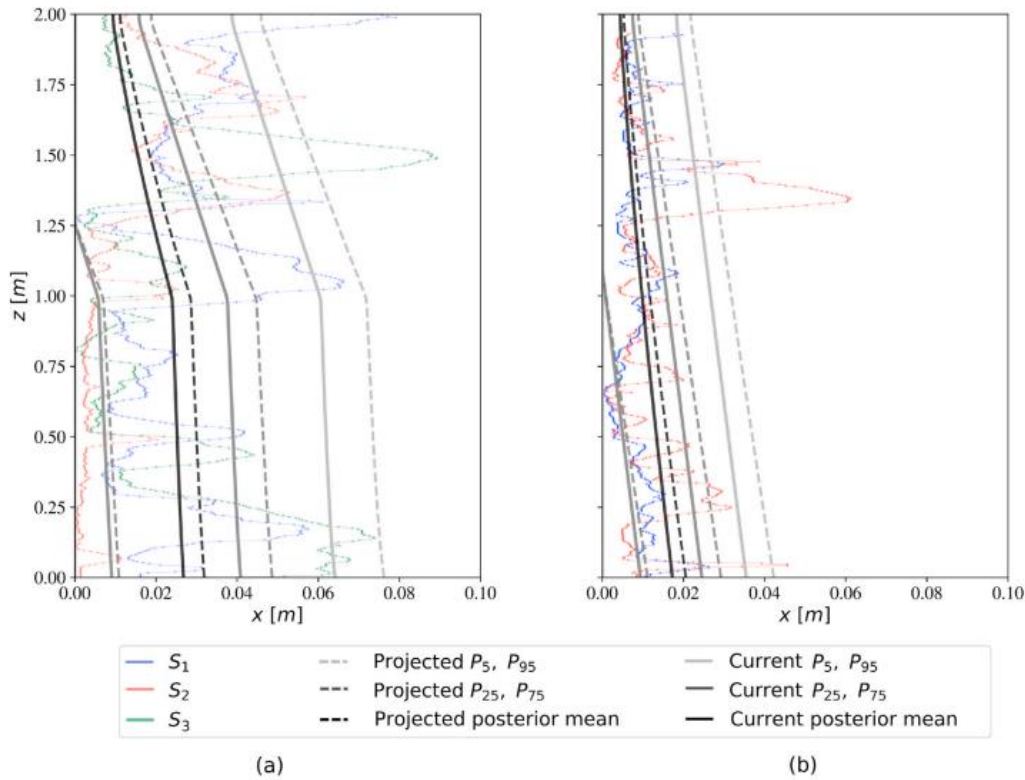
Figure 10. Current and prognosticated posterior mean degradation and confidence intervals ( $P_5, P_{25}, P_{75}, P_{95}$ ) against the experimental degradation data ( $S_1, S_2, S_3$ ) for (a) the buttress, and (b) the main façade of Monastery of San Jerónimo.

In case of the study of the degradation depth, Figure 10 defines the OEDP to use in Equation 3.

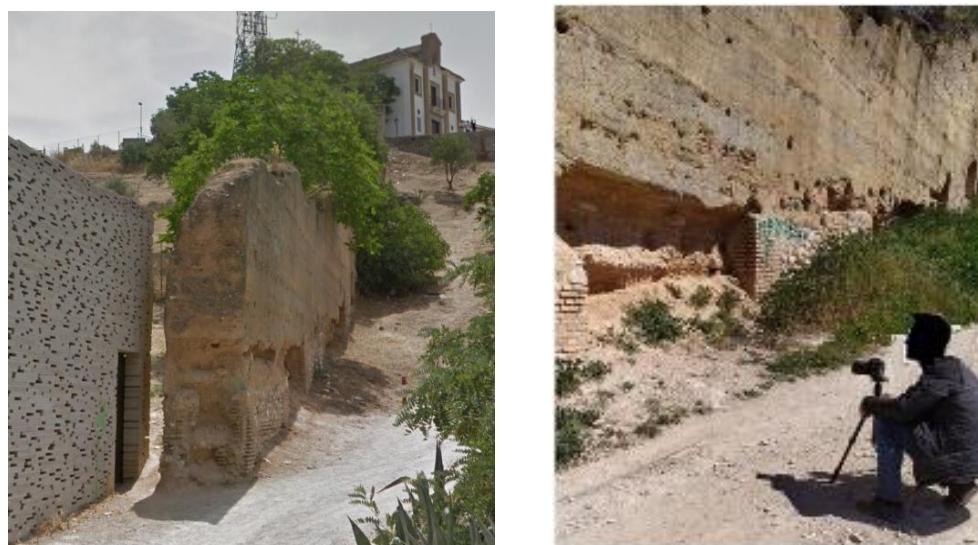
Figure 12. Zirid wall. Photogrammetry of the site.

The digital photogrammetry is used as non-destructive technique for mapping degradation data. Several high-resolution images are taken using a digital still camera (Nikon D7200, 18 mm focal length), a tripod and a remote shutter connected to the camera's wifi to take photos without disturbing the camera. Then, the digital images are processed out of digital images and 3D spatial data are generated, denoted as photogrammetric point cloud (PPC). The degradation sections are extracted from the PPC using the open source software CloudCompare (Girardeau-Montaut, 2016), a 3D point cloud and mesh processing software. Then the data is exported in a suitable format to be read.

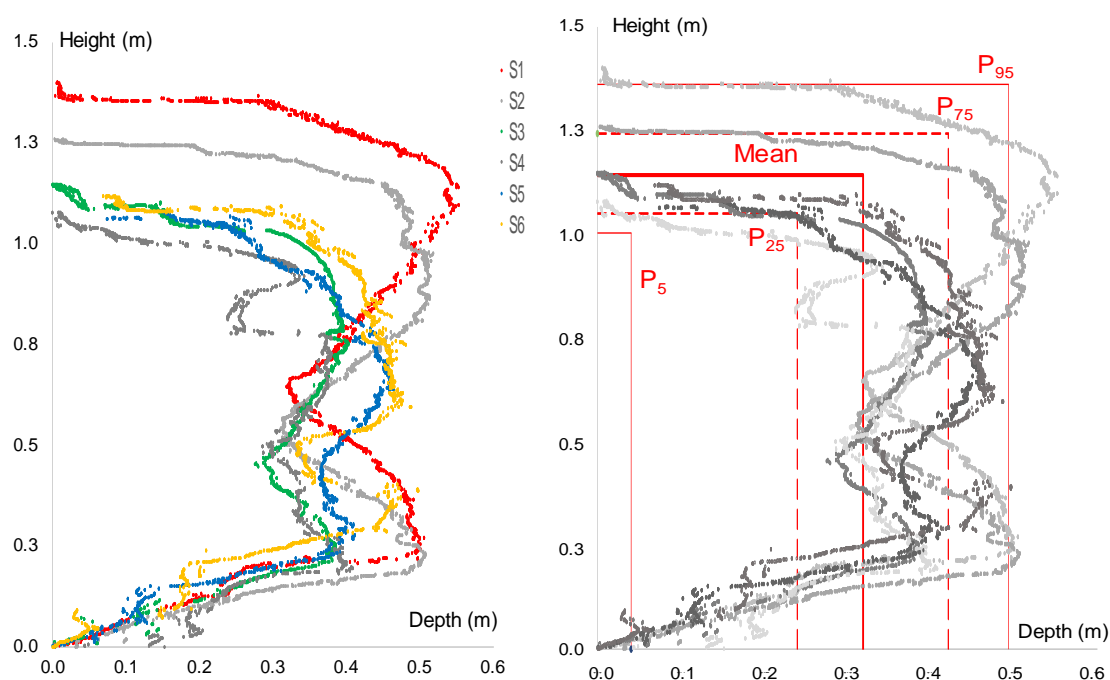
Degraded sections S1 to S6 are represented in Figure 14. As can be seen, the degradation effect affects up to 1.4 meters height and 0.6 m depth. Once the

sections are geometrically defined, the degradation pattern is obtained based on lineal regression. Given the shapes of the degraded sections, a rectangular candidate degradation profile (see Figure 14b) is considered, which represents reasonably well the experimental data. In Figure 14b mean and 5 th, 25 th, 75th and 95th percentiles are indicated. As can be seen in Figure 14b, the mean values of the degraded height and depth are 0.32 and 1.14 m, respectively.

Figure 14. Degradation pattern of rammed earth. a) Sections studied (see Figure 6). b) Rectangular adjusted degraded profiles of rammed earth from linear regression.

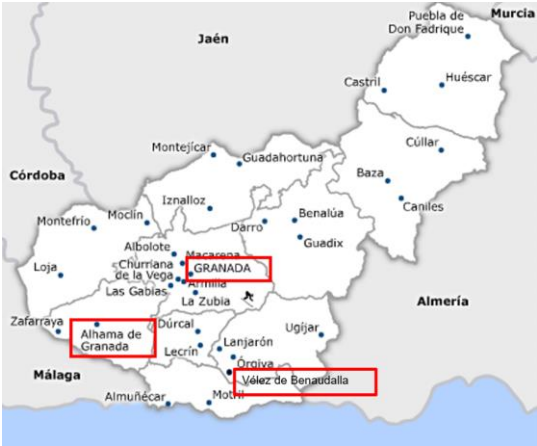
The initial study is based on photogrammetry. Figure 15 shows the three locations, the name of the buildings, and the main environmental characteristics of these places. Figure 16 shows the two other buildings studied besides San Jerónimo.

Figure 15. Point Location of the three locations and CH buildings. San Jerónimo in Granada, del Carmen Church in Alhama de Granada, and Nuestra Señora del Rosario Church in Vélez de Benaudalla.

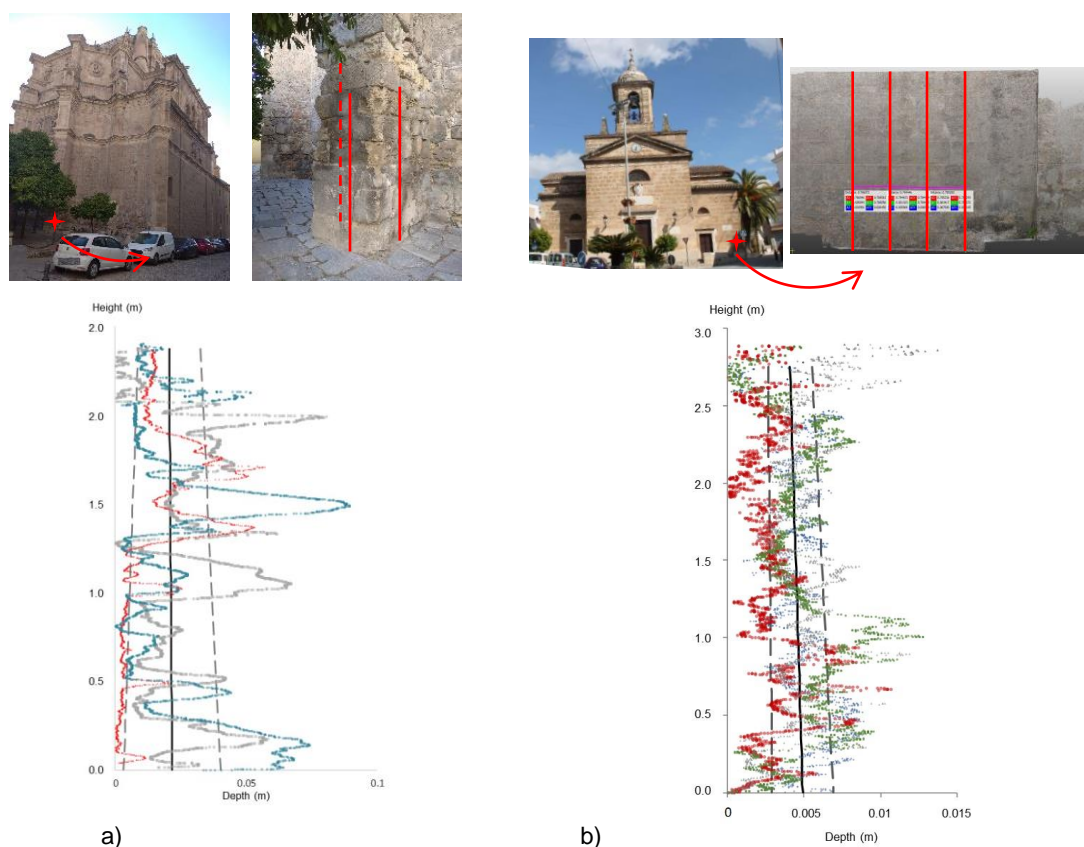
Table 1 summarizes the main parameters measured in the three monuments. Triangular degradation patterns have been considered, as suggested in (Jalón et al., 2020) for calcarenite in Granada. The mean degraded area and the standard deviation of the adjusted degradation patterns are shown in the last two columns of Table 1. It can be observed that degradation is less important in Nuestra Señora del Rosario in Vélez de Benaudalla, a location near the coast. The higher level of degradation appears in the buttresses behind apse of San Jerónimo monastery. Figures 9 and 18.

Figure 18. Recession patterns of a) Butress of San Jerónimo in Granada, b) Main façade of Nuestra Señora del Rosario in Vélez de Benaudalla.

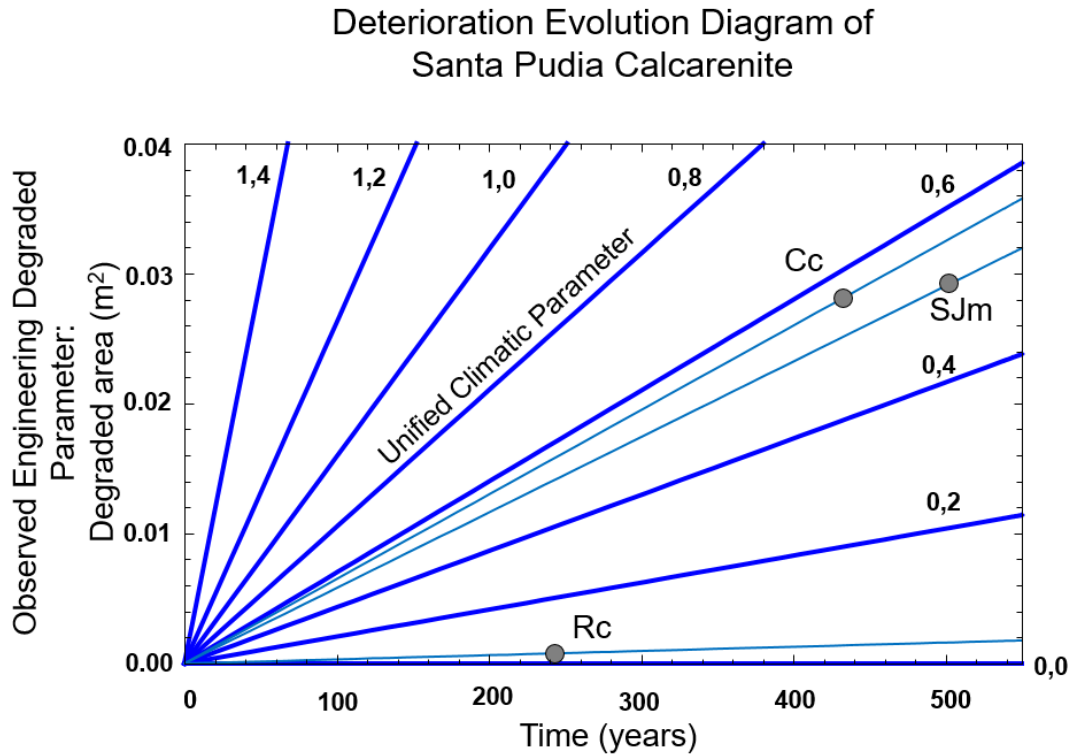
Resulting in  $\xi=0.0001022$ ,  $a_1=0.01025$  and  $a_2=0.00007030$ . The obtained deterioration function has been represented in Figure 19 for different values of the UCP.

Figure 19. Deterioration function depending on the age and the unified climatic parameter. Legend: Cc= Del Carmen church in Alhama de Granada, Rc= Rosario church in Vélez de Benaudalla, SJm= San Jerónimo monastery in Granada.

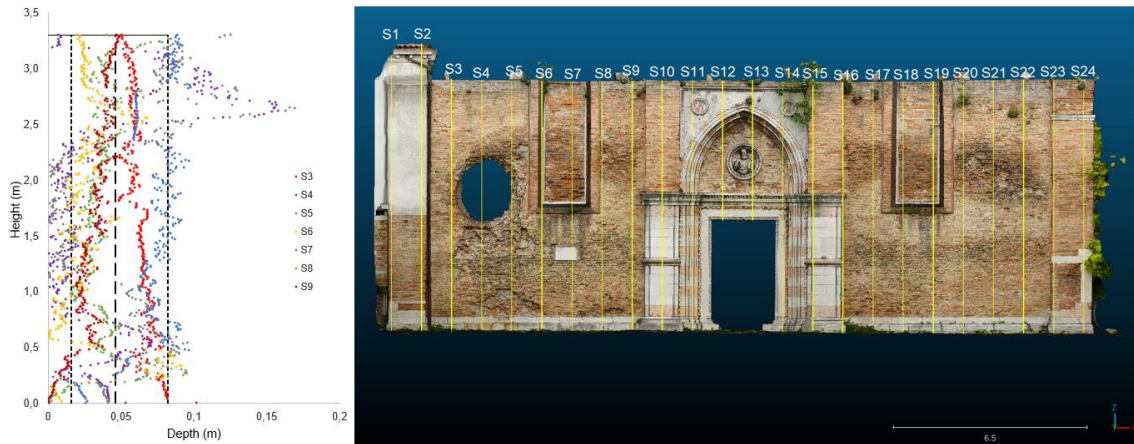
Due to the shape of the degradation in the façades (Figure 20 and 21), a constant degradation thickness along the height of the façade has been considered as OEDP.

Figure 20. Photogrammetric study of the west façade of Santa Maria di Servi, Venice.

The east façade has been altered along its history, being difficult to obtain a total recession rate. Only the upper part of Section 3 (S3), at both sides of the wall, seems trustful, see Figures 20 and 21.

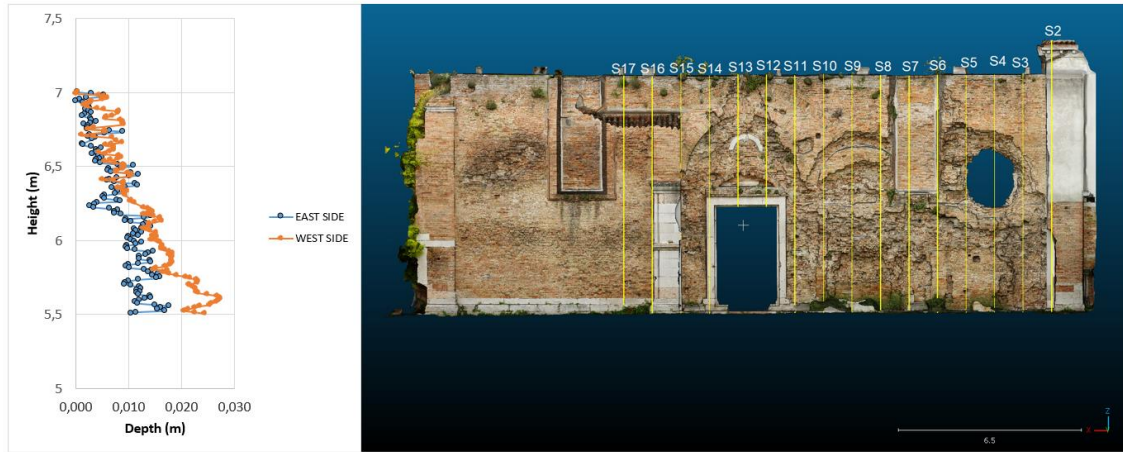
Figure 21. Photogrammetric study of the east façade of Santa Maria di Servi, Venice.

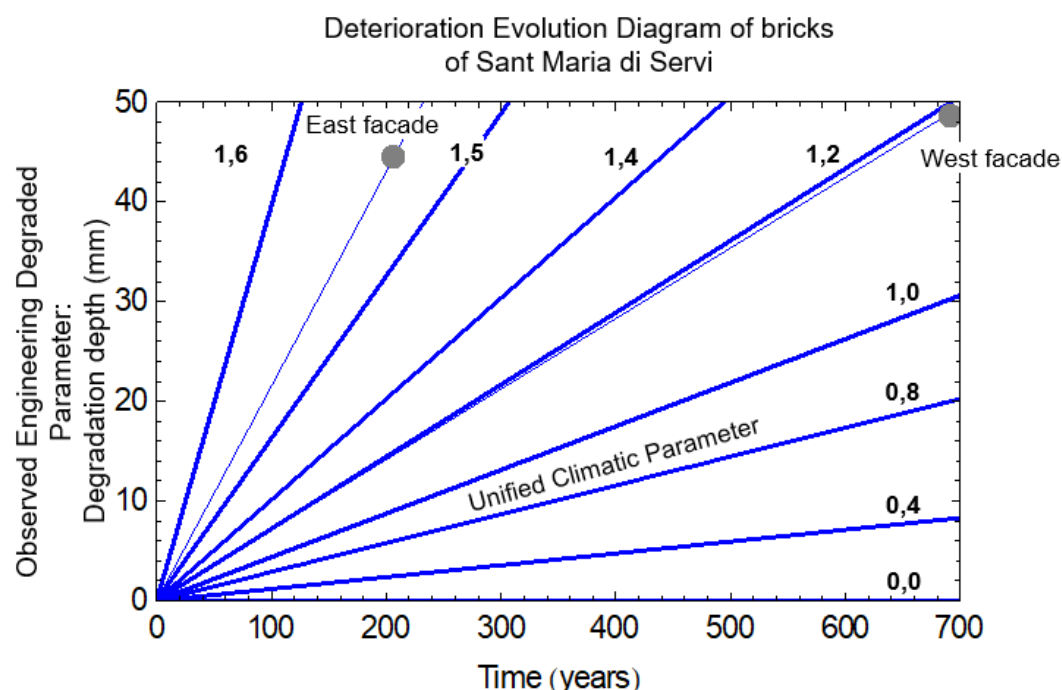
Equation 10 is plotted in Figure 22.

Figure 22. Deterioration Evolution Diagram of the bricks of Santa Maria di Servi, Venice.

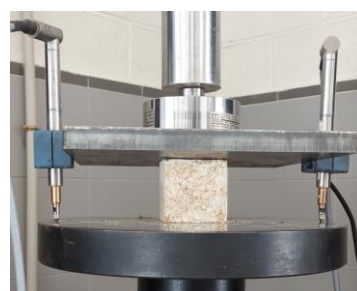
The Unconfined Compressive Strength (UCS) of the rammed earth was experimentally obtained from specimens prepared in laboratory. The earth material was hand-mixed with the optimum moisture content (8% by mass). A cylindrical mold (15 cm diameter, 30 cm height) was used to prepare the samples. Consequently, the resulting RE samples had an aspect ratio of 2 (it is important to avoid smaller aspect ratios according to (Aubert *et al.*, 2013)). The moist soil was poured into the mold and compacted in 6 layers with 2 kg of material for each one. Each layer received the Proctor Energy ( $E = 0.583 \text{ J/cm}^3$ ), which was measured with a manual rammer. The objective of this manufacturing strategy is to obtain a RE sample as similar as possible to in situ material. After the compaction process, the RE samples were removed from the molds and left drying for 4 months in normal atmosphere. They were considered “air-dry” when moisture content remained constant, which occurred approximately at the 25th day. Finally, the bottom and top surfaces of the RE samples were capped with a mortar in order to provide a flat smooth surface. The average  $\sigma$ - $\epsilon$  compression curve is represented in Figure 25.

Figure 25. (a) Experimental results of compression tests of SPC, (b) uniaxial compression test setup, (c) test setup for determining the Elastic Modulus.

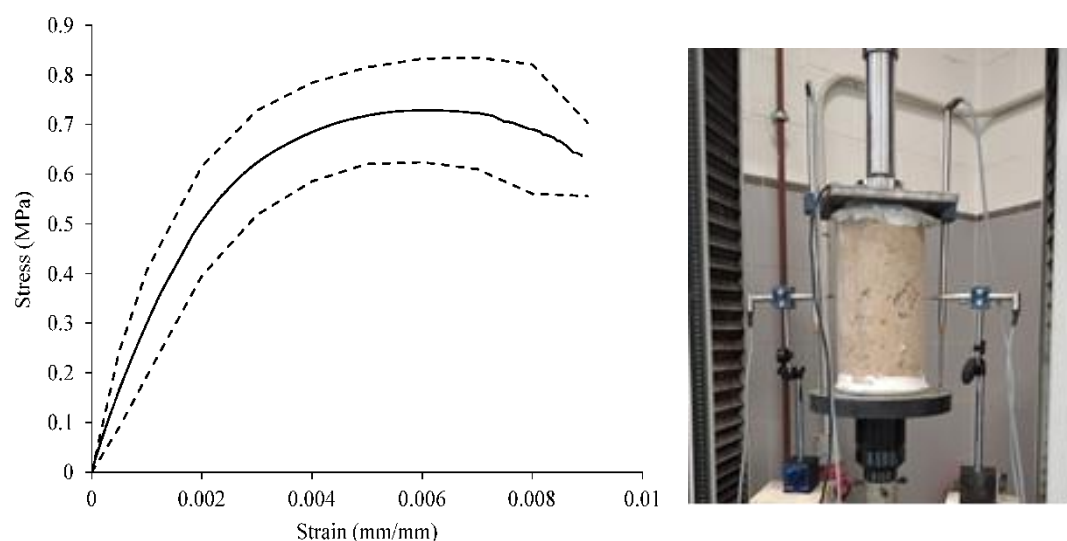
Figure 26. Average stress-strain curves of all the RE samples tested (black curves). Dashed black curves correspond to the standard deviation of compressive stress

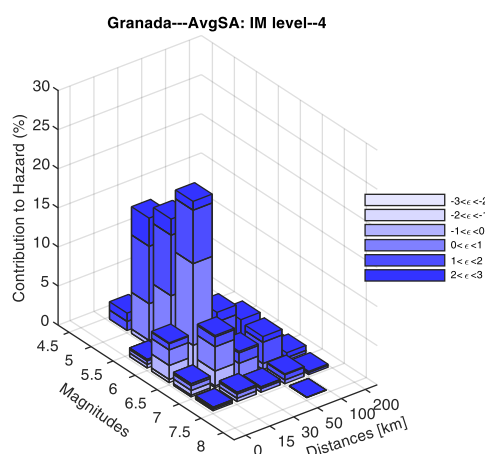
Disaggregation analysis (Bazzurro and Cornell, 1999) was conducted for each IM level. Figure 29 shows the disaggregation bar charts corresponding to the fourth IM level.

Figure 29. Disaggregation analysis results obtained for a return period of 475 years of AvgSA in Granada.
