Fragility Curves for Historical Structures with Degradation Factors Obtained from 3D Photogrammetry

Abstract: The influence of the effects of the degradation of materials on the seismic fragility of Cultural Heritage buildings in Granada (Spain) is investigated. The degradation of the material, which mainly happens at the lower levels of the façades, is obtained by using 3D photogrammetry data. Fragility curves for three cultural heritage constructions in Granada are calculated by using FE nonlinear dynamic analyses for both non-deteriorated and deteriorated geometries. The Finite Elements (FE) models, based on the macro-modelling technique, are subjected to ground motions for the city of Granada, which were selected by considering Probabilistic Seismic Hazard Analysis (PSHA) methodology with their probability of occurrence. The response of each model is analyzed for different seismic Intensity Measure (IM) levels, which, in this study, correspond to average pseudo-acceleration. The procedure is applied to three monuments in Granada that were built with two different constructions materials: calcarenite and rammed earth. The damage mechanisms considered are roof displacement or ma

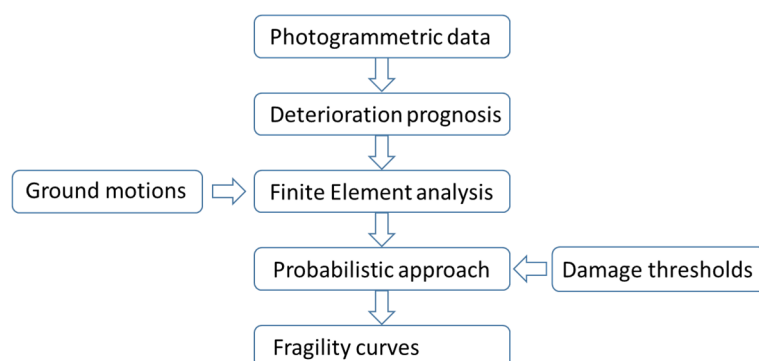
Figure 1. Flow chart of the methodology.

This paper proposes a methodology for calculating the probability of exceeding a certain performance objective of a damaged historical monument as a function of the intensity of ground motion, see the flow chart shown in Figure 1. A deterioration pattern is calculated using 3D photogrammetric data, as in [8]. A linear interpolation from the age of the construction to its current state is calculated to obtain a deterioration prognosis that can be applicable to future events.

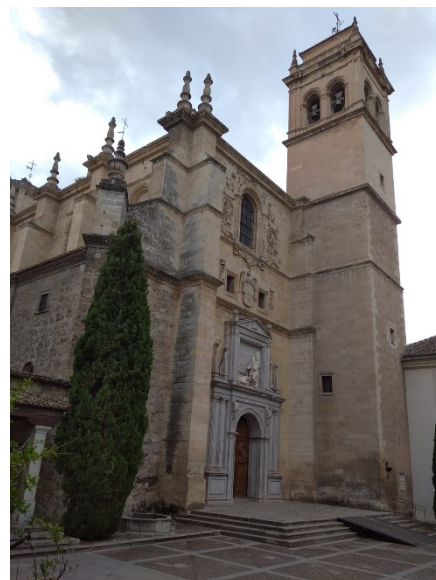
Figure 2. (a) The Church of San Jerónimo monastery of Granada and (b) cloister.

The Church of the Monastery of San Jerónimo, which started being built in 1519, has a Latin cross plan with a polygonal apse. Entering through the main door of this church, the tower is on the right of the facade, see Figure 2a. The tower was finished in 1565, being its upper half demolished at the beginning of the 19th century and rebuilt in the 20th century. Figure 2b shows that one of the lateral façades of the church is attached to a cloister. The church is built of Santa Pudía stone.

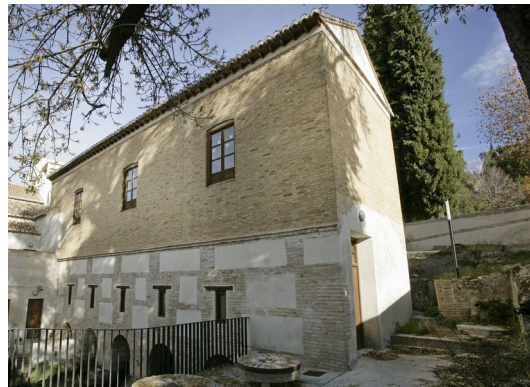
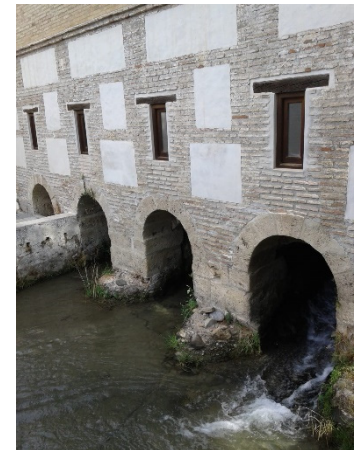
Figure 3. Molino del Marqués de Rivas, (a) lateral view, (b) detail of the foundations.

The area of the building close to the foundations is made of SPs (Figure 3), which supports walls of rammed earth and brick. The building has one floor, with a typical gabled roof supported on wooden beams.

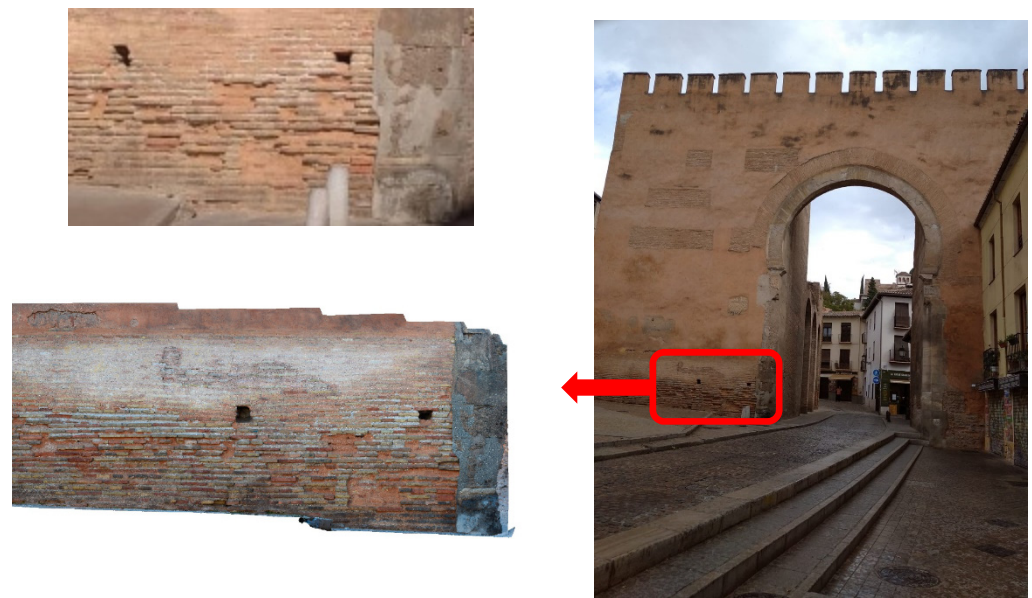
Figure 5. Detail of the restoration work carried out with bricks on the east façade of Puerta Elvira.

Recession patterns of SPs and their linear evolution over time using empirical descriptions based on photogrammetry have recently been proposed [8]. Degradation patterns for RE construction cannot be obtained for PE, because it has had major restoration work done using bricks in the lower part of the east façade (the part of the monument built with rammed earth that is most affected by degradation factors, see Figure 5).

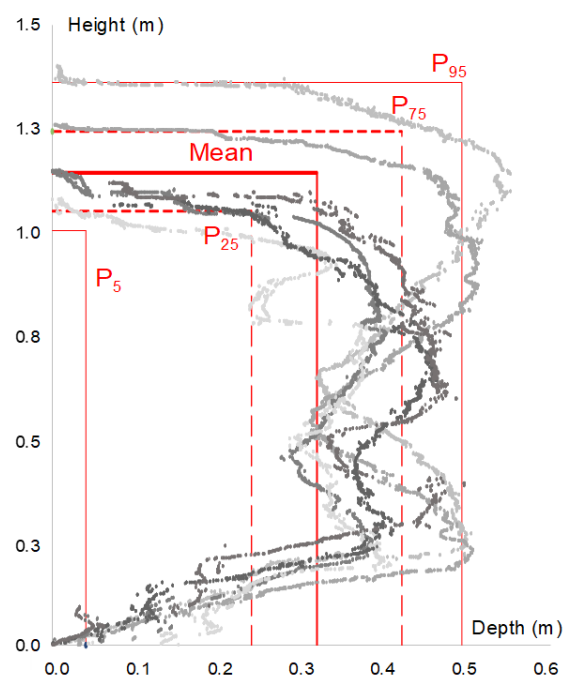
Figure 8. Degradation pattern of rammed earth. Sections studied (see Figure 8) and rectangular adjusted degradation profiles obtained by using linear regression.

To obtain the degradation pattern of the rammed earth six (S1 to S6) of the 21 sections indicated in Figure 7 are considered. Degraded sections S1 to S6 are represented in Figure 8. As can be seen, the degradation effect reaches a height of up to 1.4 m and a depth of 0.6 m. Once the sections are geometrically defined, the degradation pattern is obtained by using lineal regression. Given the shapes of the degraded sections, a rectangular candidate degradation profile (see Figure 8) is considered, which represents the data obtained reasonably well, especially considering that the lower part (from 0 to 0.3 m) is composed of unconsolidated material, obtained from the degradation of the upper part. In Figure 8 mean and 5th, 25th, 75th and 95th percentiles are indicated. Figure 8 shows that the mean values of the degraded height and depth are 0.32 and 1.14 m, respectively.

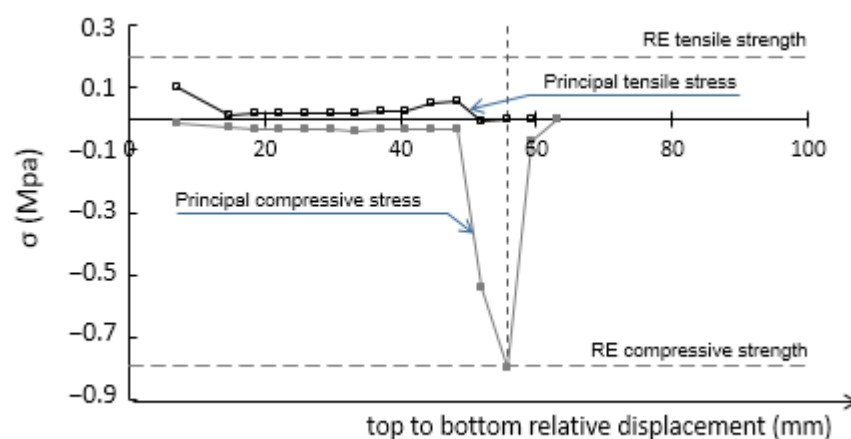
Figure 13. Maximum and minimum principal stresses as functions of the relative displacement imposed between the upper part of the main body of PE for the non-degraded numerical model, see Figure 9. FE push-over static analysis.

The threshold displacement was obtained from a FE push-over static analysis of PE. Maximum and minimum principal stresses in the element of rammed earth in the extrados of the arch next to the apex as a function of the relative displacement imposed at the top of the arch of PE (see Figure 9) are represented in Figure 13. In Figure 13 the tensile and compressive strengths of rammed earth are represented by horizontal dashed lines. As Figure 13 shows, the threshold displacement (or damage threshold, see Figure 1) was adopted as the one for which the compressive strength of the rammed earth was reached (compression is negative). The threshold displacement is 55.5 mm.

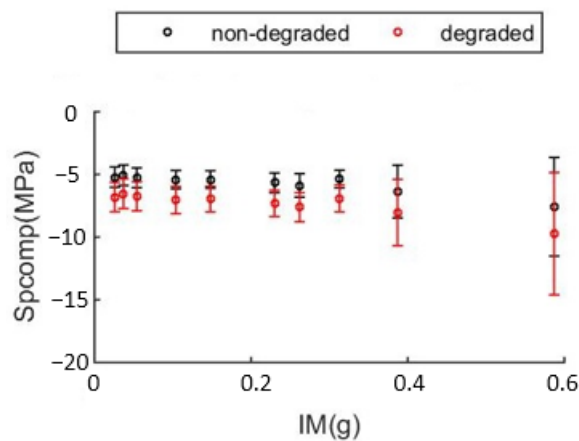
Figure 16. Mean and SD of the minimum compressive principal stresses.

The mean values and the SD of the minimum principal compression stress for the IMs considered are represented in Figure 16.

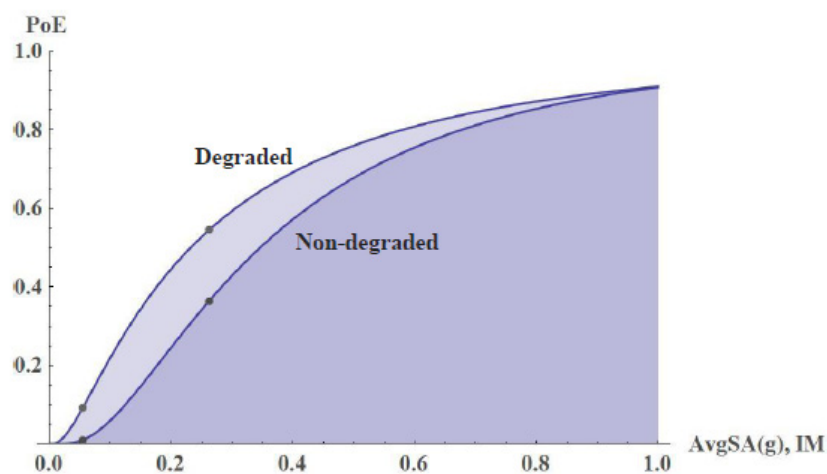
Figure 18. Fragility curve for Molino del Marqués de Rivas. Reference parameter: story drift corresponding to 0.01 of the height at point P.

Figure 18 shows that for an average pseudo-acceleration of 0.23 g, there is around 50% probability of exceedance of the drift considered as allowable in this study. However, given that the stress levels are well below the compressive strength of SPs and that no tensile stresses were developed, it can be concluded that the SPs degradation does not affect the structural behavior of the Molino del Marqués de Rivas over the entire IM range.

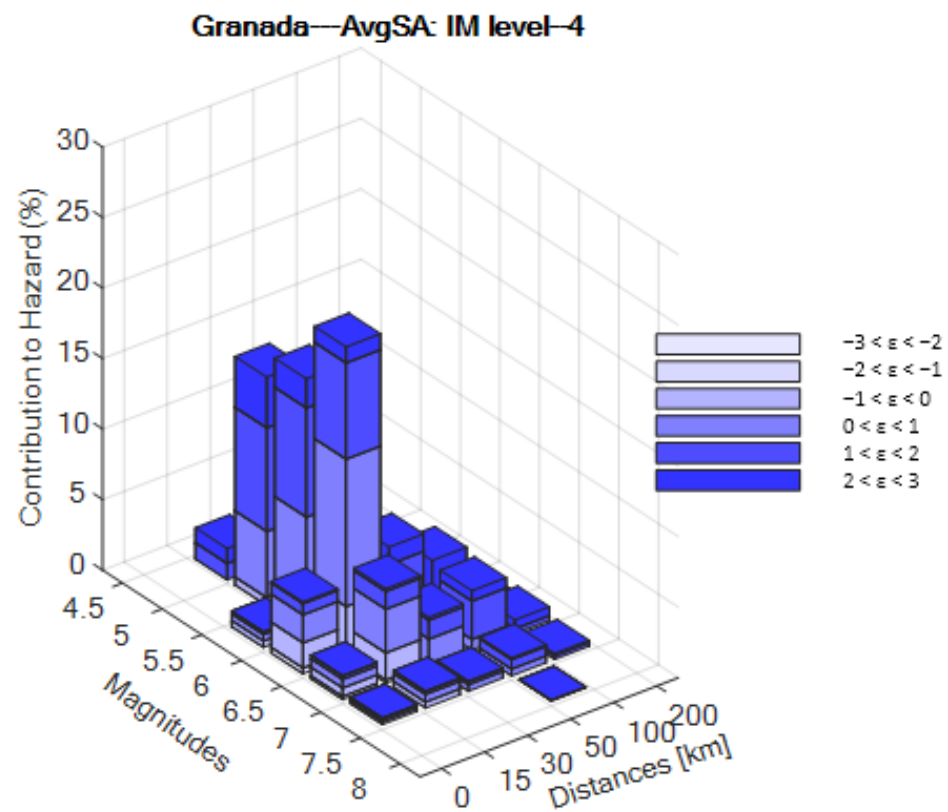
Figure A2. Disaggregation analysis results obtained for a return period of 475 years of *AvgSA* in Granada.

The disaggregation analysis [38] was conducted for each *IM* level. Figure A2 shows the disaggregation bar charts corresponding to the fourth *IM* level.

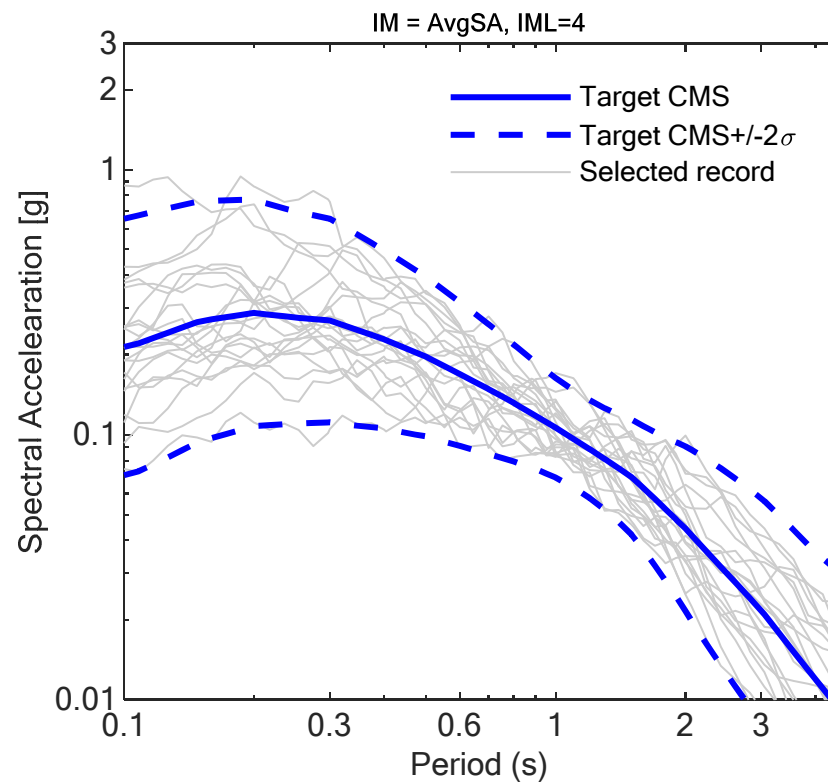
**Figure A3.** Selected records and the 2.5th/50th/97.5th percentiles for Granada using *AvgSA* as the conditioning *IM* corresponding to a return period of 475 years.

The records were selected from the NGA-West database [42] and no distinction between pulse-like and non-pulse-like records was made. Moreover, no limitations for the causal parameters of the selected records in terms of \bar{M} , \bar{R} , and V_{S30} were accounted for in the selection. This means that it is assumed that the spectral shape can explain all the characteristics of the hazard at the sites, and there is no need to specifically select the records that match certain bins of \bar{M} , \bar{R} and V_{S30} or pulse/non-pulse that could be observed at the site (see [43] for more details). Figure A3 shows the records selected and 2.5/50/97.5th percentiles of the CS target spectra for the fourth IM Level.
